MOUNT EDGCUMBE JOINT COMMITTEE – SUPPLEMENT PACK I

10. Mount Edgcumbe Fire Damage Options Appraisal:

Barrow Centre, Mount Edgcumbe.

Fire Damage Refurbishment - Options Appraisal

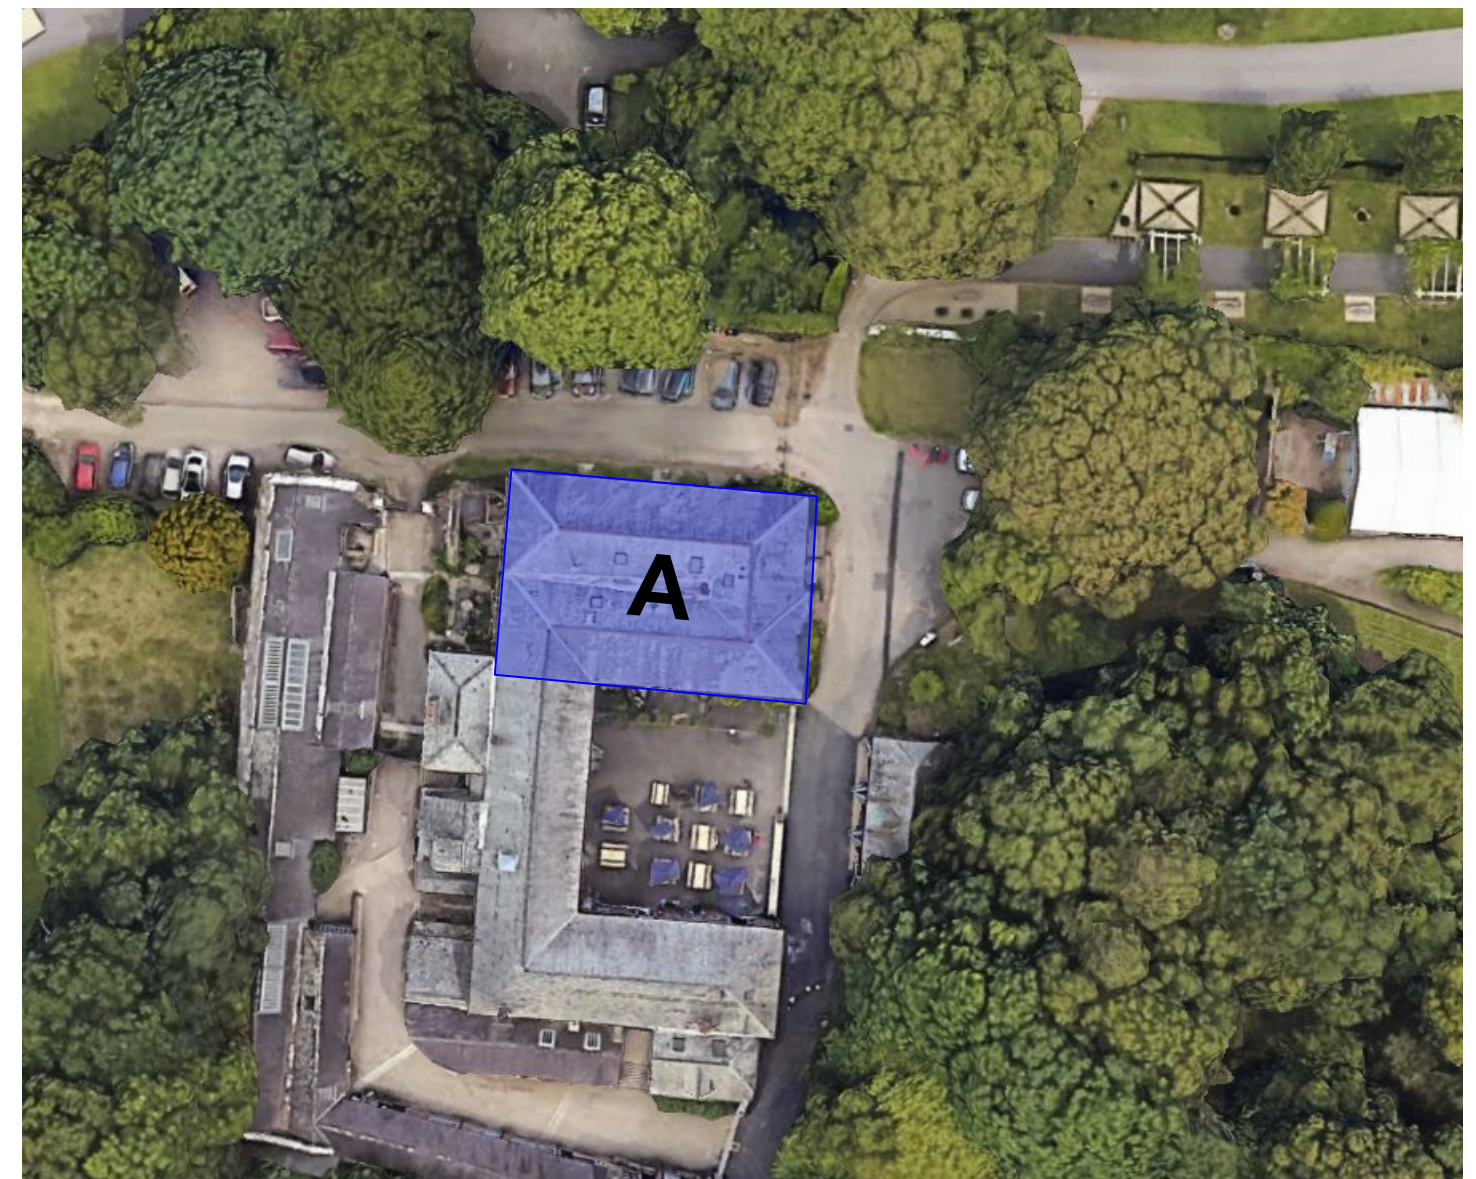
The area marked A is the section of the Barrow centre that has been damaged by the fire and subsequent water ingress due to the lack of weather proofing.

Fig. 1. Area shaded in blue denoting the fire damaged Barrow Centre Accommodation Block.

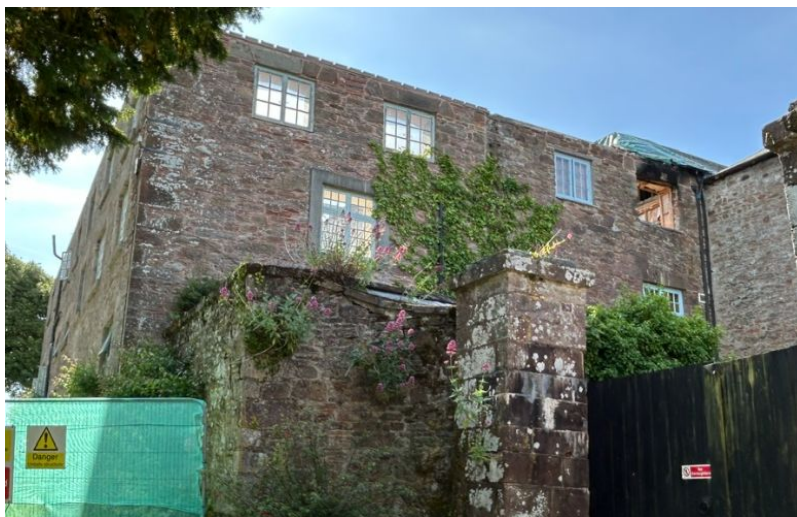
Fig. 10. Photo 2 -
East elevation general view

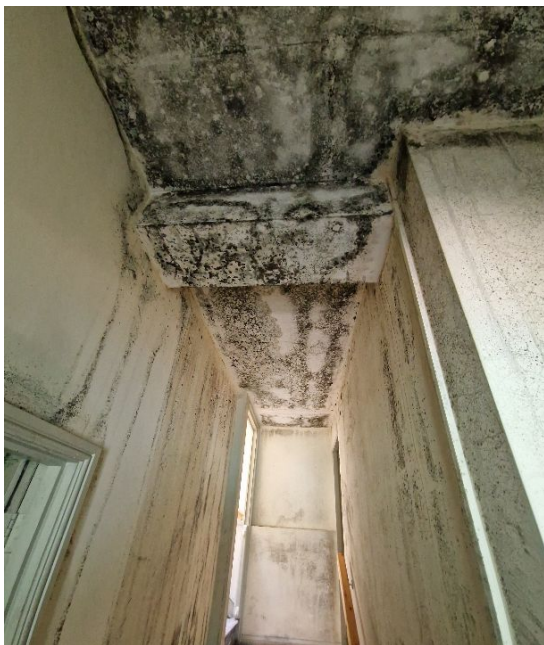
Fig. 13. Photo 5 - Yew Tree Cottage lower ground. Black mould growth

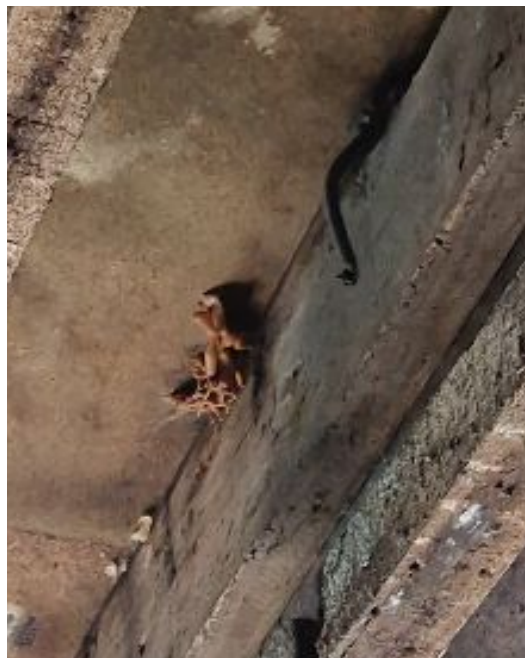
Fig. 15. Photo 7 - Fungal growth observed to timber suspended floor

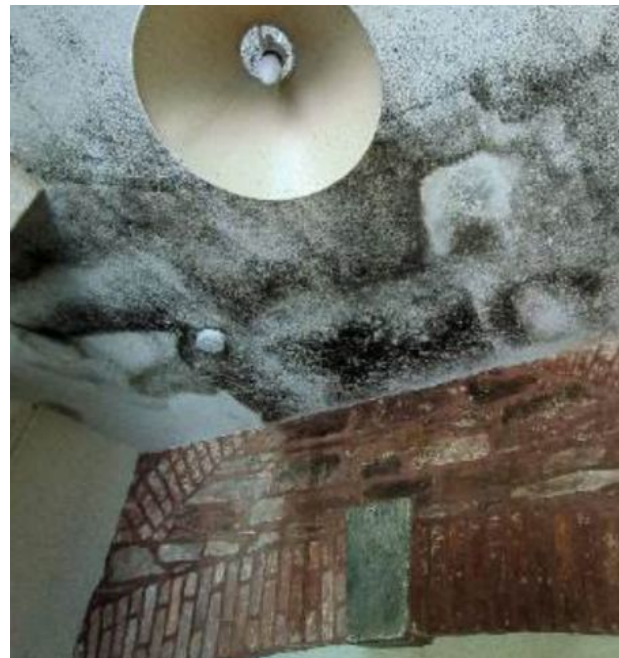
Fig. 16. Photo 8 - Horseshoe Cottage, black mould on lobby ceiling

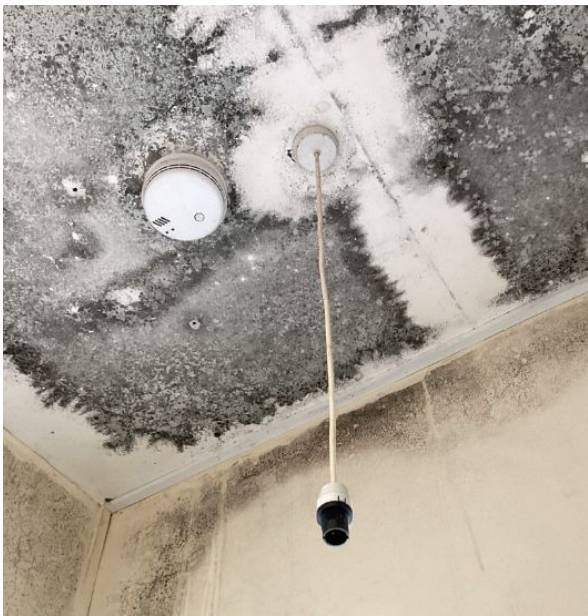
Fig. 17. Photo 9 - Water damaged Upvc ceiling rose and cable

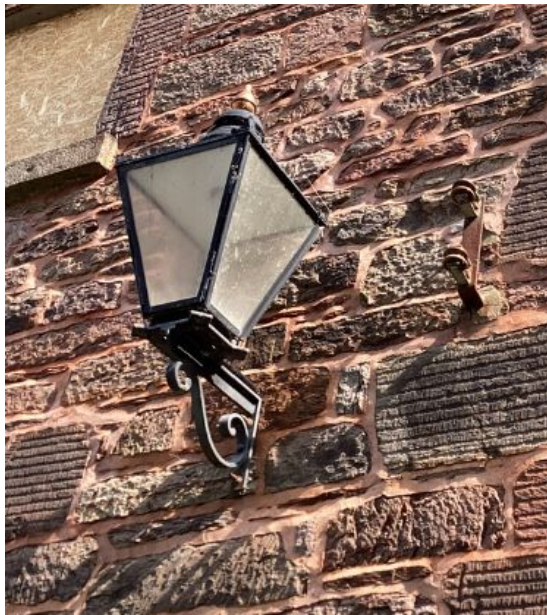
Fig. 18. Photo 10 - External light fixed to stone wall requires renewal

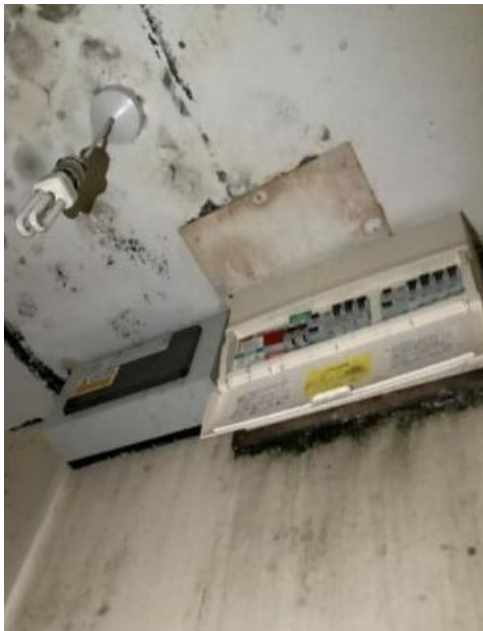
Fig. 20. Photo 12 - Distribution board water damaged

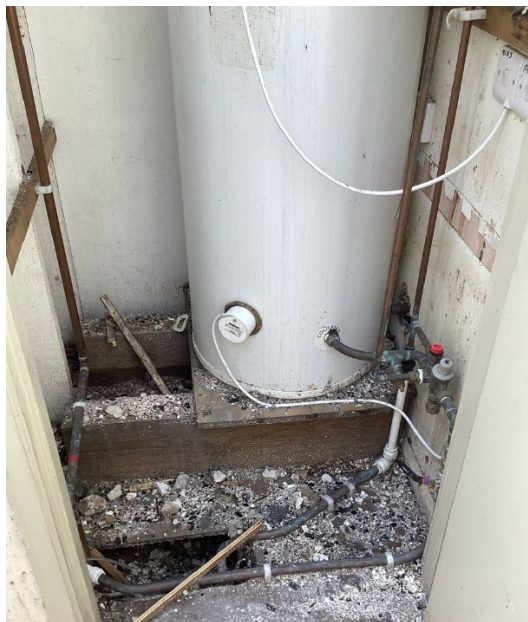
Fig. 21. Photo 13 - Yew Tree Cottage, Immersion heater likely water damaged

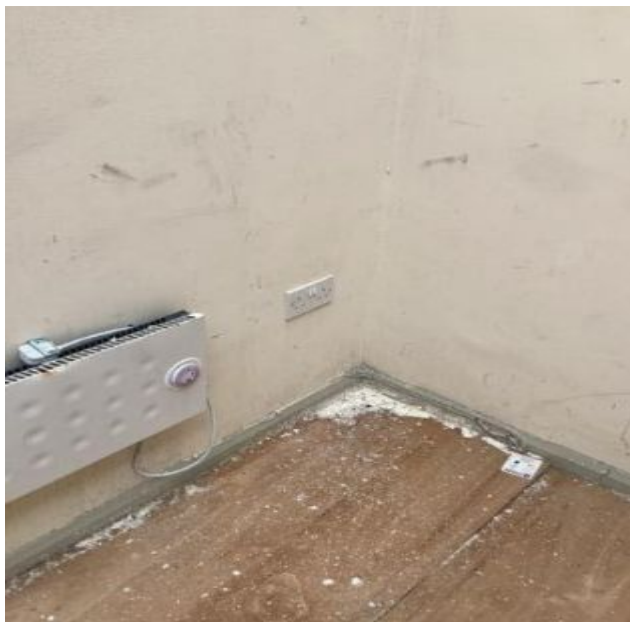
Fig. 22. Photo 14 - Yew Tree Cottage, electric heater water damaged

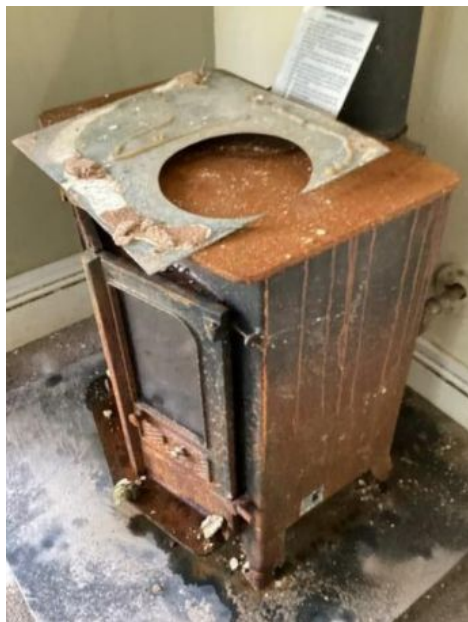
Fig. 23. Photo 15 - Horseshoe Cottage, Wood burner heavily corroded

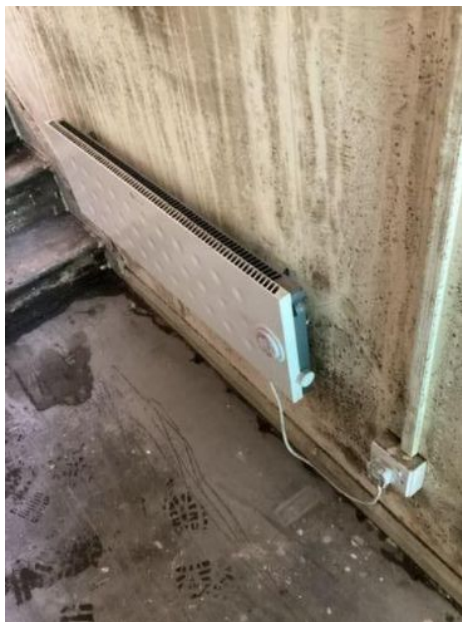
Fig. 24. Photo 16 - Yew Tree Cottage, electric heater damaged

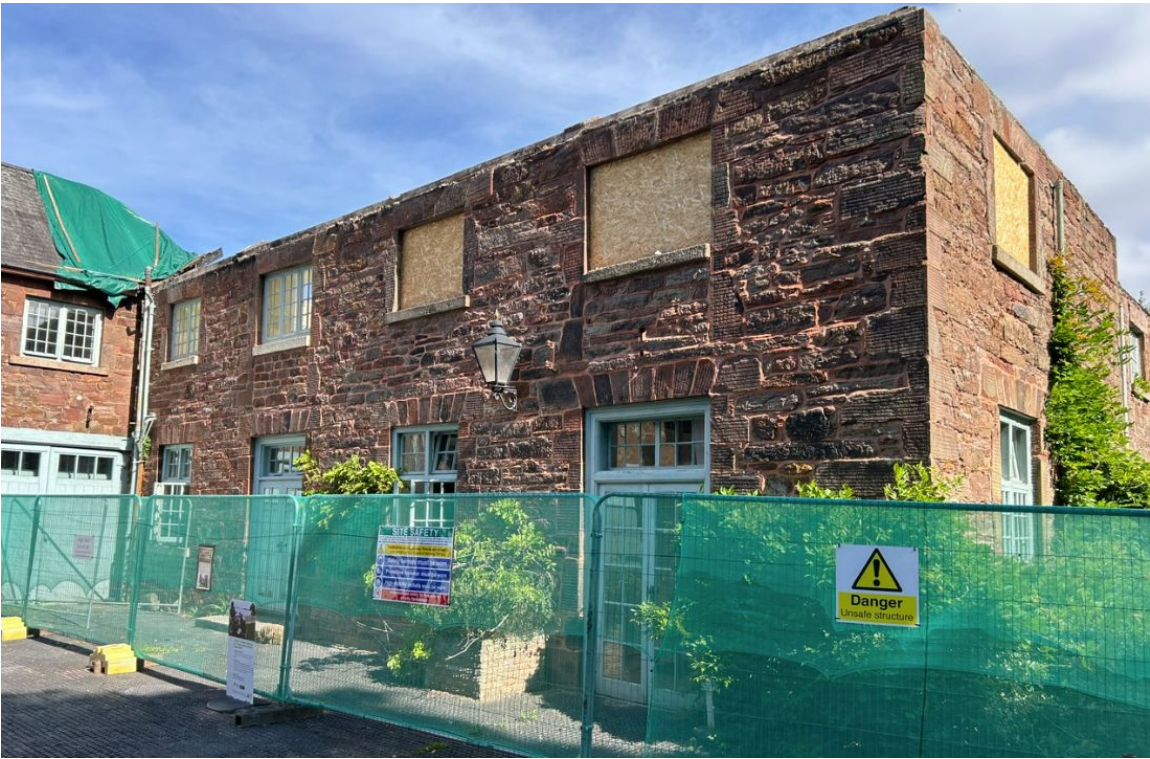
Fig. 25. Photo 17 -
Boarded windows to the courtyard elevation of the
Barrow Centre Accommodation Block.

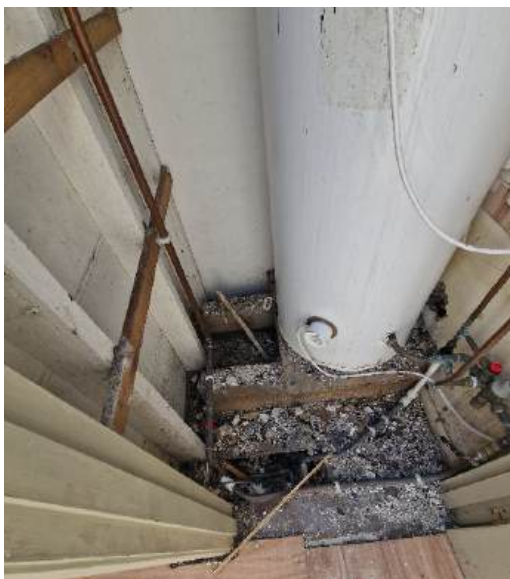
Photograph 17 - Floor condition in immersion cupboard (GF Yew tree cottage)

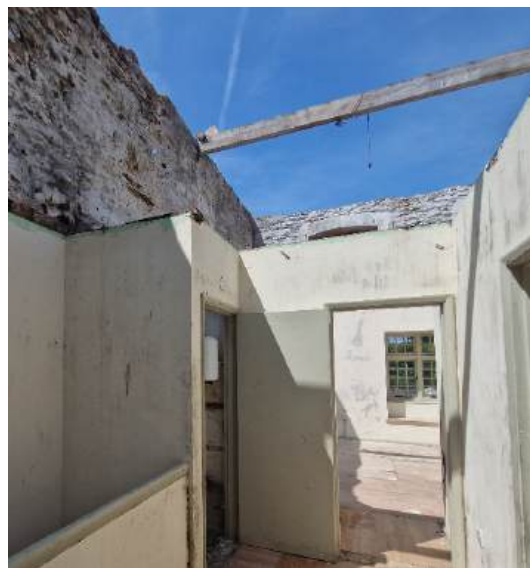
Photograph 18 - No ceiling in hallway (GF Yew tree cottage)

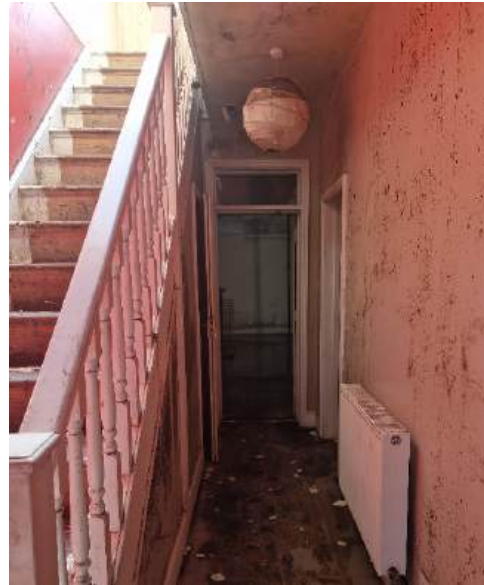
Photograph 22 - Staining to hallway walls (GF Flat 6)

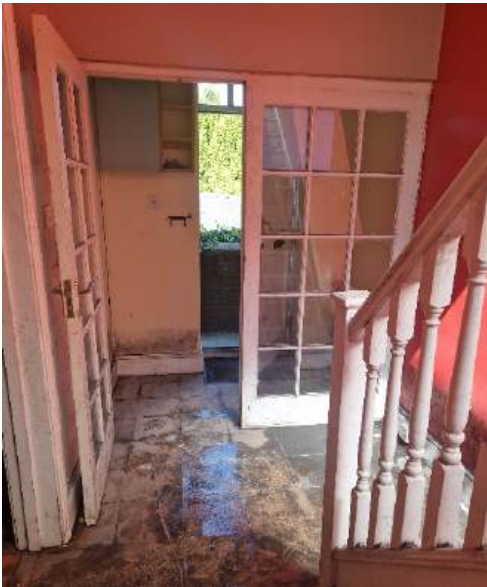
Photograph 23 - tiled floor finish in hallway (GF Flat 6)

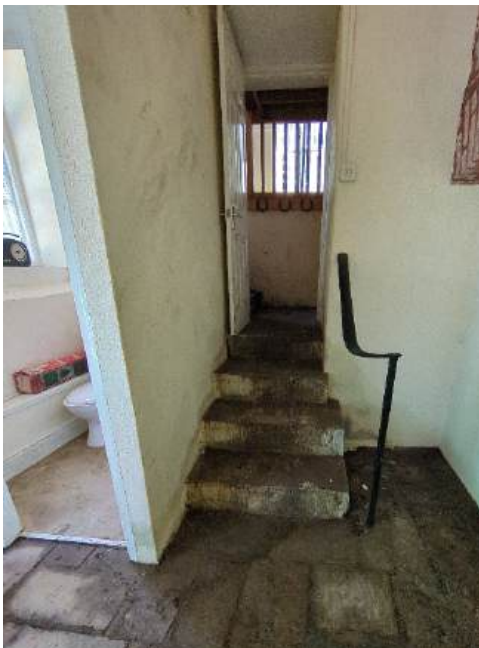
Photograph 31 - Concrete staircase heavily stained (LGF Horseshoe cottage)

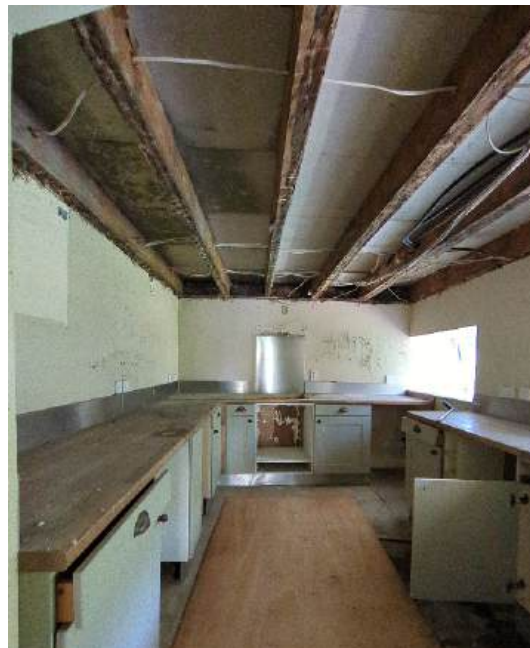
Photograph 32 - kitchen ceiling finish removed (GF Horseshoe cottage)

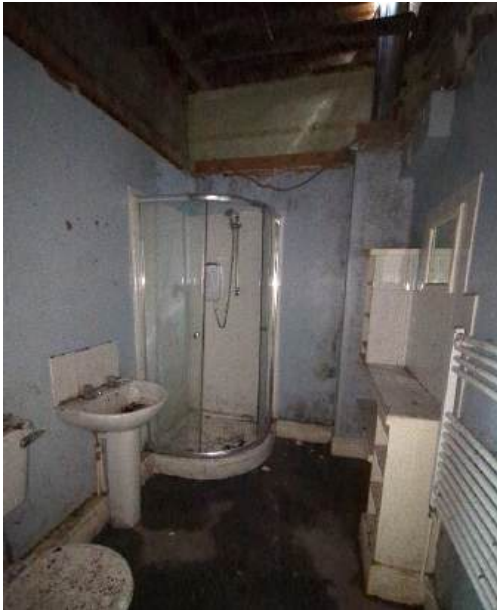
Photograph 37 - Sanitary units heavily stained (GF Horseshoe cottage)

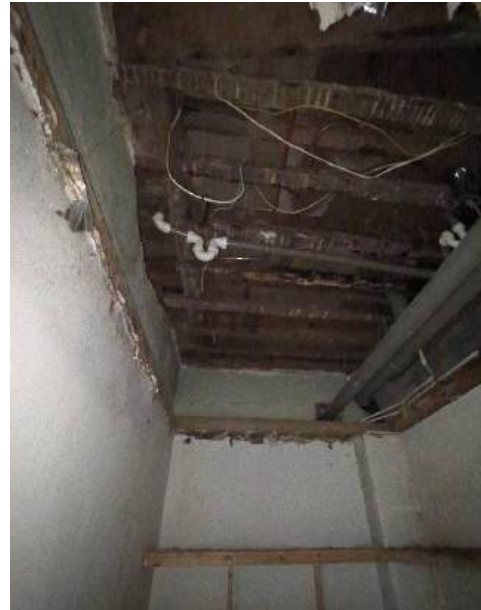
Photograph 38 - Store ceiling finish removed (GF Horseshoe cottage)

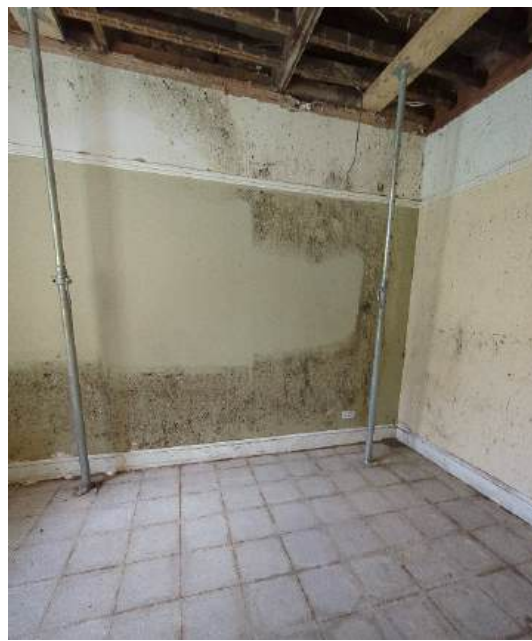
Photograph 44 - Bedroom 2 wall finish stained (GF Horseshoe cottage)

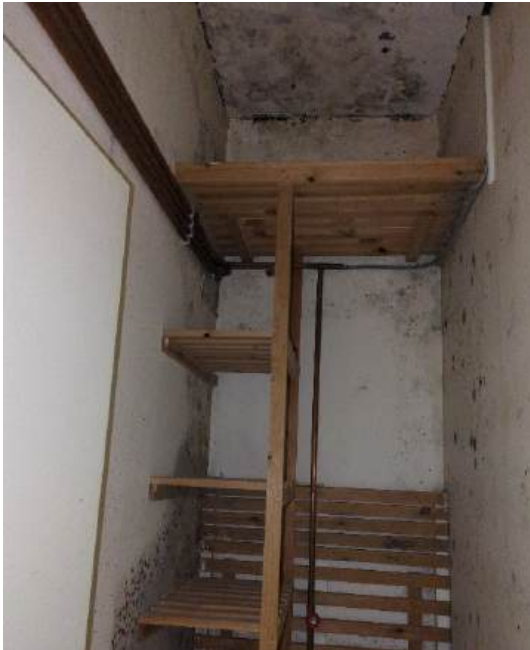
Photograph 45 - Airing cupboard ceiling finish moldy (GF Horseshoe cottage)

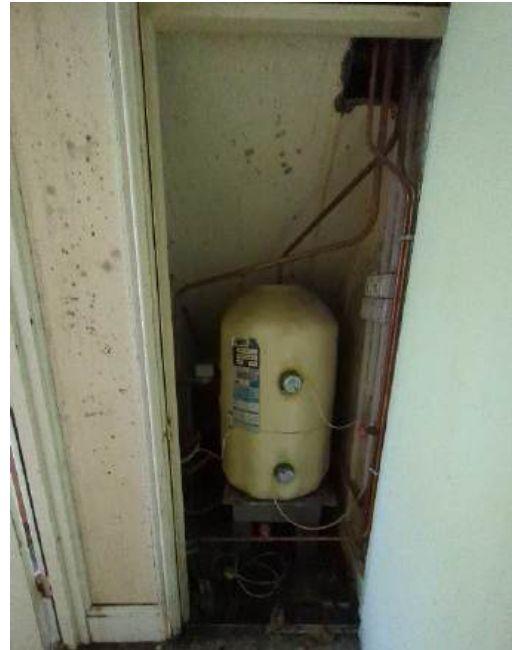
Photograph 46 - Immersion cupboard ceiling finish stained

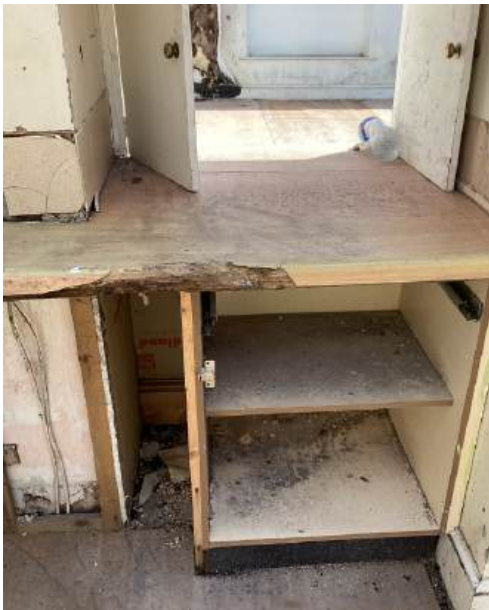
Photograph 47 - kitchen units damaged ((1F Horseshoe cottage)

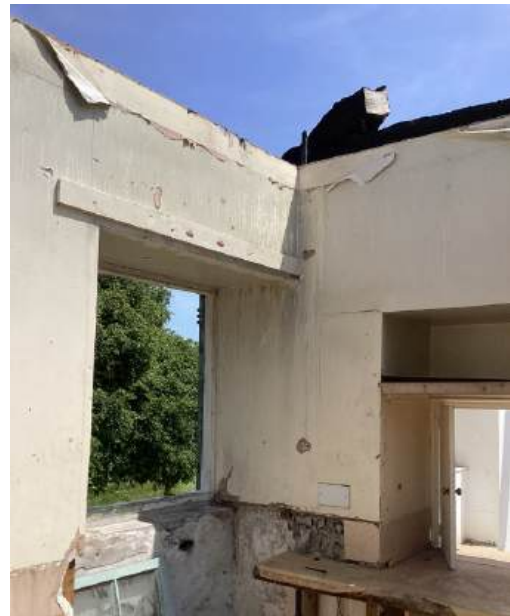
Photograph 48 - Lounge windows damaged (1F Horseshoe cottage)

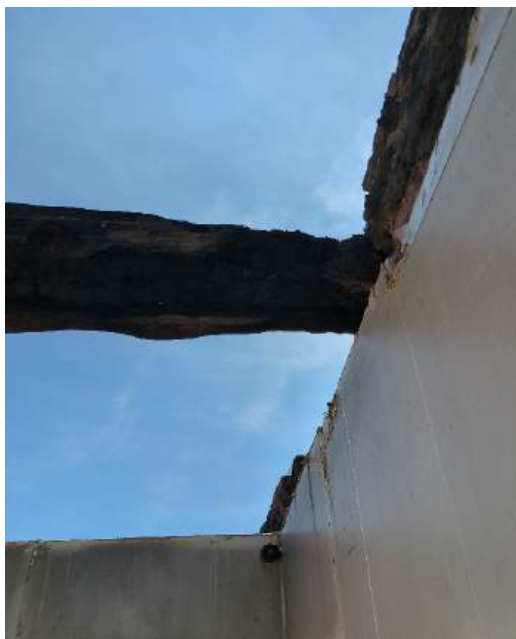
Photograph 49 - Timber roof truss heavily charred (1F Horseshoe cottage)

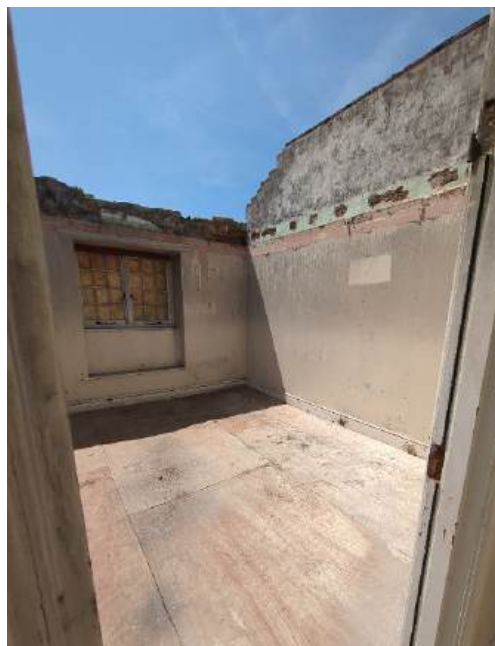
Photograph 50 - Bedroom 1 wall finishes stained (1F Horseshoe cottage)

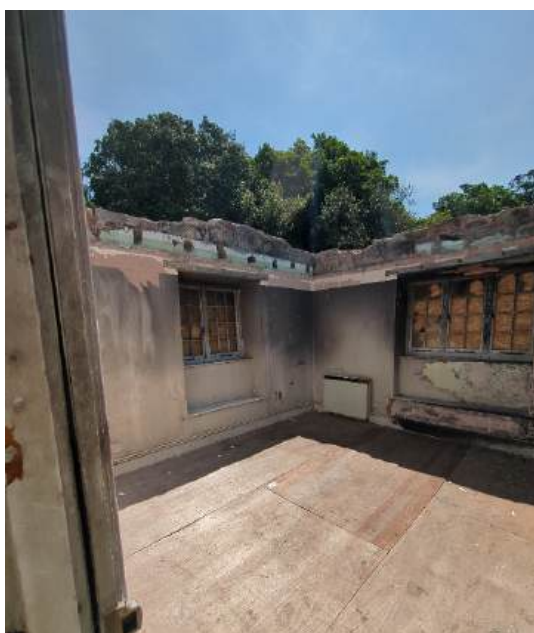
Photograph 51 - Bedroom 2 wall finishes stained (1F Horseshoe cottage)

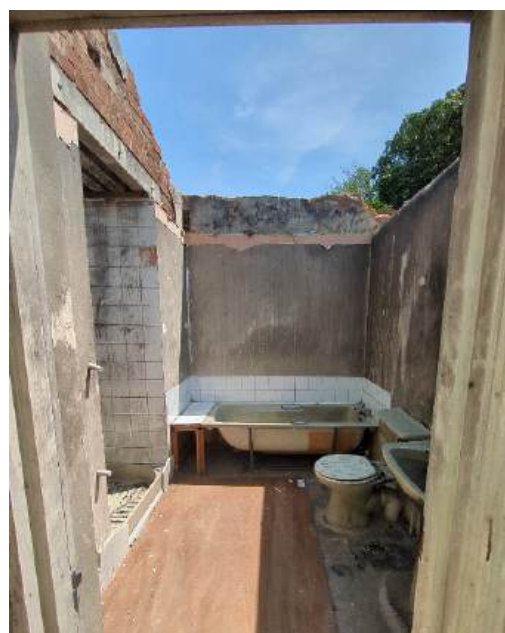
Photograph 52 - Sanitary units are smoke stained (1F Horseshoe cottage)

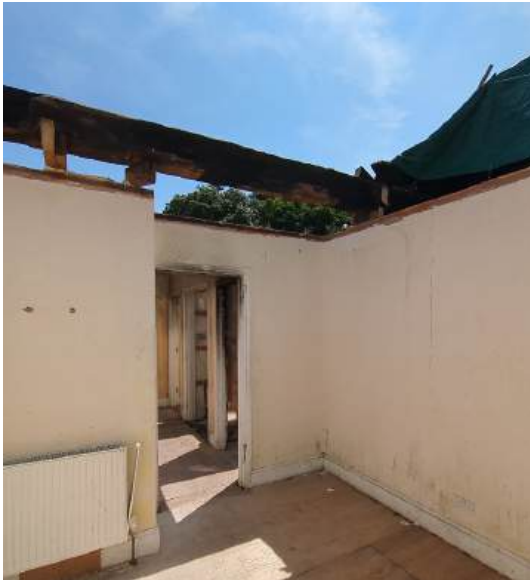
Photograph 53 - Significant charring to the timber truss in bedroom 1 (1F flat 6)

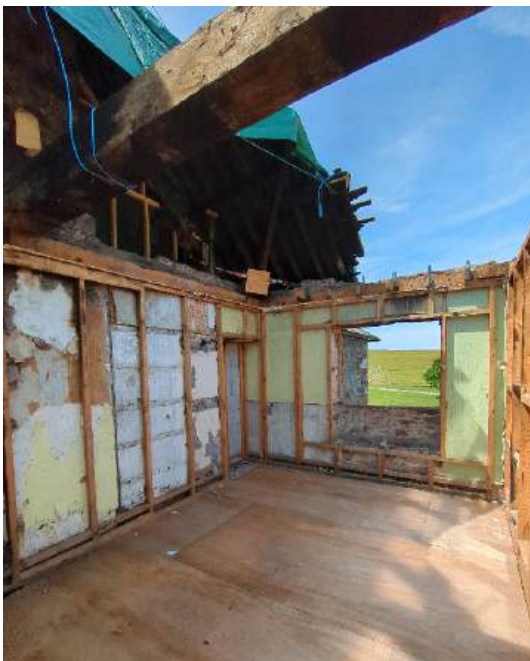
Photograph 55 - Bedroom 2 windows damaged (1F flat 6)

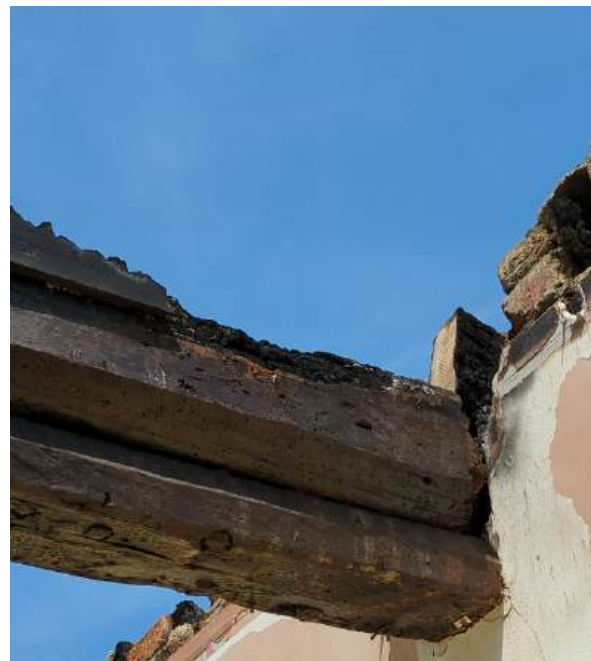
Photograph 56 - significant charring to timber truss in bedroom 3 (1F flat 6)

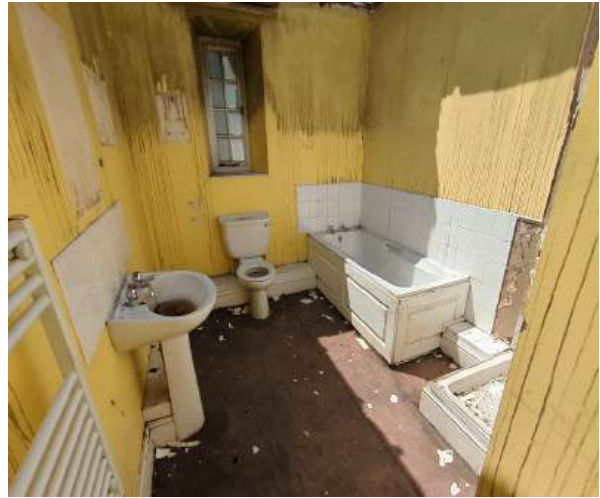
Photograph 58 - Sanitary units stained (1F flat 6)

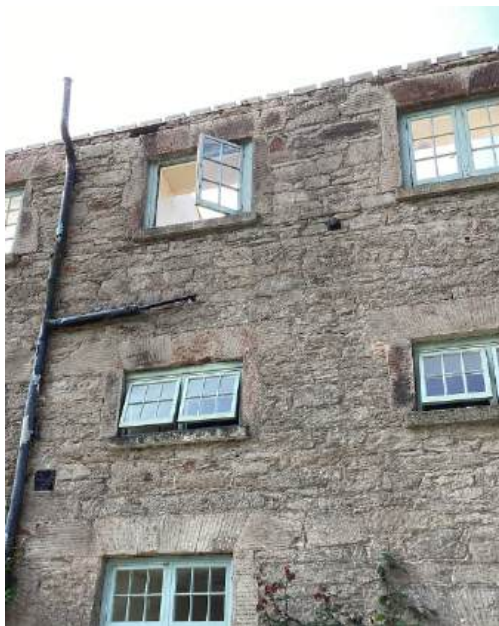
Photograph 59 - Staining to key stones (North elevation)

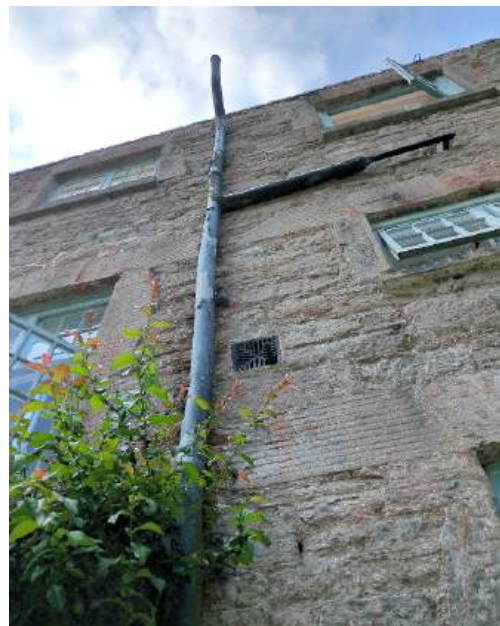
Photograph 60 - Decorative wear to SVP (North elevation)

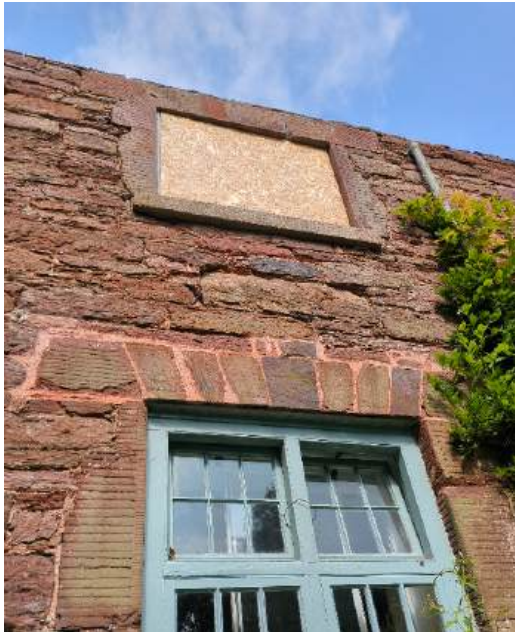
Photograph 61 - Boarded over window (East elevation)

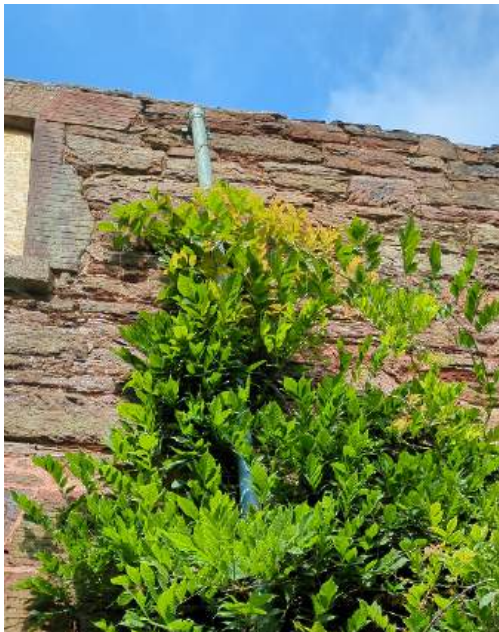
Photograph 63 - Decorative wear on downpipe (East elevation)

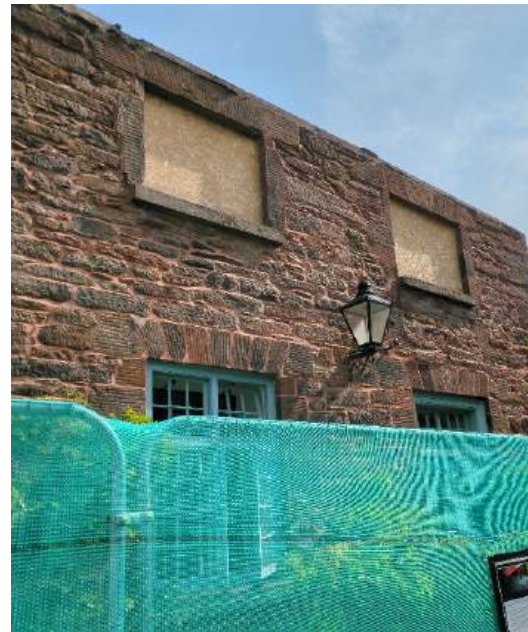
Photograph 64 - Boarded over window (South elevation)

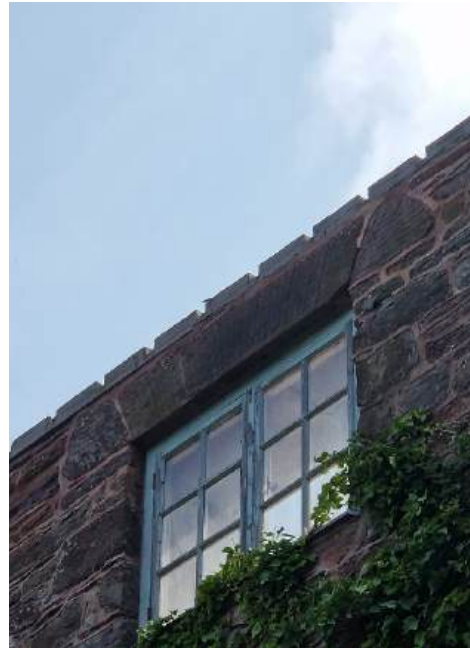
Photograph 66 - Smoke stained key stones (West
elevation)

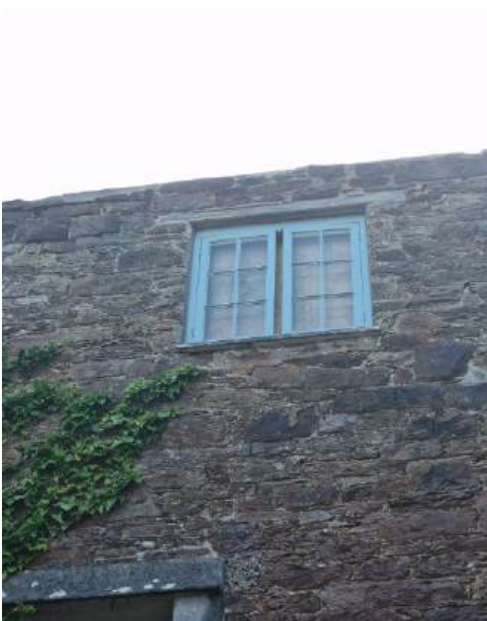
Photograph 67 - Missing timber mullion
(West elevation)

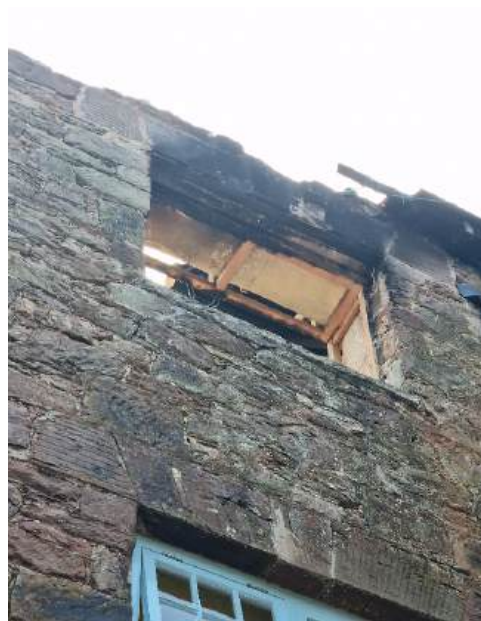
Photograph 68 - blown out window (West elevation)

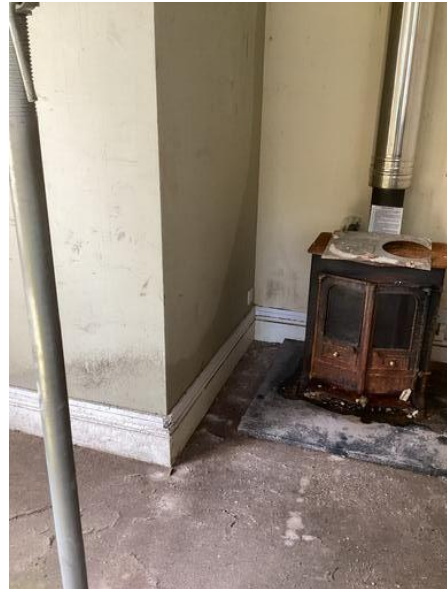
Photograph 20 - Horseshoe Cottage (Lounge)
Wood Burner With Back Boiler

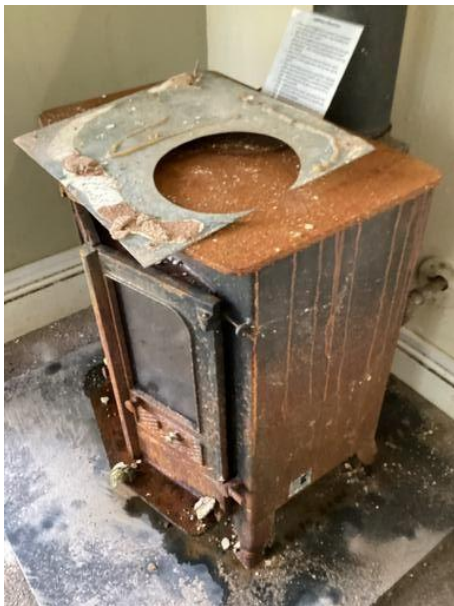
Photograph 21 - Horseshoe Cottage
Wood Burner With Back Boiler

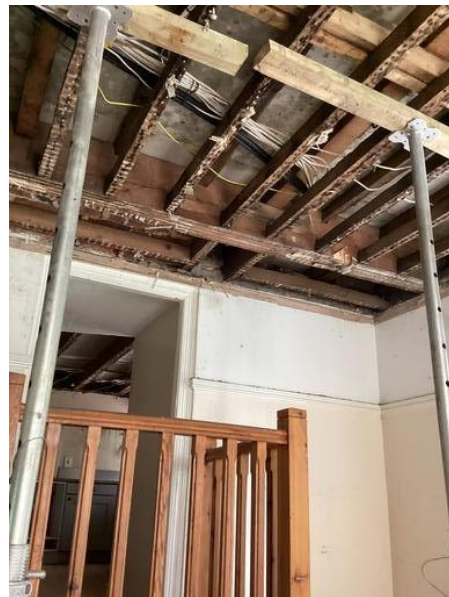
Photograph 22 - Horseshoe Cottage (Lounge)
General Wiring

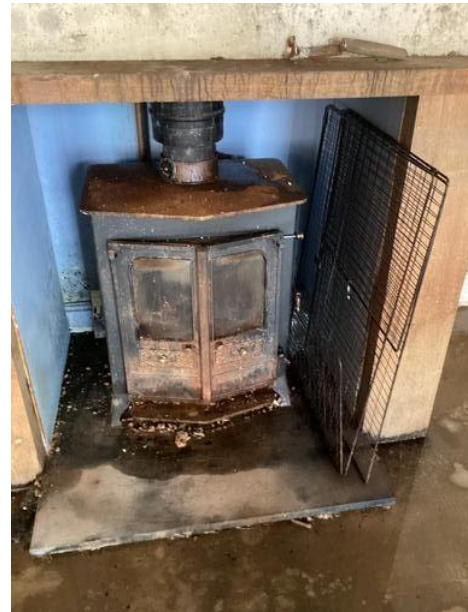
Photograph 54 - Flat 6 (Lounge)
Wood Burner With Back Boiler

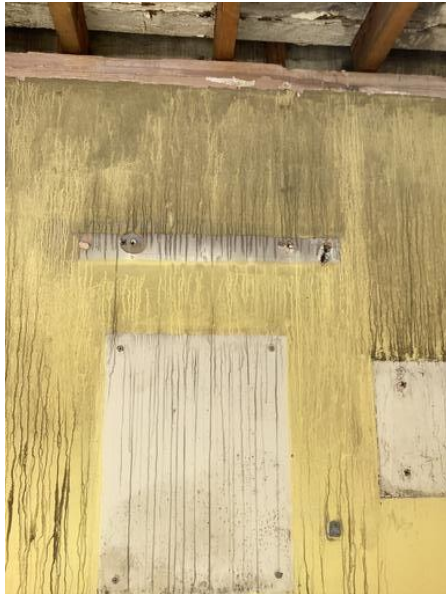
Photograph 63 - Flat 6 (Bath)
Missing Mirror Light

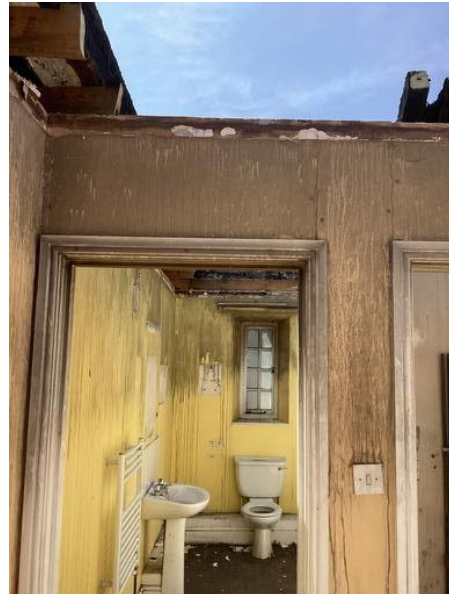
Photograph 64 - Flat 6 (Bath)
General & Light Switch

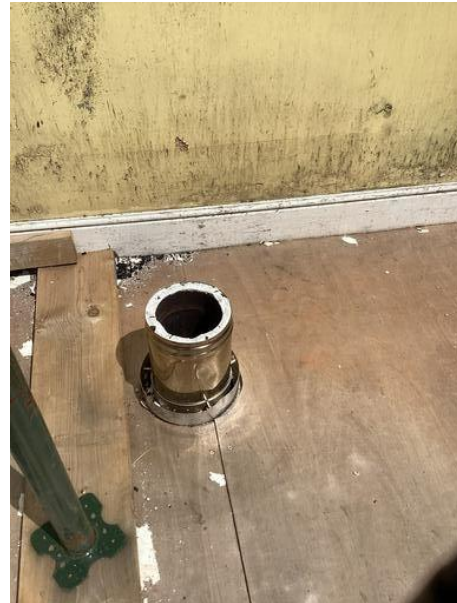
Photograph 68 - Flat 6 (Bed 3)
Wood Burning Flue

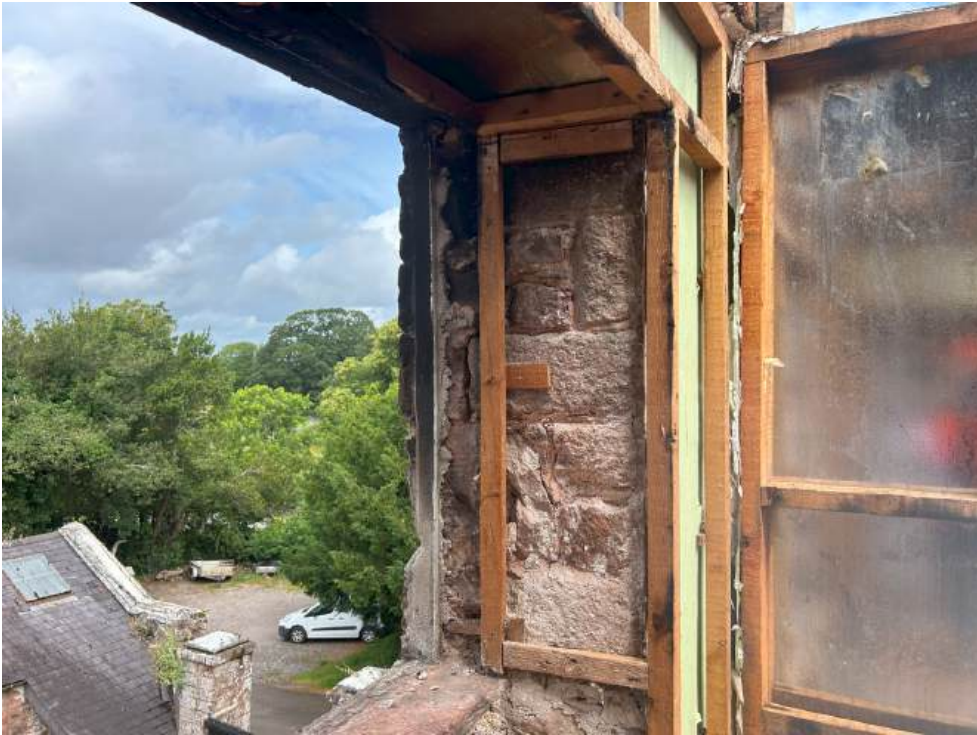
- There were no discernible defects to the 550mm thick solid stone walls. The wall thickness was measured at first floor level at a window opening. Refer to photograph 5.
- There were no discernible defects to the timber floor joists. We note that the floor had been propped and our understanding is that the propping was intended to support the additional load associated with the collapsed roof and ceiling structure over.
- A new cut roof will need to be designed and detailed to replace the original structure.
- The existing lintels will need to be inspected to ensure that they have not been affected by the fire.
- Some minor cracking was noted to the plaster finishes. Refer to photograph 6.

Photograph 5 - 550mm thick external stone walls.

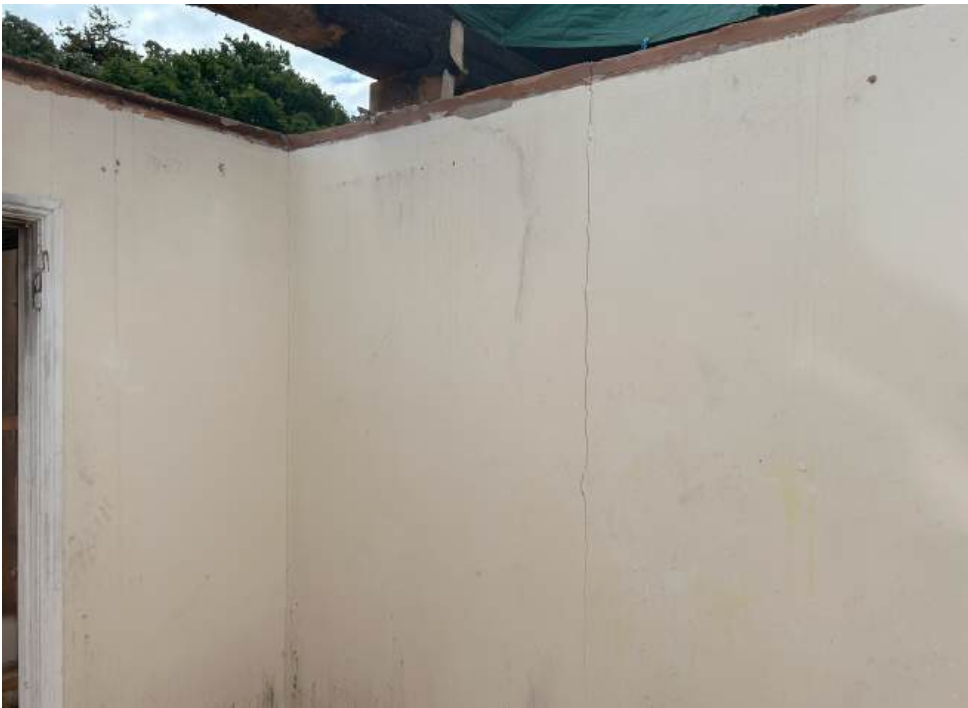
Photograph 6 - Crack to plaster finishes at first floor.

Plaster Inspection - Finishes should be removed locally to thoroughly inspect the noted crack in Flat 6.

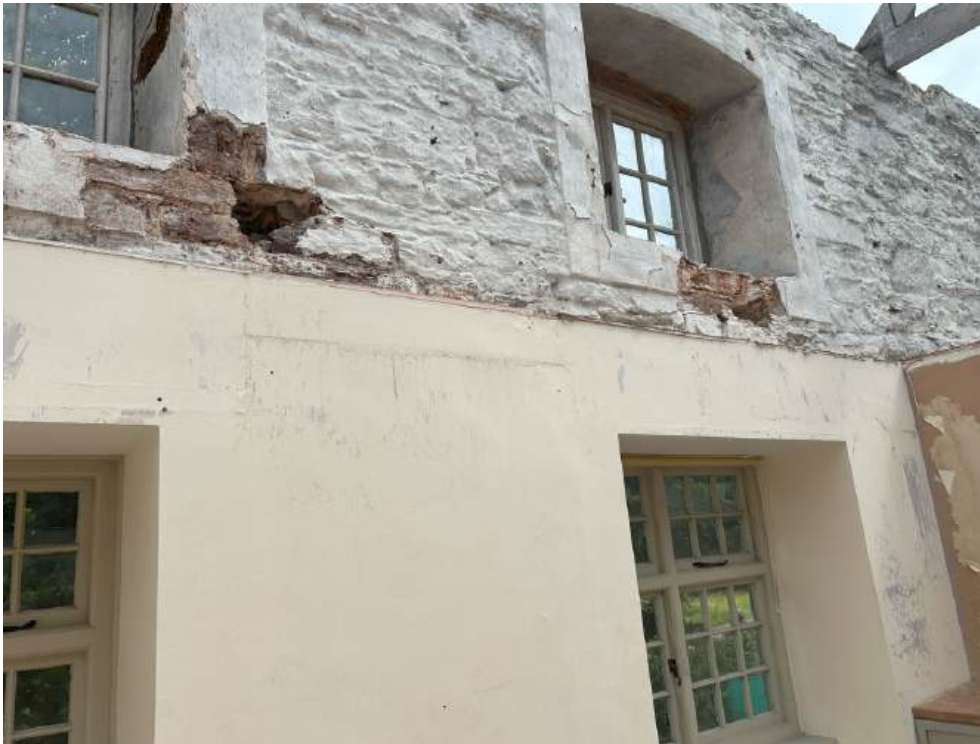
- There were no discernible defects to the solid stone walls.
- Some stone blocks on the inner face of the external walls were missing and these will need to be replaced and re-set in lime mortar. Refer to photograph 7.
- There were no discernible defects to the timber floor joists. We note that the floor had been propped and our understanding is that the propping was intended to support the additional load associated with the collapsed roof and ceiling structure over.
- A new cut roof will need to be designed and detailed to replace the original structure.
- The existing lintels will need to be inspected to ensure that they have not been affected by the fire.
- There was significant damp to the walls and ceiling. Refer to photograph 8.

Photograph 7 - Missing stone blocks.

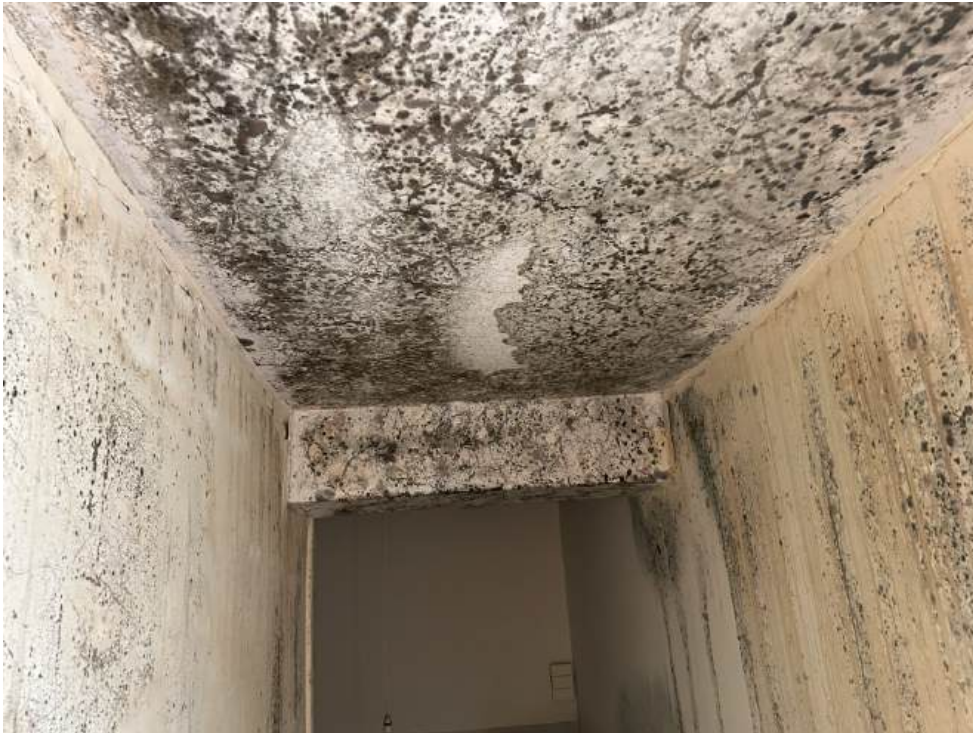
Photograph 8 - Damp to walls and ceiling.

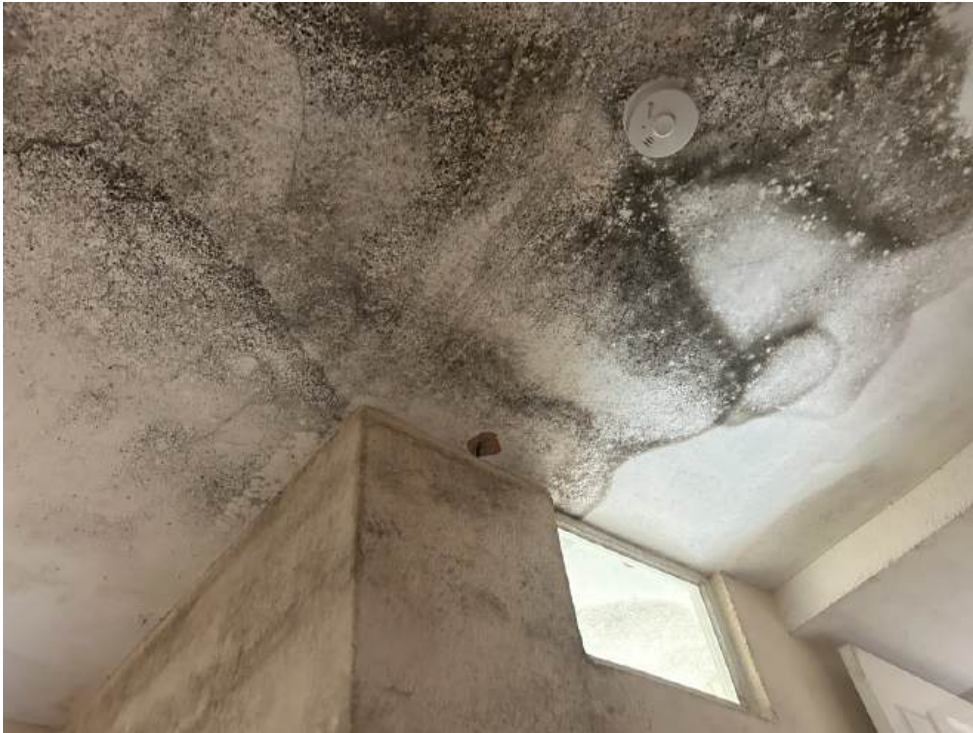
- There were no discernible defects to the solid stone walls.
- There were no discernible defects to the timber floor joists. We note that the floor had been propped and our understanding is that the propping was intended to support the additional load associated with the collapsed roof and ceiling structure over. Flat 3 is believed to be above Horse Shoe Cottage.
- A new cut roof will need to be designed and detailed to replace the original structure.
- The existing lintels will need to be inspected to ensure that they have not been affected by the fire.
- There was significant damp to the walls and ceiling. Refer to photograph 9.

Photograph 9 - Damp to walls and ceiling
