MOUNT EDGCUMBE JOINT COMMITTEE – SUPPLEMENT PACK I

10. Mount Edgcumbe Fire Damage Options Appraisal:

Barrow Centre, Mount Edgcumbe.

Fire Damage Refurbishment - Options Appraisal

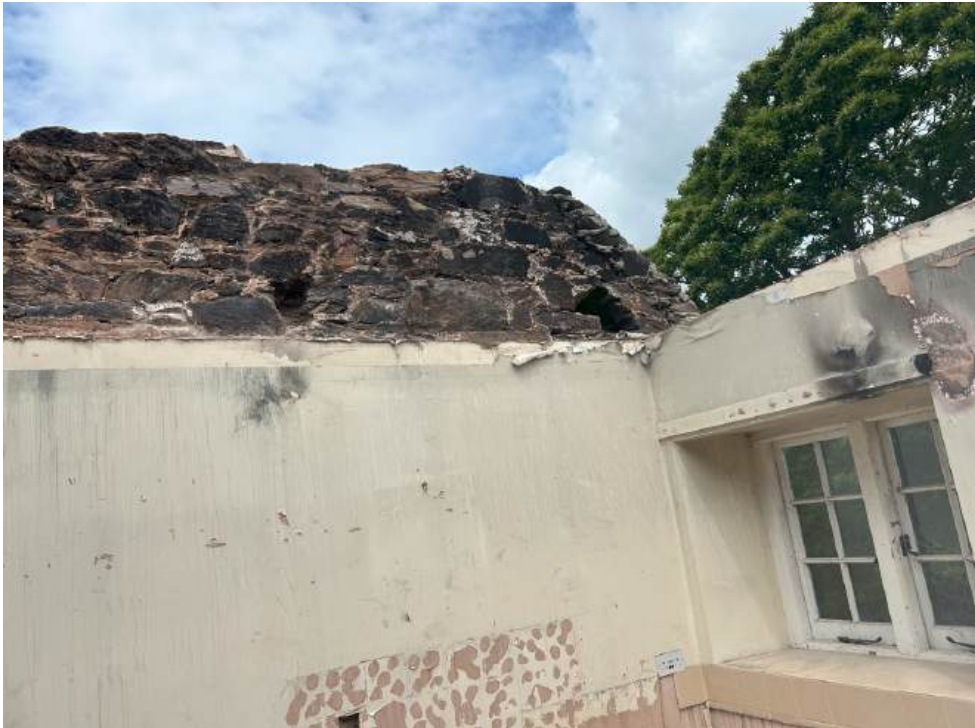
- There were no discernible defects to the solid stone walls.
- A new cut roof will need to be designed and detailed to replace the original structure.
- The existing lintels will need to be inspected to ensure that they have not been affected by the fire.
- Some stone blocks on the inner face of the external walls were missing and these will need to be replaced and re-set in lime mortar. Refer to photograph 10.
- There were remnants of charred timber embedded within the solid stone walls. These will need to be removed. Refer to photograph 11.

Photograph 10 - Missing stone blocks.

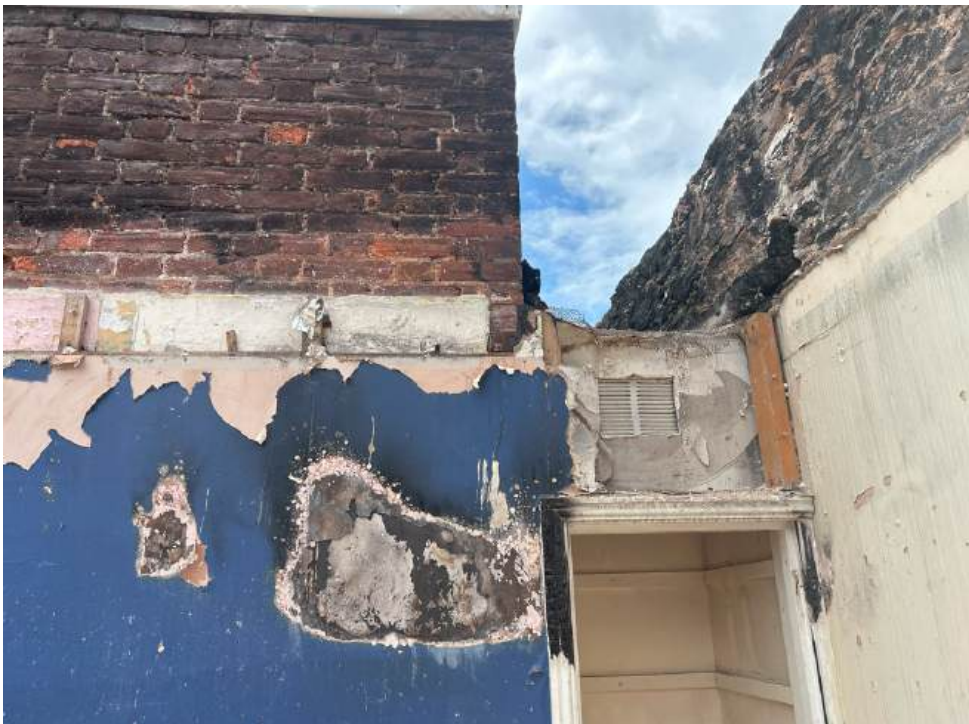
Photograph 11 - Charred timber embedded in stone wall..

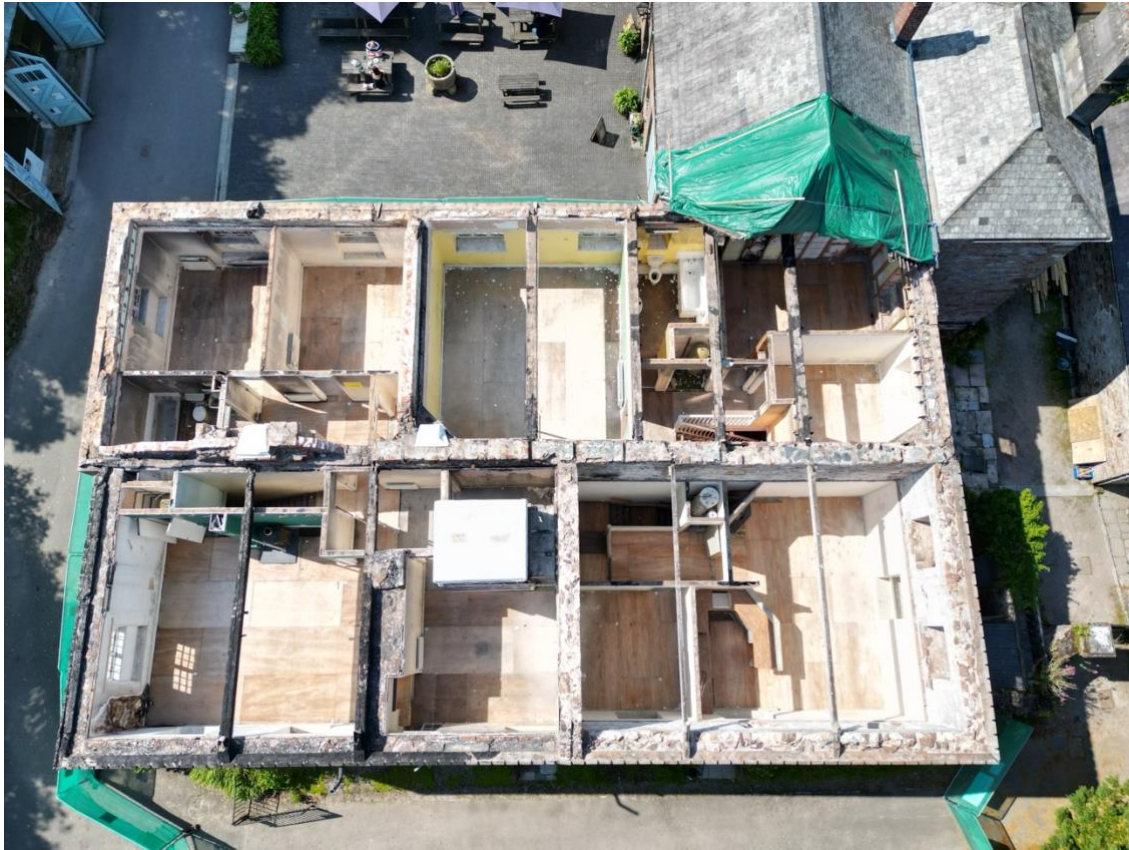
Figure 3 Scott and Co drone photo taken in June 2025 of roof are following on from the fire.

The roof supporting roof structure again is almost completely burnt out by the fire. We can see that this was a cut timber arrayed in a series of roof trusses. It is likely that there were intersecting purlins between these with a central ridge beam at the head of the roof.

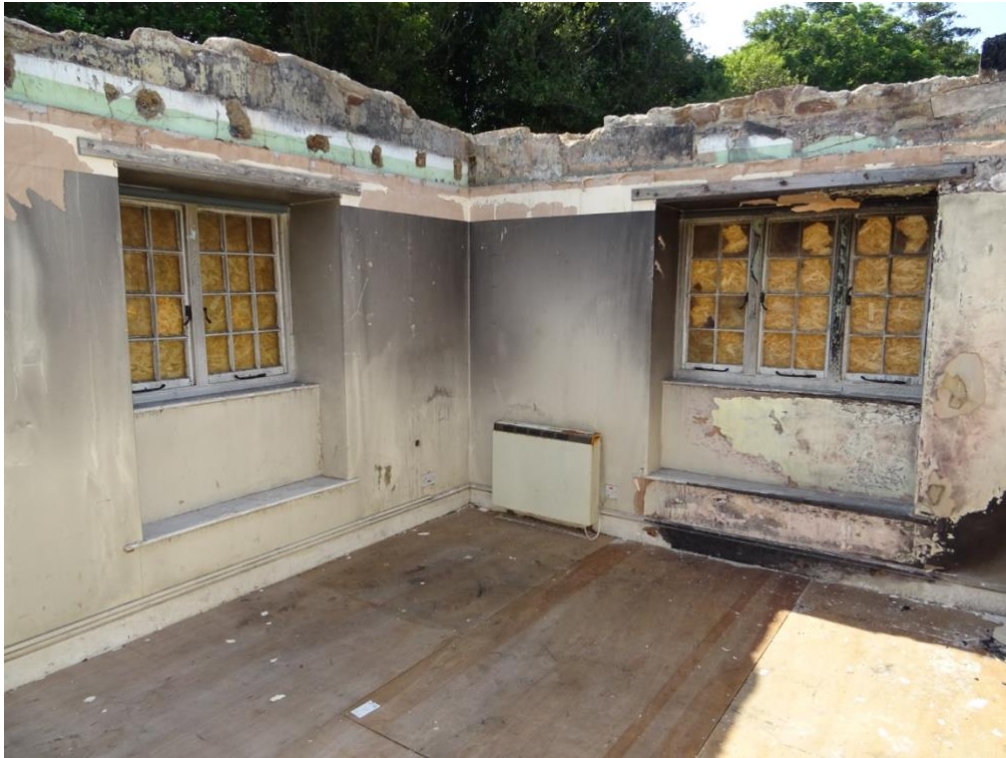
Figure 15 Damaged and undulating wall head. Also damaged and boarded windows.

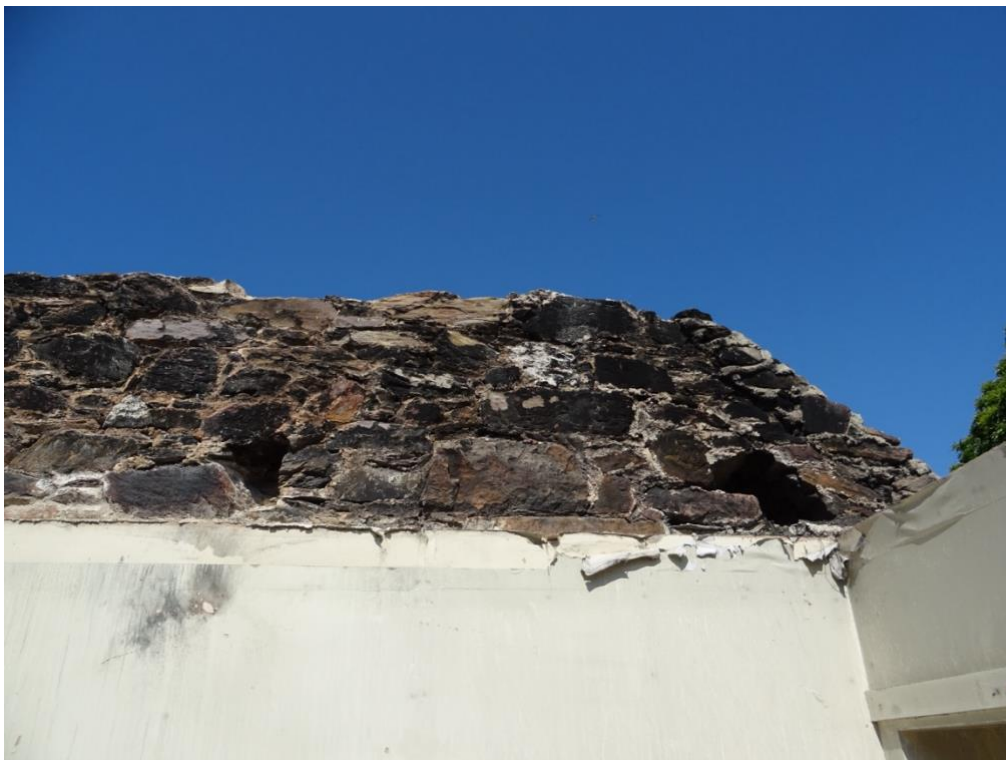
Figure 16 Fire damaged wallhead.

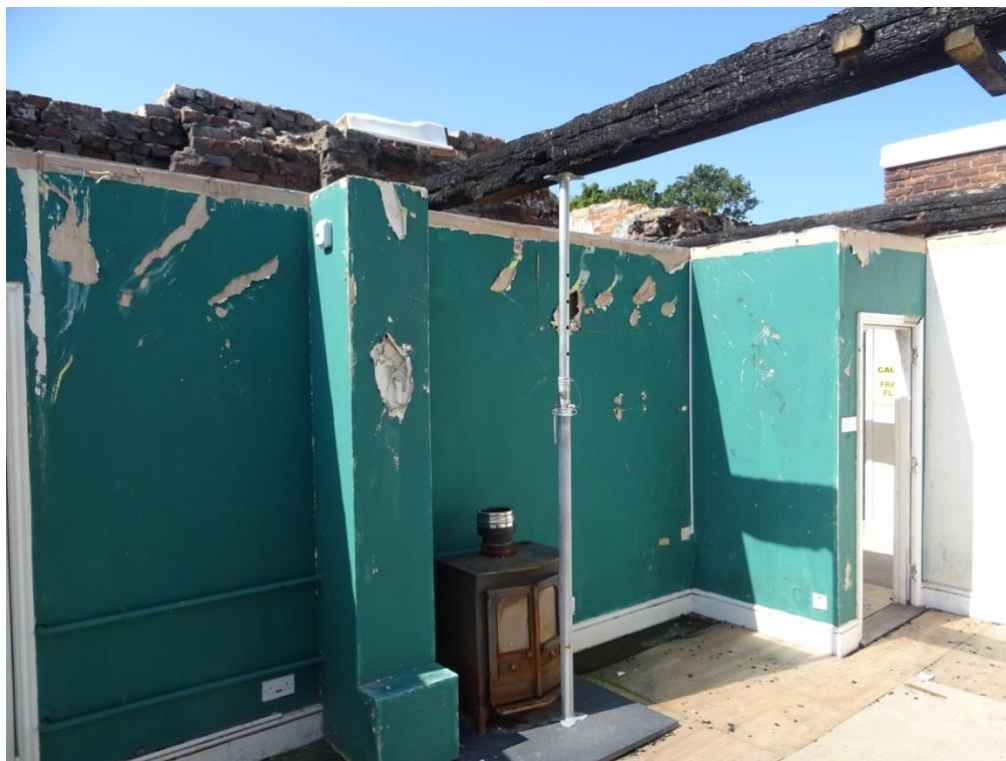
Figure 17 Retained chord tie beam.
