Plymouth City Council – Risk Assessment March Review

The Hoe Foreshore 2010

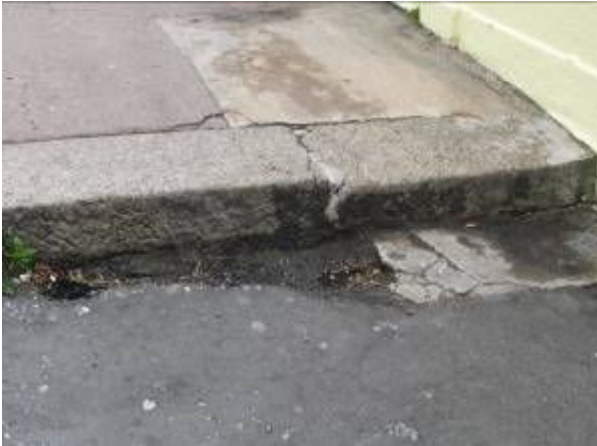
<p>Image 1</p> <p>Steps to Pebbleside beach – surface broken Repairs needed along path length</p> <p><b>Work Completed</b> ✓</p> <p>←</p> <hr/> <p>Image 2</p> <p>As above image 1</p> <p><b>Work Completed</b> ✓</p> <p>→</p>

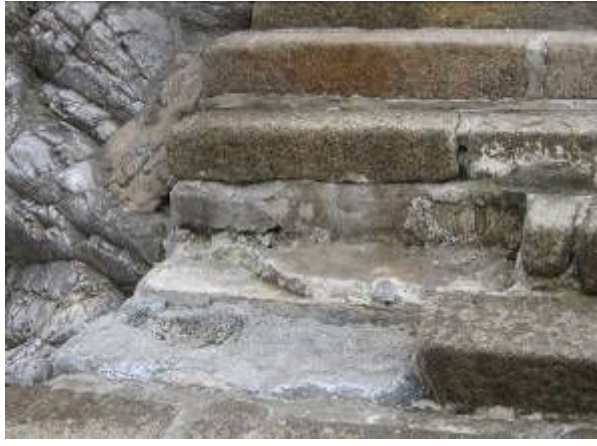
<p>Image 3</p> <p>As above image 1</p> <p><b>Work Completed</b> ✓</p> <p>←</p> <hr/> <p>Image 4</p> <p>Steps to Pebbleside beach – Section of steps missing, repair required</p> <p><b>Work Completed</b> ✓</p> <p>→</p>

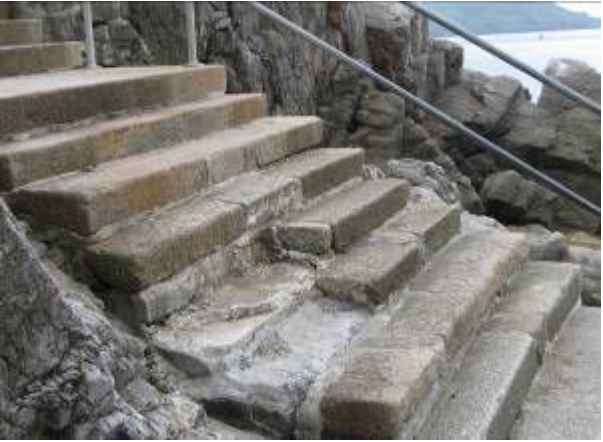
<p>Image 5</p> <p>Steps to Pebbleside beach – section of steps damaged <b>Work Completed</b> ✓</p> <p>←</p> <hr/> <p>Image 6</p> <p>Steps to Pebbleside beach, handrail damaged and section missing – Repair and replace handrail <b>Repair completed</b> <b>Bottom section of railing needs replacing</b></p> <p>→</p>

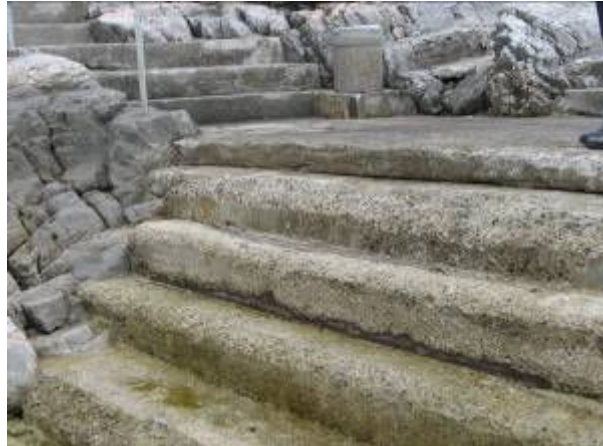
<p>Image 7</p> <p>Steps below café, edge worn away by winter storm – need to be rebuilt <b>Work Completed</b> ✓</p> <p>←</p> <hr/> <p>Image 8</p> <p>As above, also no handrail, need to install one <b>New hand-rail still needed</b></p> <p>→</p>

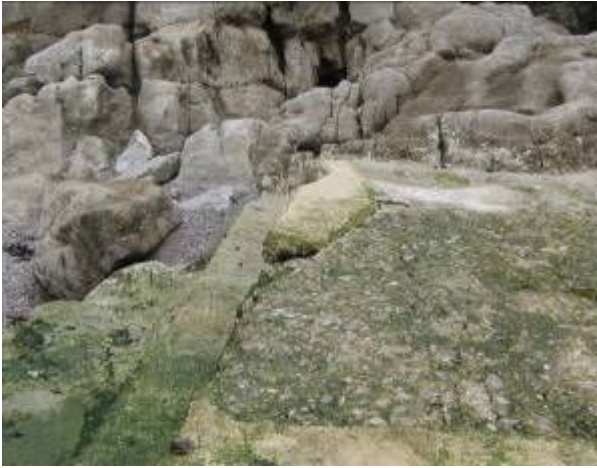
<p>Image 9 Below café, sections of steps damaged and worn away – needs repairing</p> <p><b>Work Completed</b> ✓</p> <p>←</p>

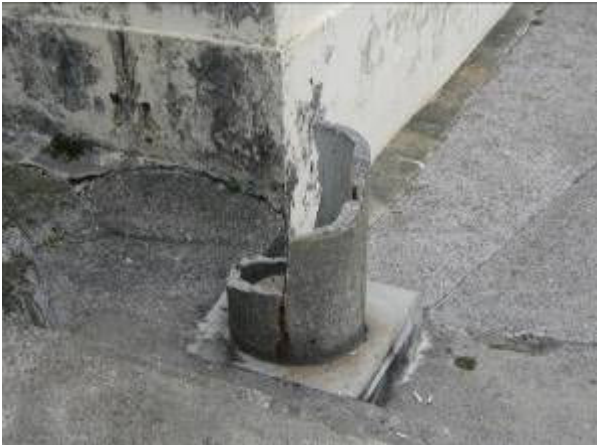
<p>Image 13</p> <p>Bin damaged by winter storm – needs replacing</p> <p><b>Bin removed</b> ✓</p> <p>←</p>

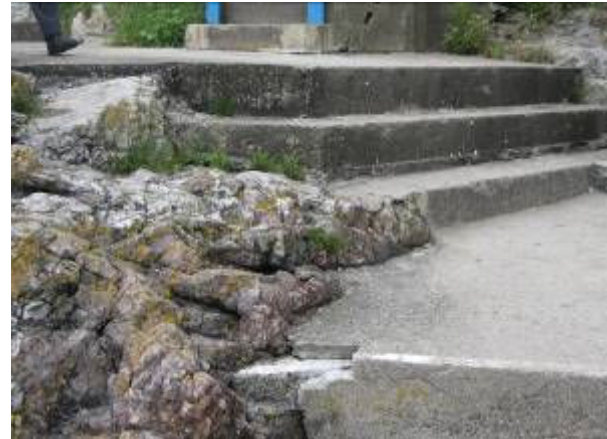
<p>Image 14</p> <p>Steps below beach huts damaged and worn, no hand rail present</p> <p><b>Hand-rail to install</b></p> <p>→</p>

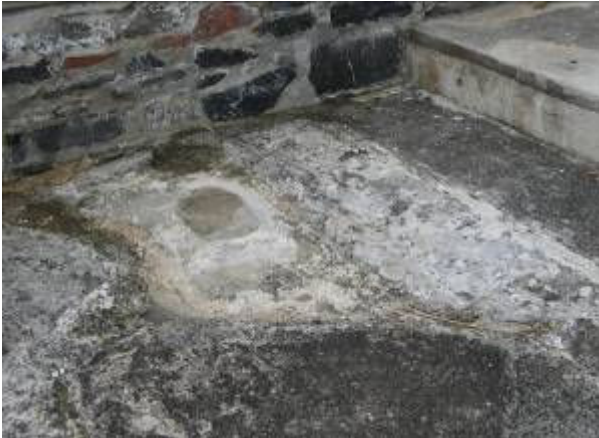
<p>Image 25</p> <p>Path damaged below seating area by winter Storm – repairs required</p> <p><b>Work Completed</b> ✓</p> <p>←</p>

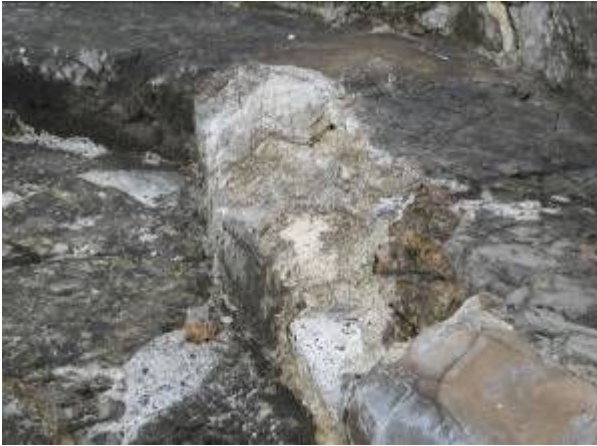
<p>Image 29</p> <p>Section of steps damaged by winter storm</p> <p><b>Work Completed</b> ✓</p> <p>←</p>

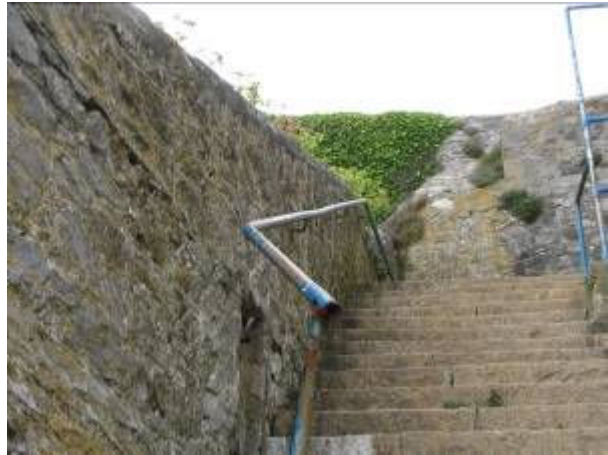
Image 37

Steps side of Leander Hut – hand rail damaged

**Work Completed** ✓

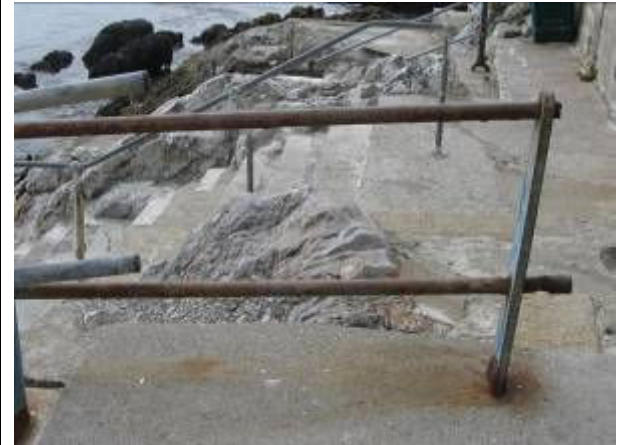
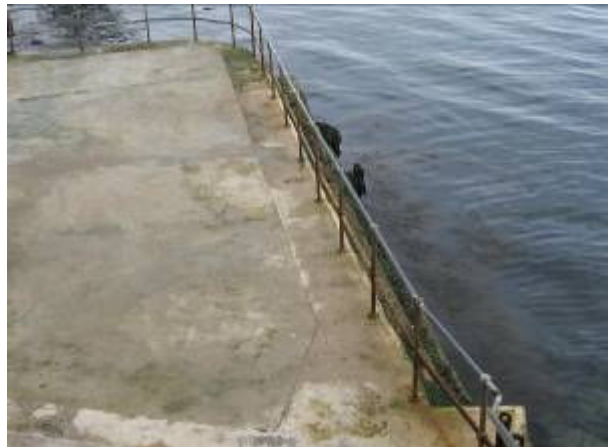
Image 39

Old men's pool now filled in – hand rail rusty and loose in ground, water collecting on new surface as not level

**Hand-rail repaired, water still collecting.**

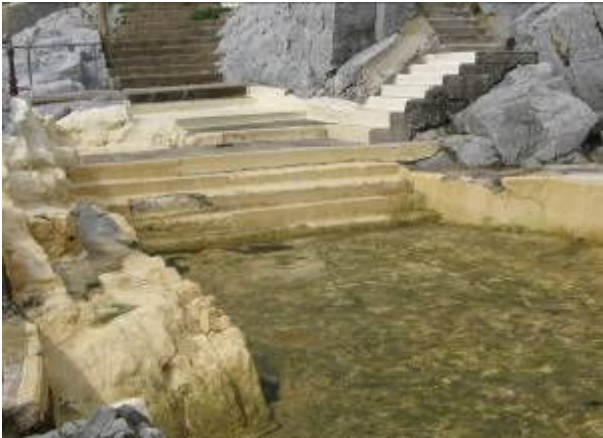
<p>Image 57</p> <p>Baby pool, steep walls breaking up, valve broken, sharp edges, glass bottles smashed in base during summer period</p> <p><b>Pool filled in</b> ✓</p> <p>←</p>

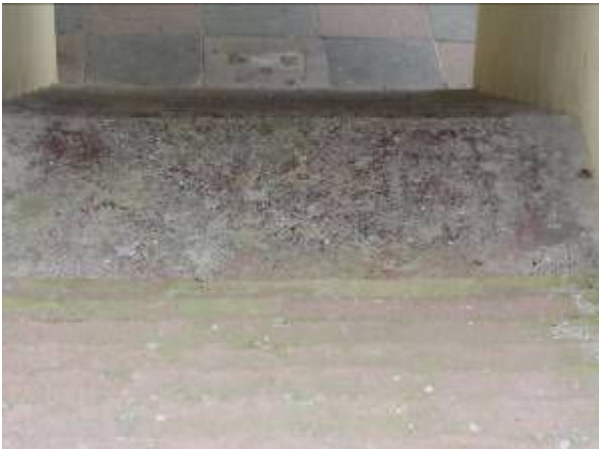
<p>Image 69</p> <p>Steps down into colonnade – edge of steps wearing – close for use.</p> <p><b>Area still wearing, needs further inspection</b></p> <p>←</p> <hr/> <p>Image 70</p> <p>As above image 69</p> <p>→</p>

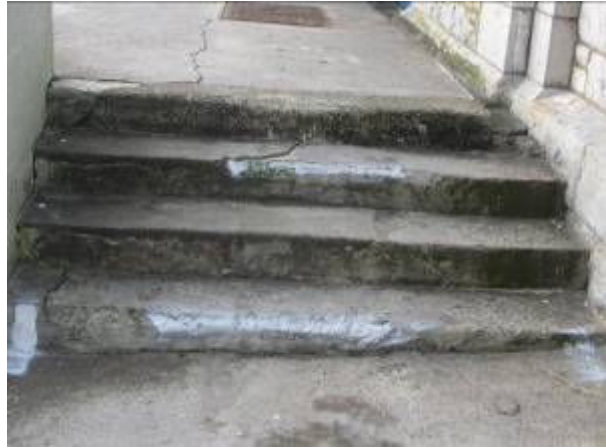
Image 89

Steps damaged following winter storm, also no hand rail

**Steps repaired**  
**Hand-rail still needed**

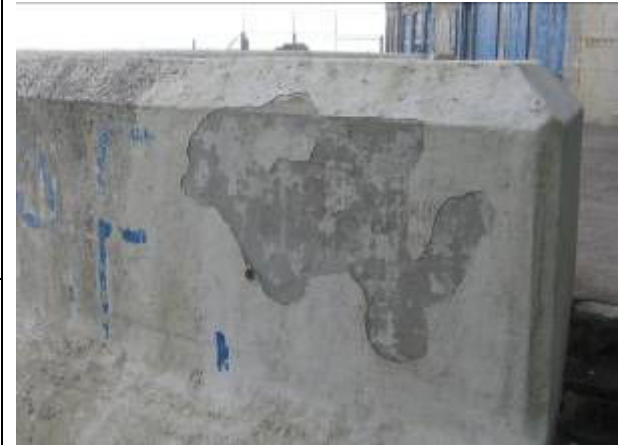
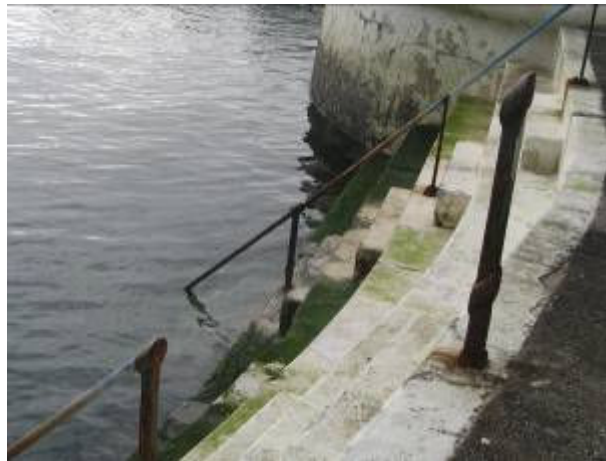
Image 91

Steps into sea, hand rail missing

**Hand-rail replaced** ✓

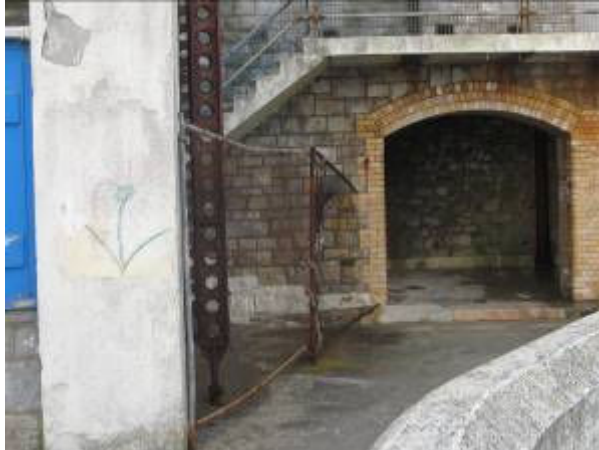
<p>Image 95</p> <p>Raised walkway held up by acro props need major work to repair</p> <p><b>Props still in place, needs major repair</b></p> <p>←</p> <p>Image 96</p> <p>As above image 95</p> <p>→</p>

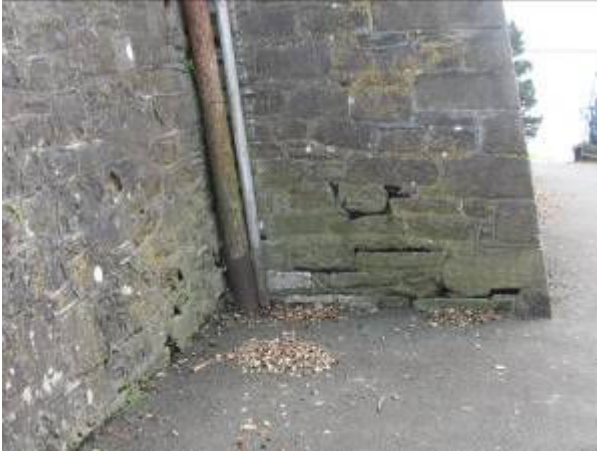
<p>Image 129</p> <p>Wall below Madeira Road, sections of stones becoming loose</p> <p><b>Work completed</b> ✓</p> <p>←</p> <p>Image 130</p> <p>Section of steps breaking up, hand rail missing</p> <p><b>Work completed</b> ✓</p> <p>→</p>	 
 	<p>Image 131</p> <p>As above image 130</p> <p><b>Work completed</b> ✓</p> <p>←</p> <p>Image 132</p> <p>Sea ladder badly damaged</p> <p><b>Work completed</b> ✓</p> <p>→</p>
