# The Guildhall Refurbishment Images.

**gillespie  
yunnie  
architects.**

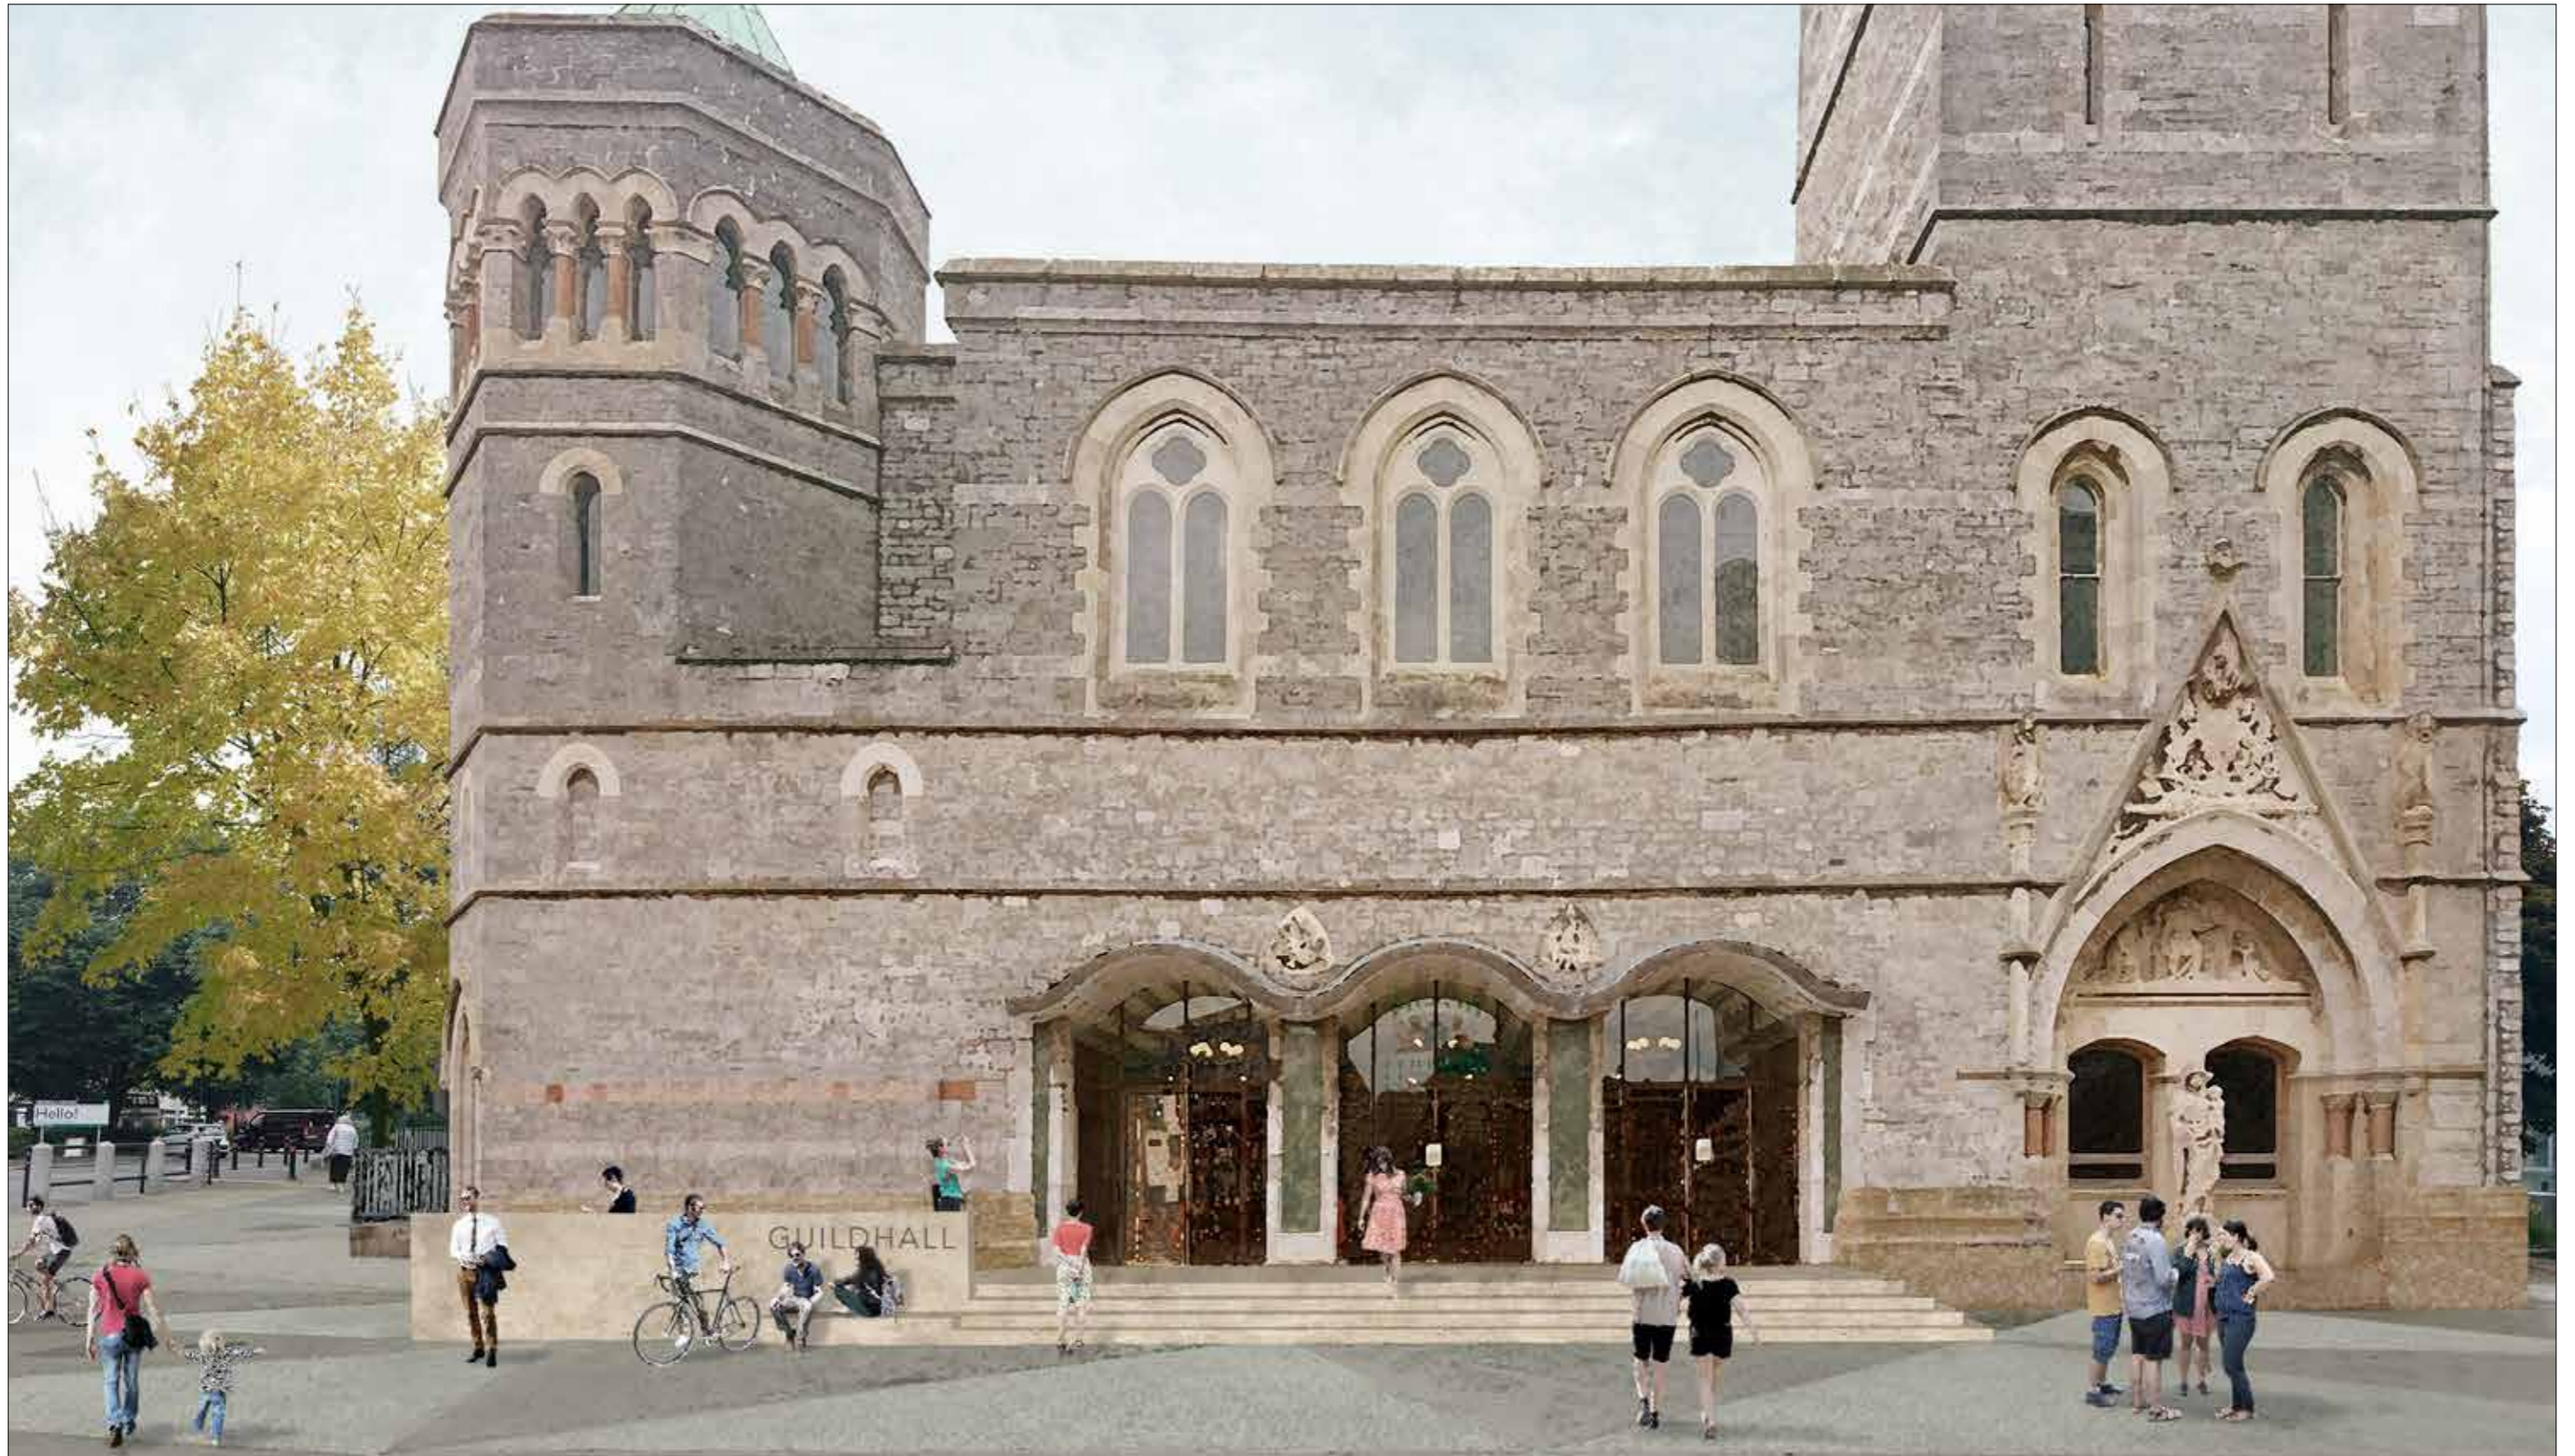
# The Guildhall Proposed New Entrance Steps & Ramp.

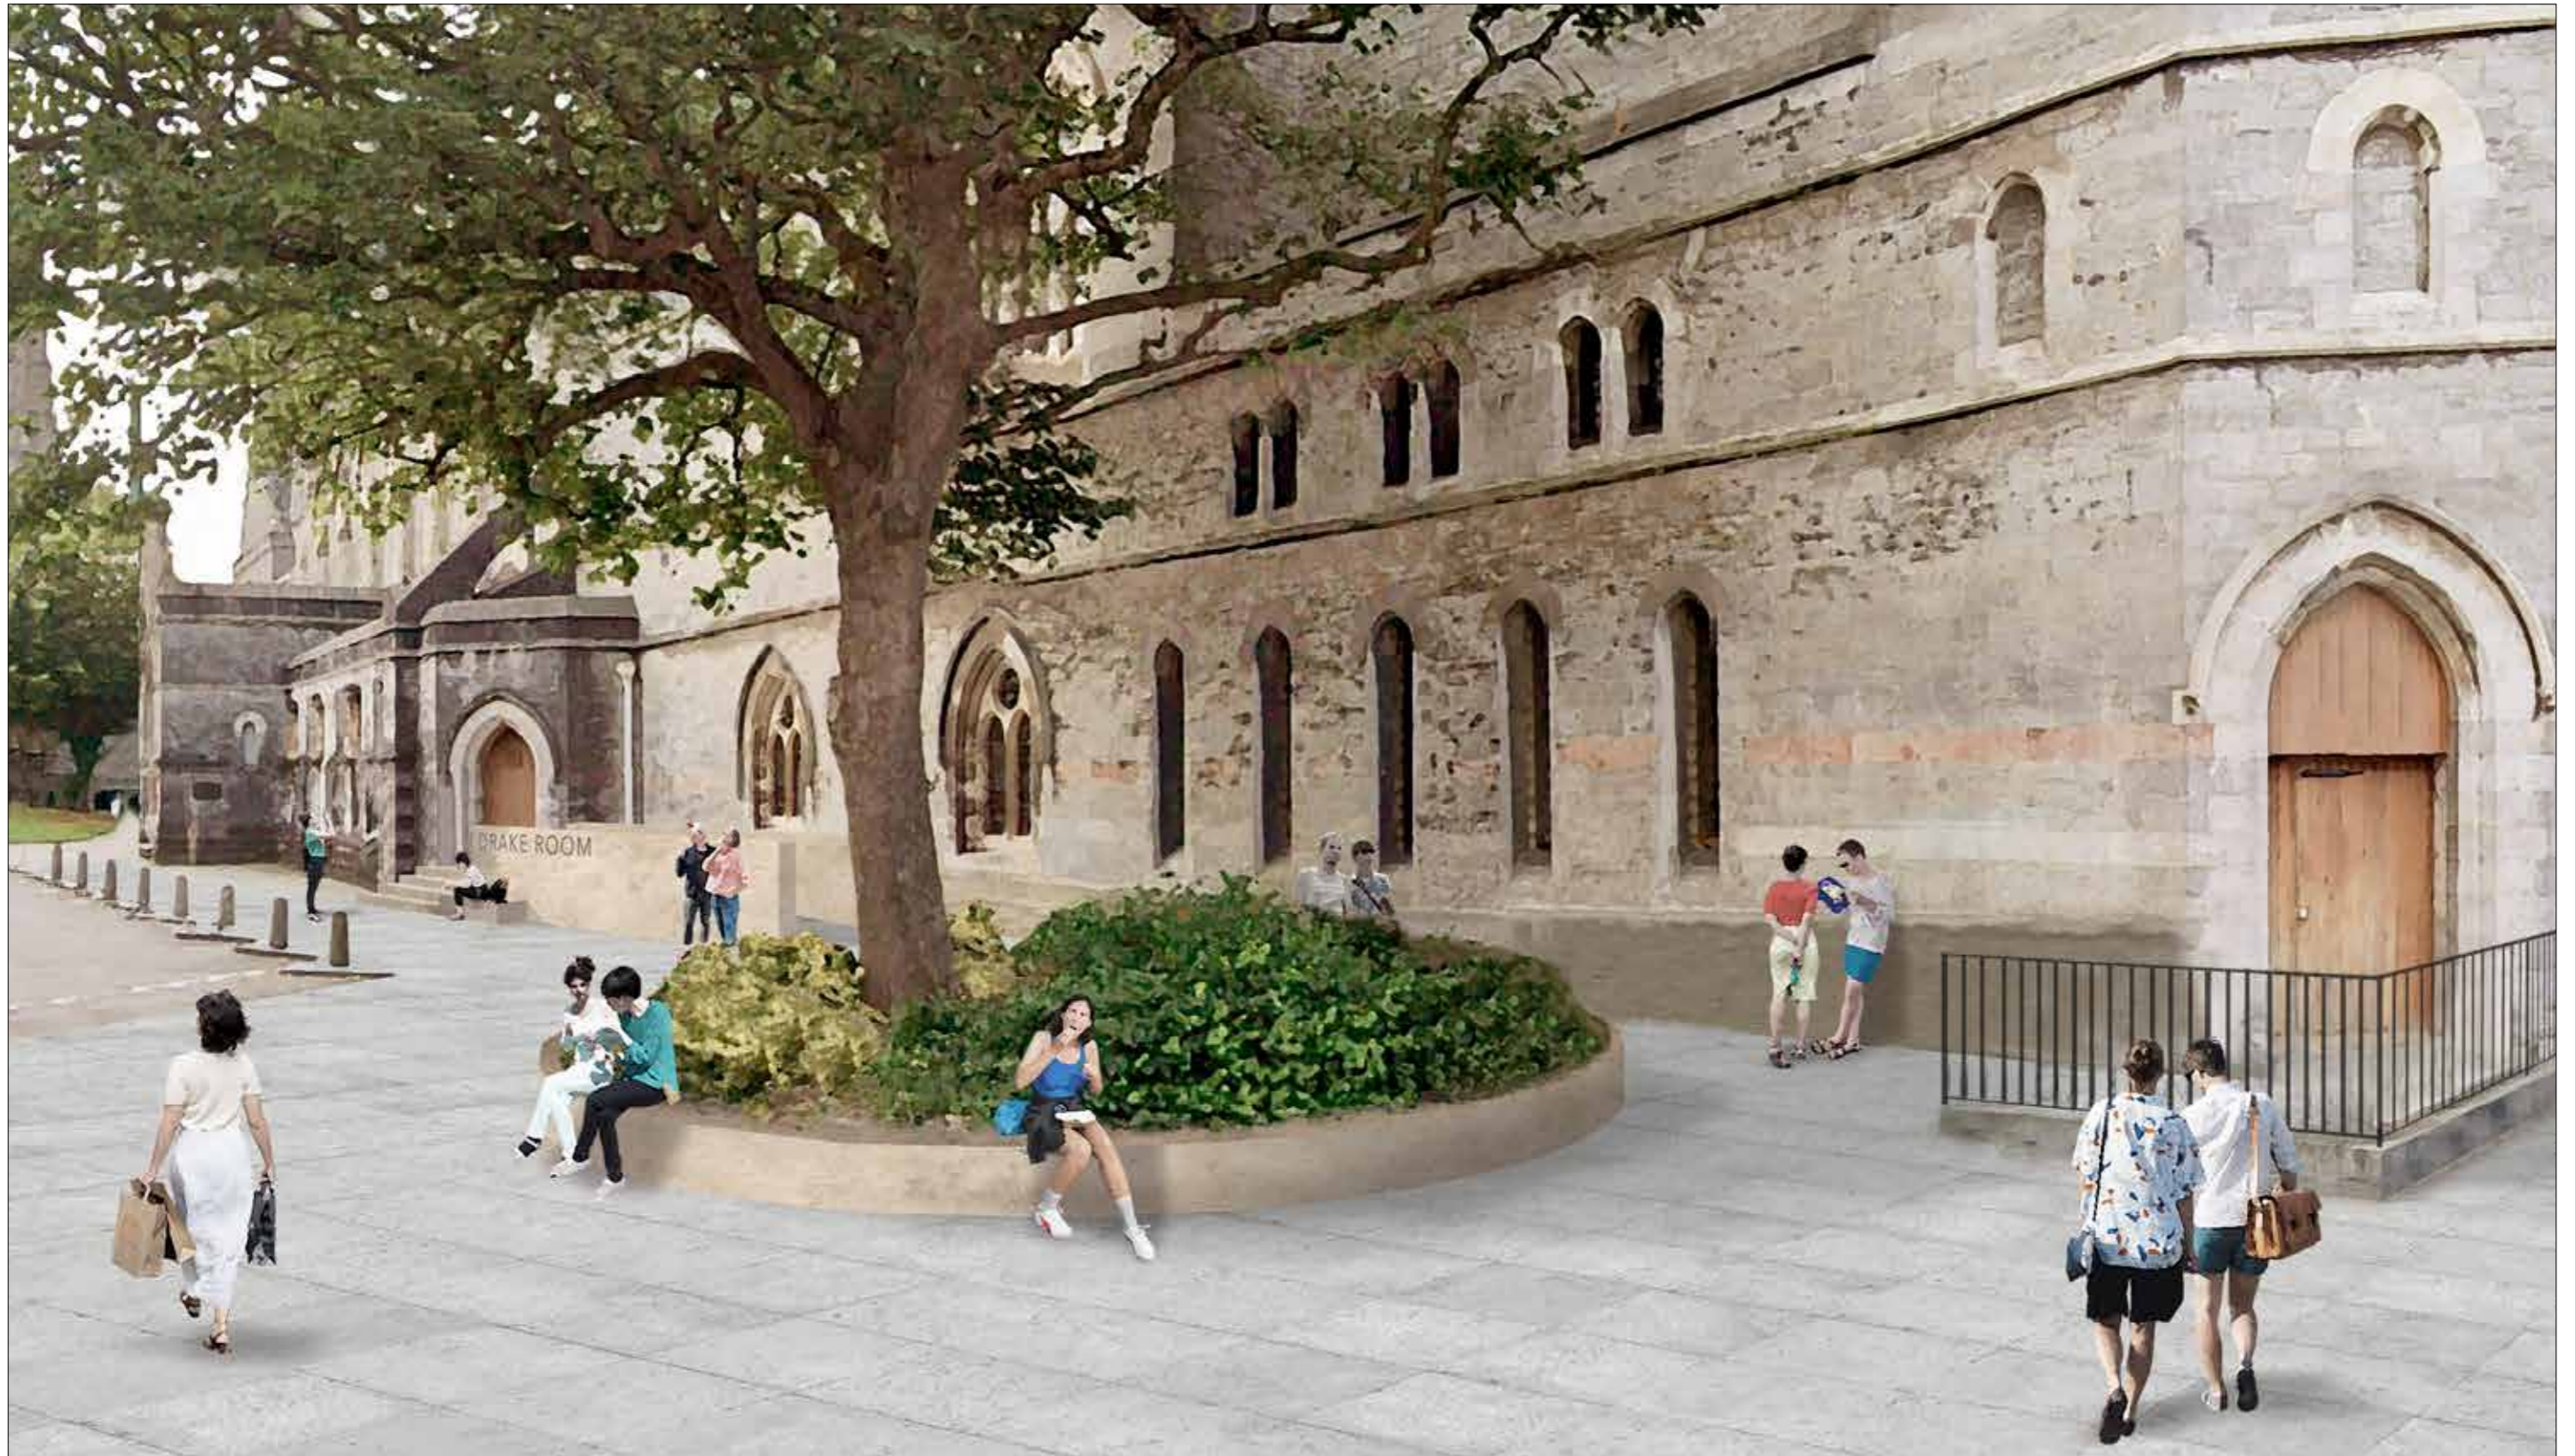
# The Drake Room Proposed New Entrance Steps & Ramp.

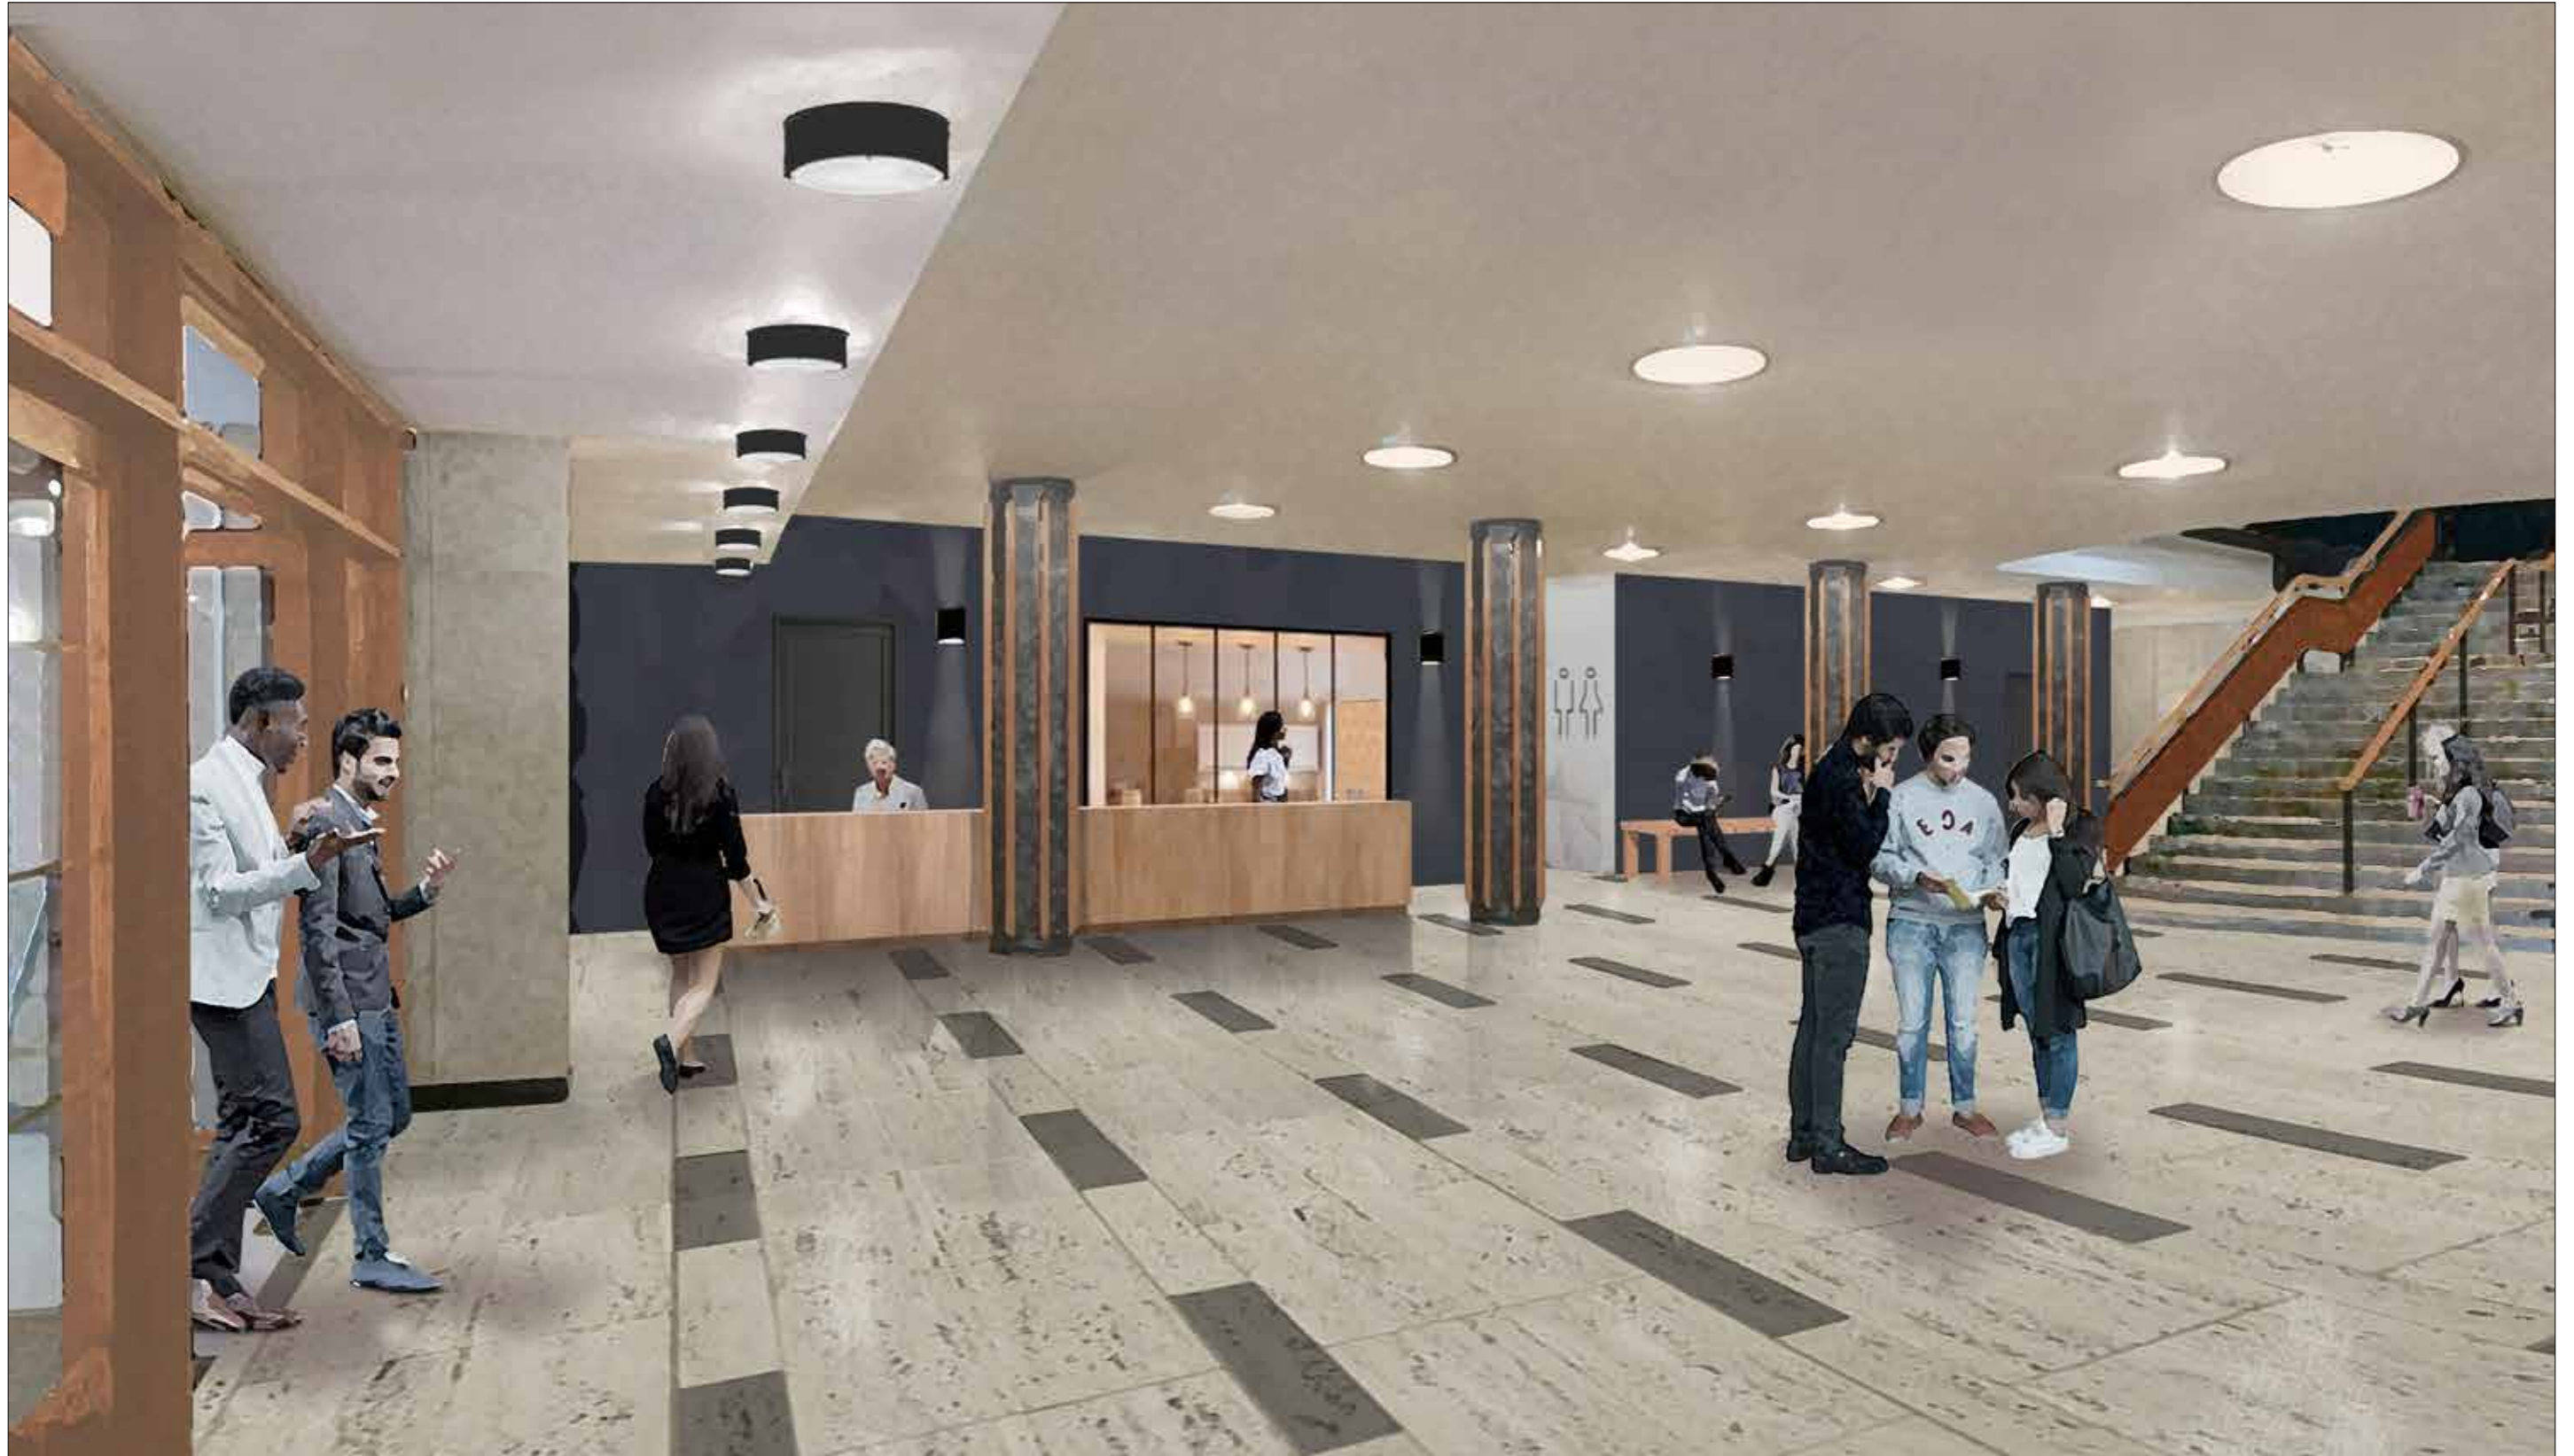
# The Guildhall Refurbished Entrance Lobby.

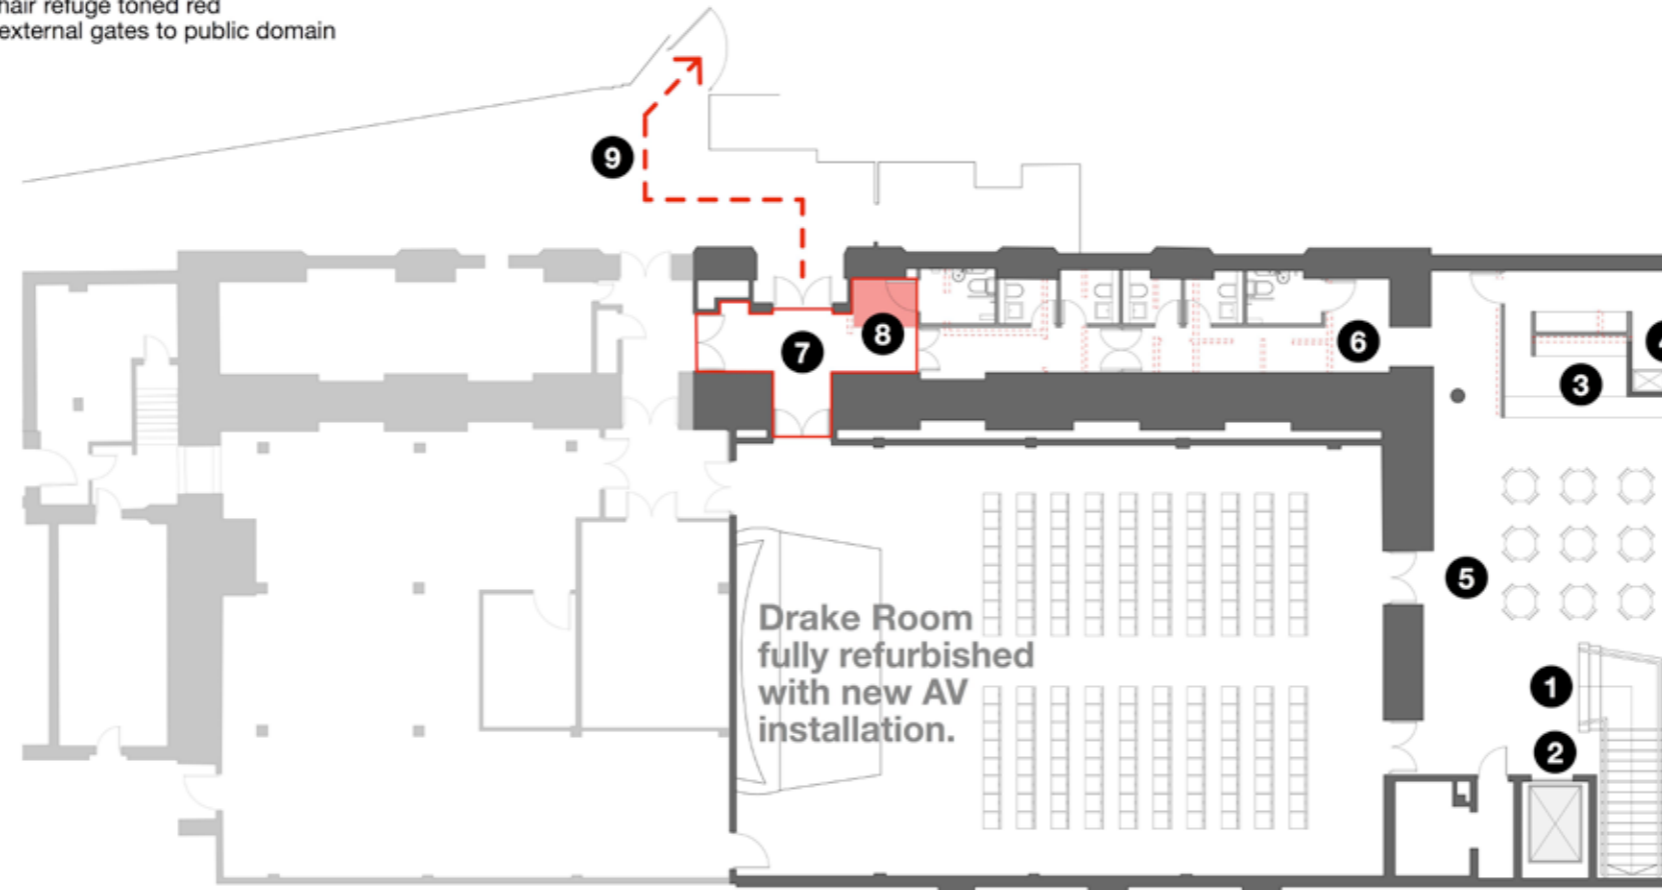
# The Guildhall Proposed Basement Plan.

1. Existing steps up to lobby and ground floor level
2. Existing lift refurbished
3. Existing bar replaced with new enclosure in same zone
4. Existing dumb waiter
5. Existing bar and lower lobby refurbished
6. Existing WCs replaced with new unisex and disabled cubicles with controlled central pass door
7. Extent of 1 hour fire protected lobby edged red
8. Provisional location of protected wheelchair refuge toned red
9. External fire escape route NB control of external gates to public domain

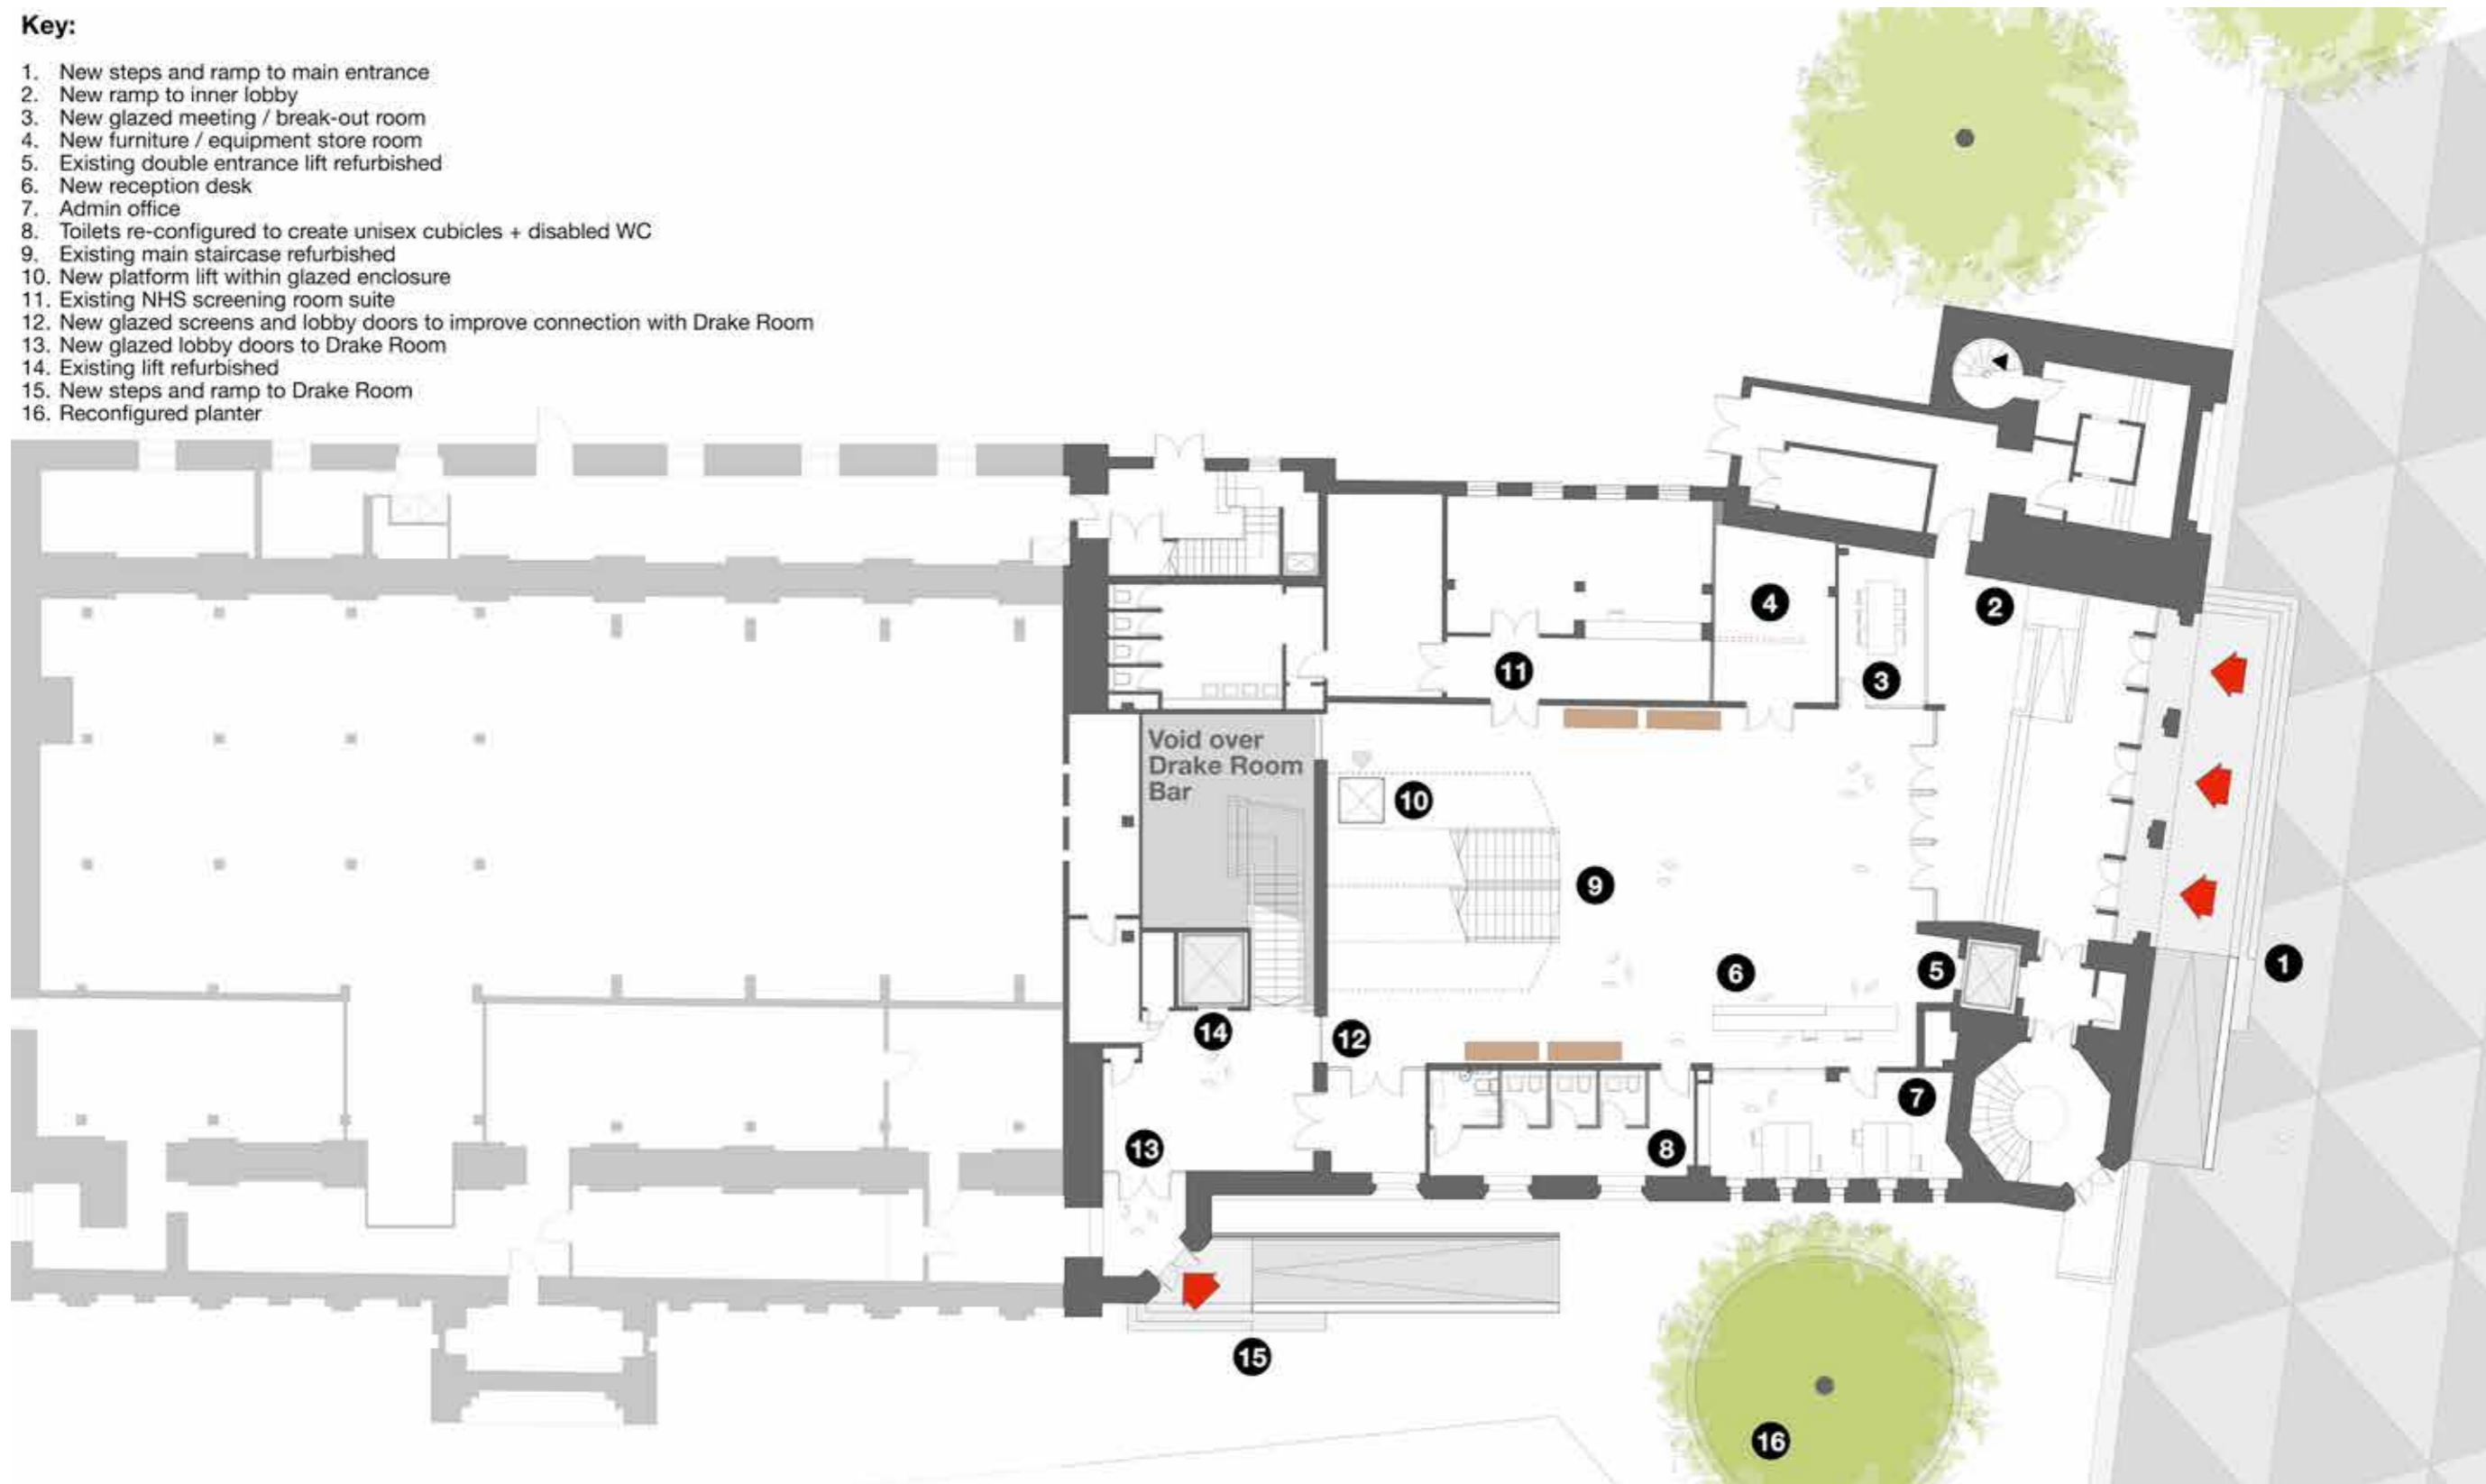
# The Guildhall Proposed Ground Floor Plan.

1. New steps and ramp to main entrance
2. New ramp to inner lobby
3. New glazed meeting / break-out room
4. New furniture / equipment store room
5. Existing double entrance lift refurbished
6. New reception desk
7. Admin office
8. Toilets re-configured to create unisex cubicles + disabled WC
9. Existing main staircase refurbished
10. New platform lift within glazed enclosure
11. Existing NHS screening room suite
12. New glazed screens and lobby doors to improve connection with Drake Room
13. New glazed lobby doors to Drake Room
14. Existing lift refurbished
15. New steps and ramp to Drake Room
16. Reconfigured planter

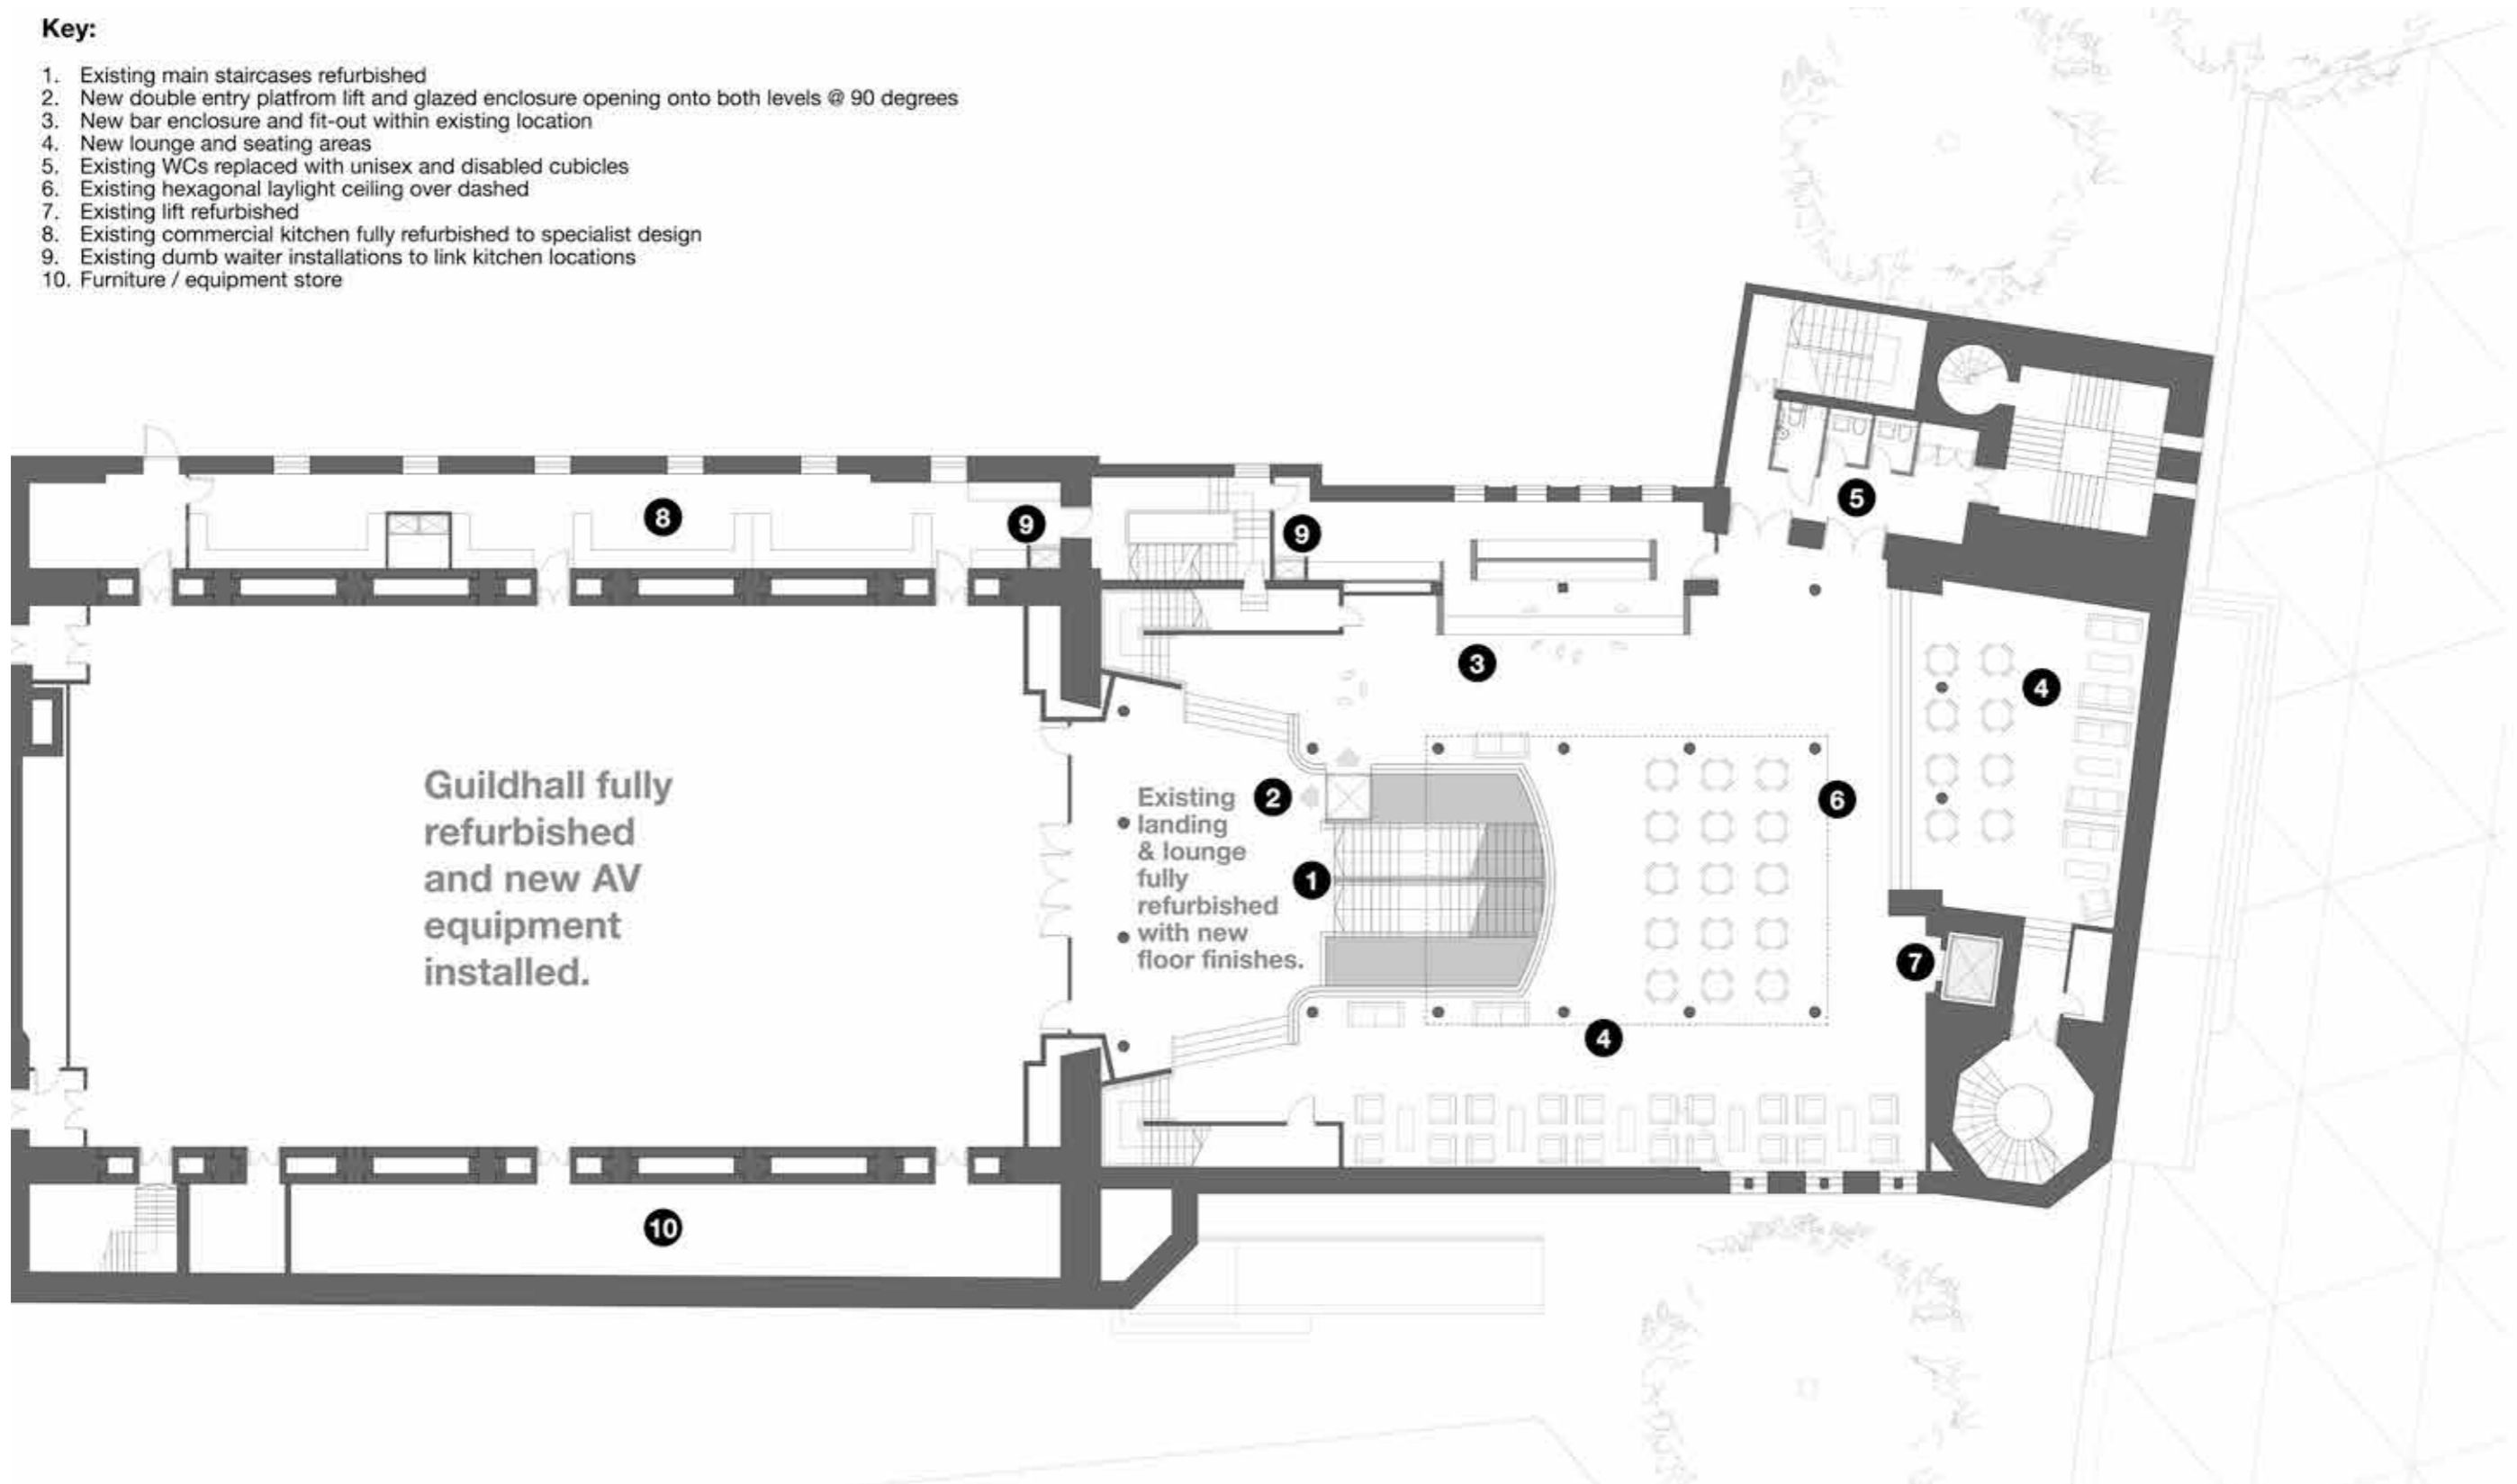
# The Guildhall Proposed First Floor Plan.

1. Existing main staircases refurbished
2. New double entry platform lift and glazed enclosure opening onto both levels @ 90 degrees
3. New bar enclosure and fit-out within existing location
4. New lounge and seating areas
5. Existing WCs replaced with unisex and disabled cubicles
6. Existing hexagonal laylight ceiling over dashed
7. Existing lift refurbished
8. Existing commercial kitchen fully refurbished to specialist design
9. Existing dumb waiter installations to link kitchen locations
10. Furniture / equipment store
