# The Guildhall Refurbishment Images.

**gillespie  
yunnie  
architects.**

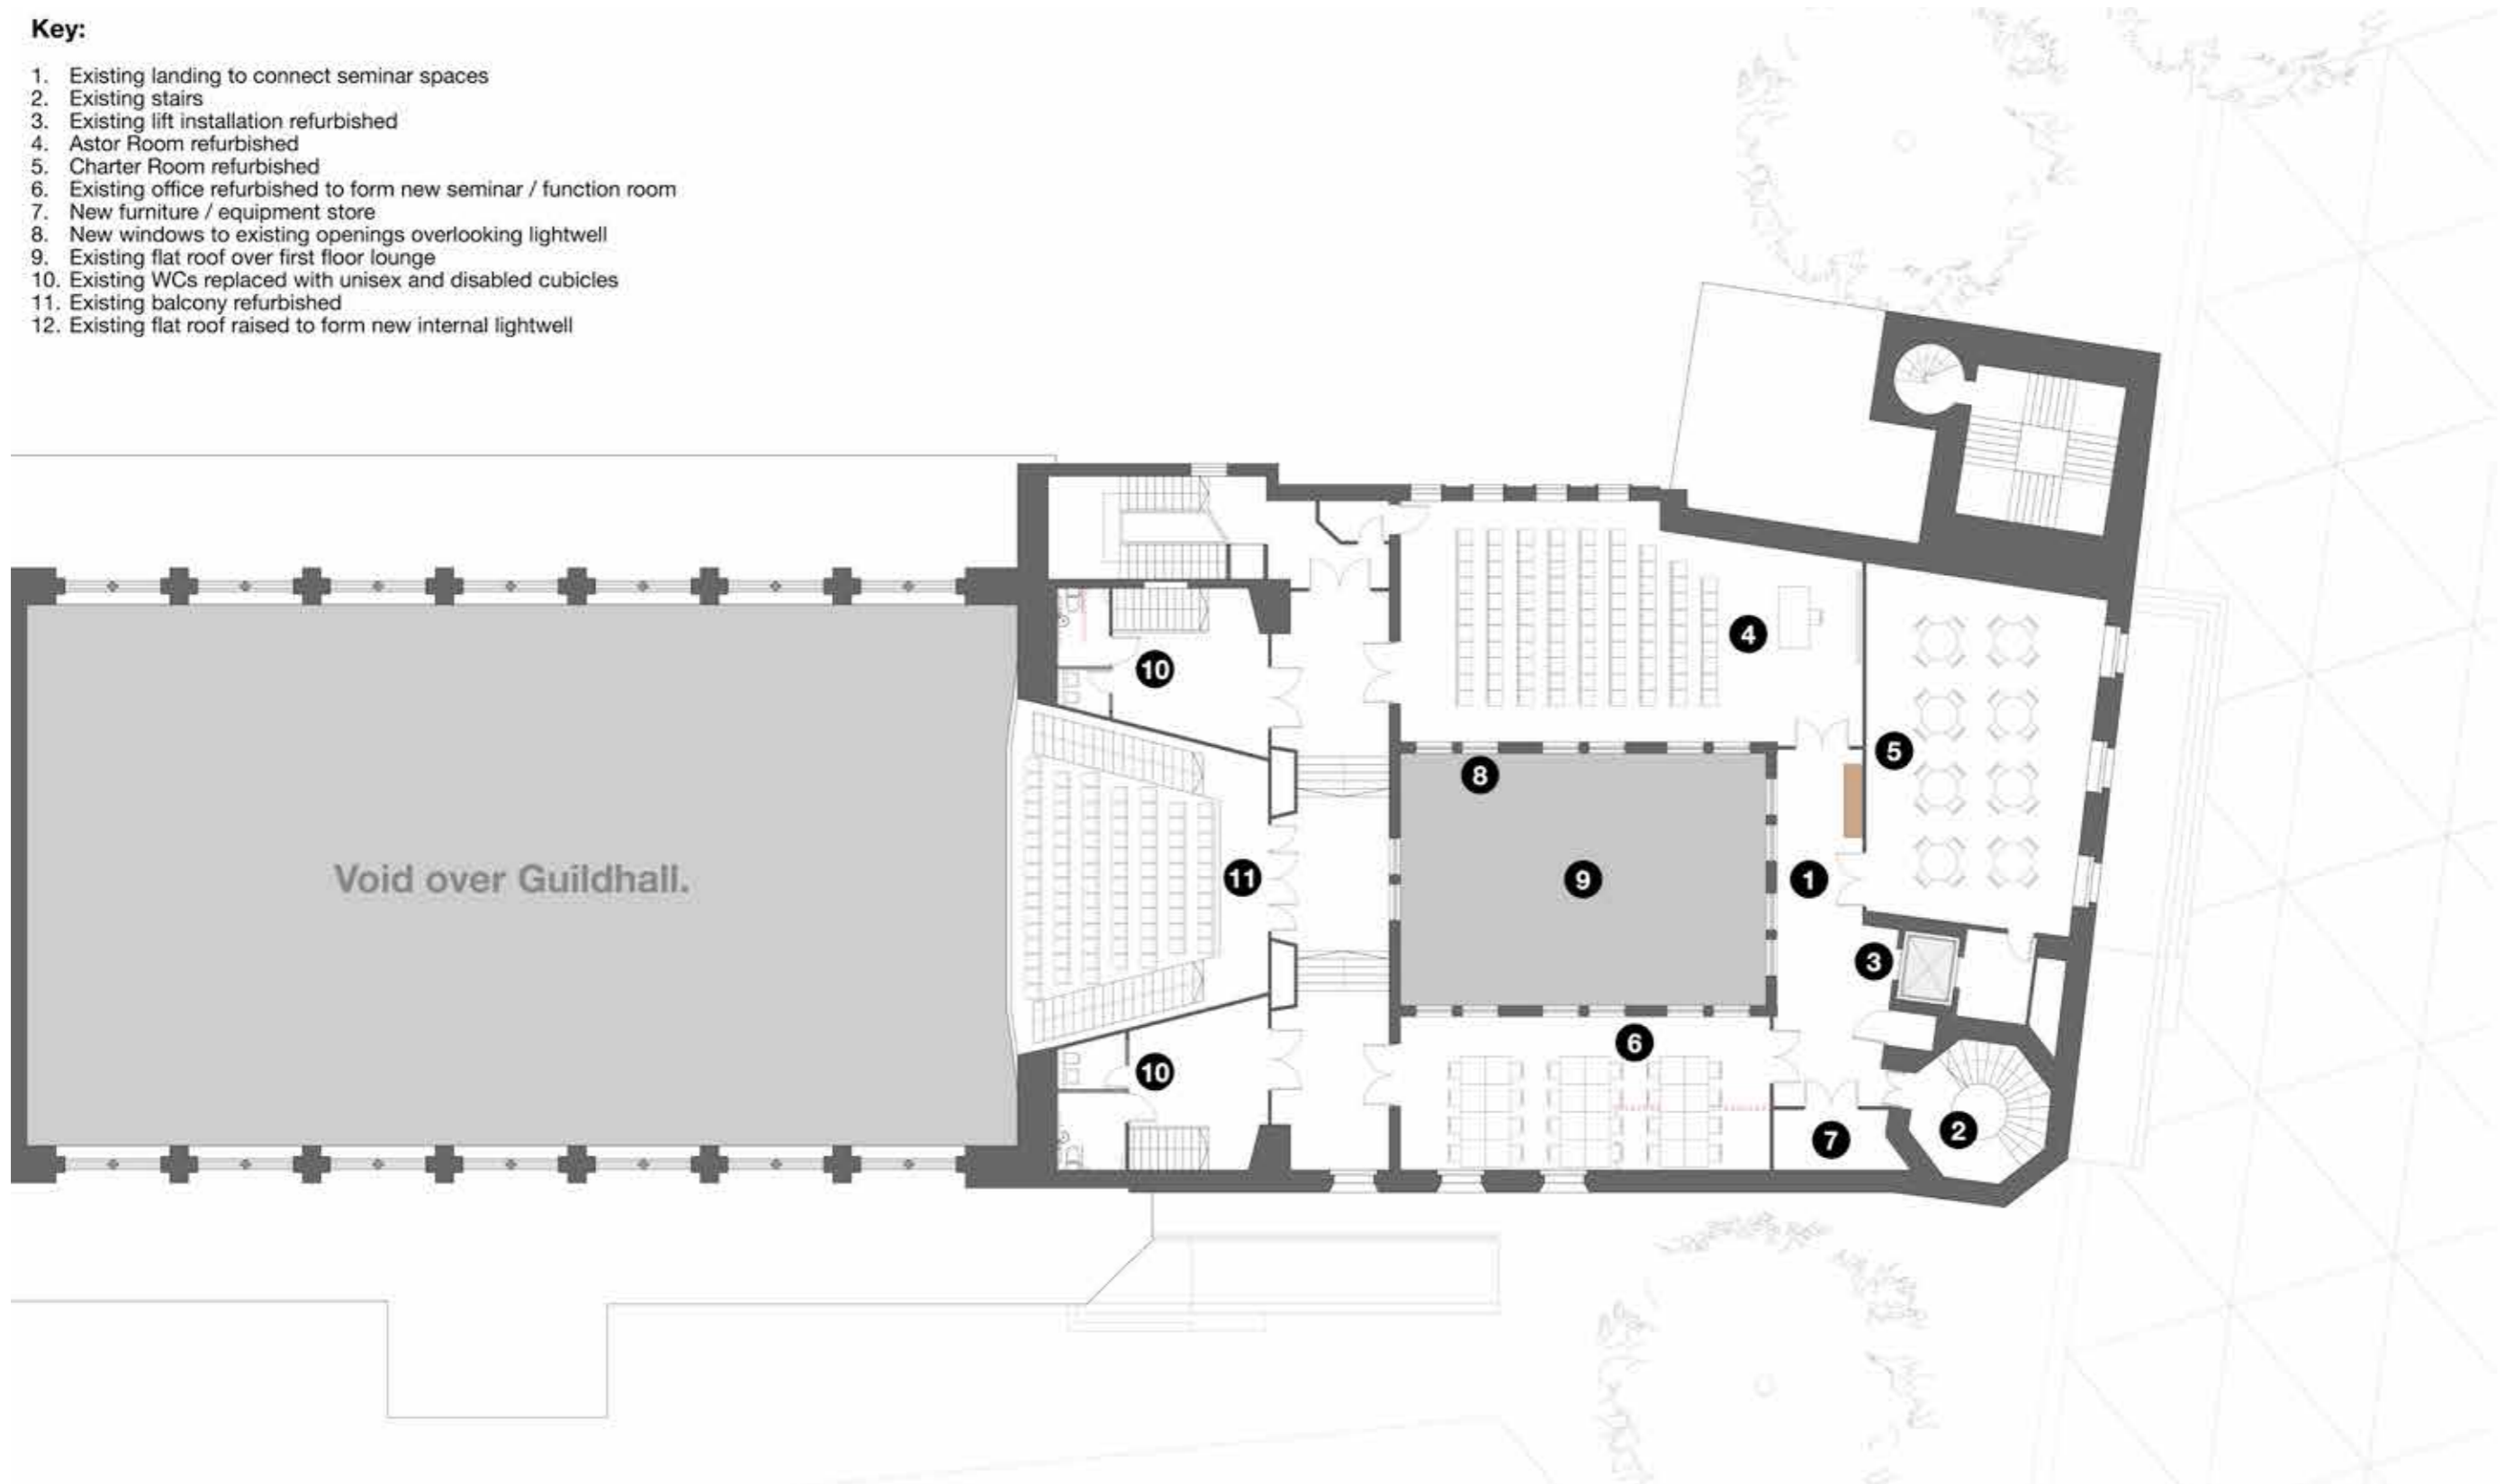
# The Guildhall Proposed Second Floor Plan.

1. Existing landing to connect seminar spaces
2. Existing stairs
3. Existing lift installation refurbished
4. Astor Room refurbished
5. Charter Room refurbished
6. Existing office refurbished to form new seminar / function room
7. New furniture / equipment store
8. New windows to existing openings overlooking lightwell
9. Existing flat roof over first floor lounge
10. Existing WCs replaced with unisex and disabled cubicles
11. Existing balcony refurbished
12. Existing flat roof raised to form new internal lightwell
