MOUNT EDGCUMBE JOINT COMMITTEE – SUPPLEMENT PACK I

10. Mount Edgcumbe Fire Damage Options Appraisal:

Barrow Centre, Mount Edgcumbe.

Fire Damage Refurbishment - Options Appraisal

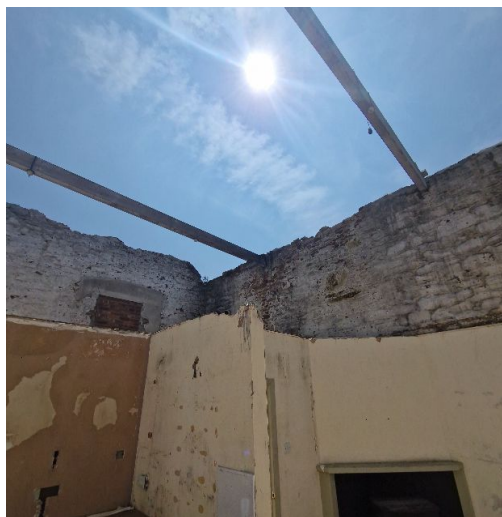
Fig. 9. Photo 1 -
Roof removed due to extensive fire damage

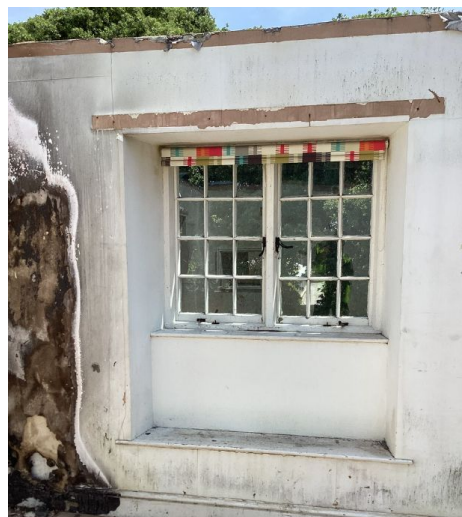
Windows - Many single-glazed timber casement windows have been removed and boarded over. The majority of the remaining windows were left ajar for ventilation. While glazing and frames generally appear satisfactory, they show swelling from water damage and some smoke staining. One window was observed with a missing central mullion.

Fig. 11. Photo 3 -
Existing timber framed single glazed windows

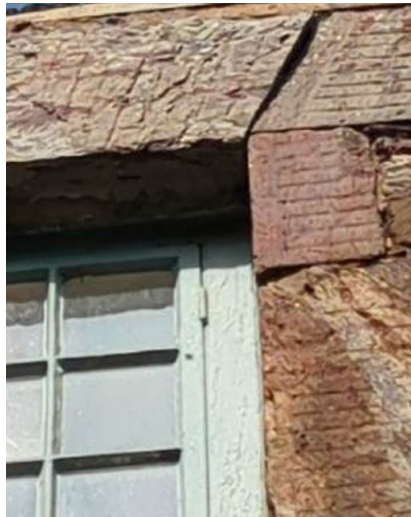
Fig. 12. Photo 4 -
Stone lintel to North East corner displaced

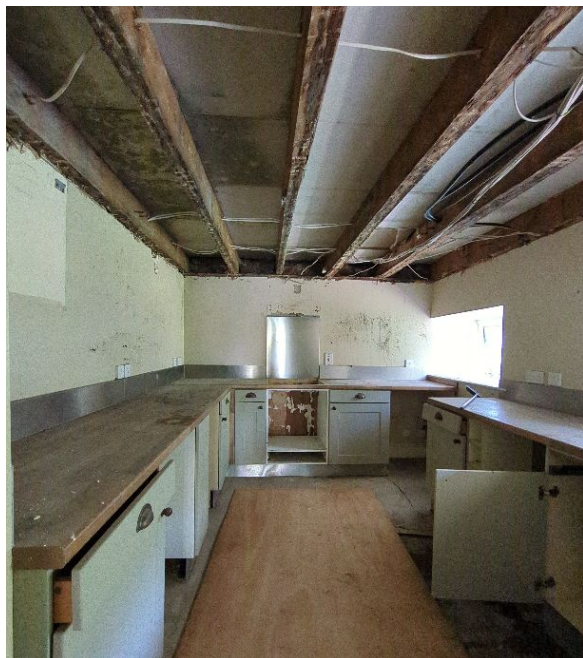
Fig. 14. Photo 6 - Horseshoe Cottage, Kitchen ceiling finish removed

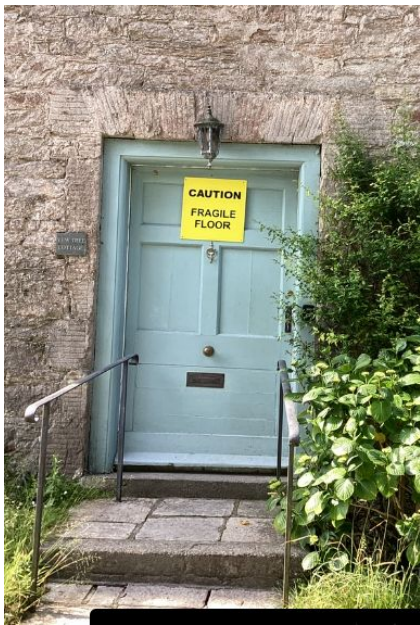
Fig. 19. Photo 11 - External light fixed above timber door requires renewal

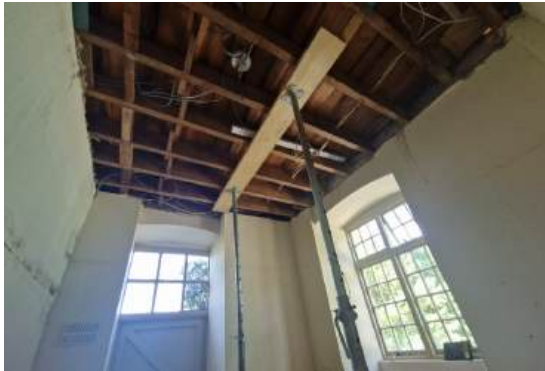
Photograph 1 - Kitchen ceiling (LGF Yew tree cottage)

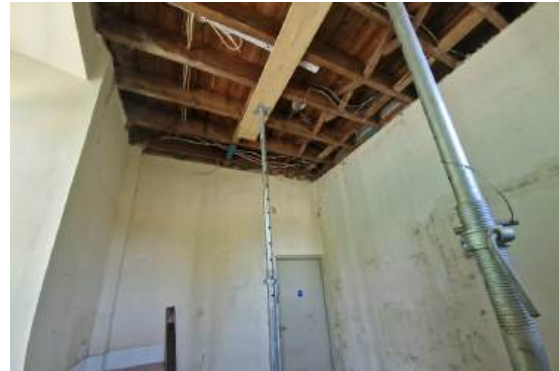
Photograph 2 - Kitchen walls saturated (LGF Yew tree cottage)

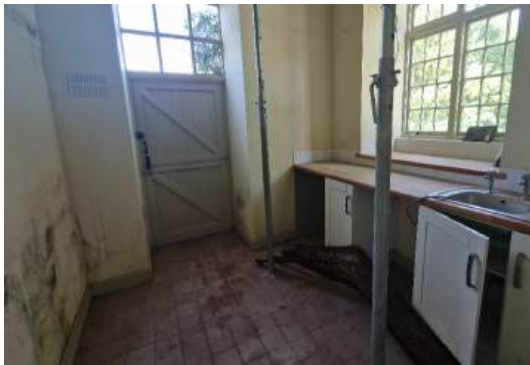
Photograph 3 - Tiled floor covering (LGF Yew tree cottage)

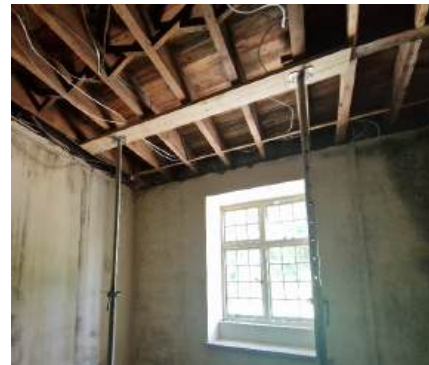
Photograph 4 - Lounge ceiling finish removed (LGF Yew tree cottage)

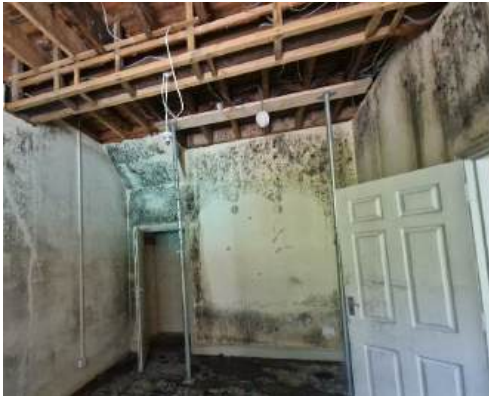
Photograph 5 - Significant mould growth on walls (LGF Yew tree cottage)

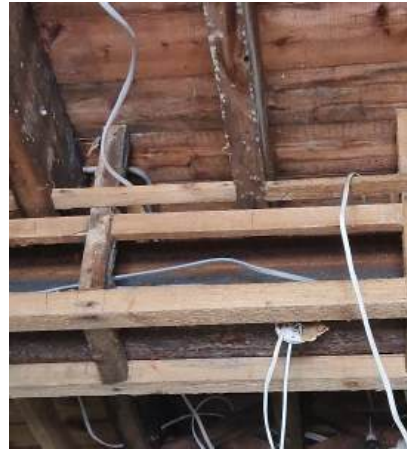
Photograph 6 - RSJ rusting (LGF Yew tree cottage)

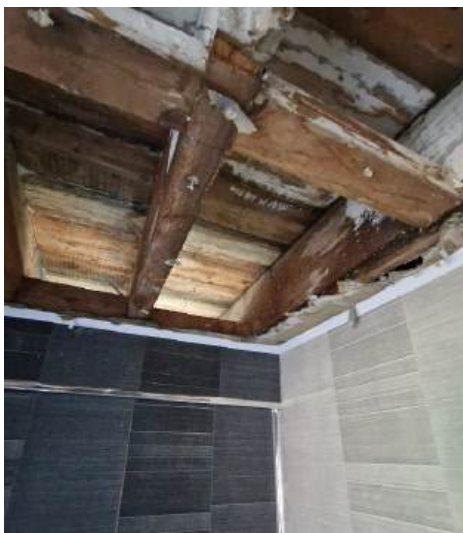
Photograph 7 - Bathroom ceiling (LGF Yew tree cottage)

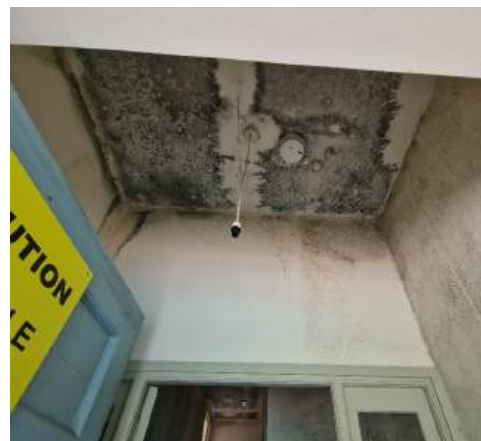
Photograph 8 - Entrance lobby ceiling (LGF Yew tree cottage)

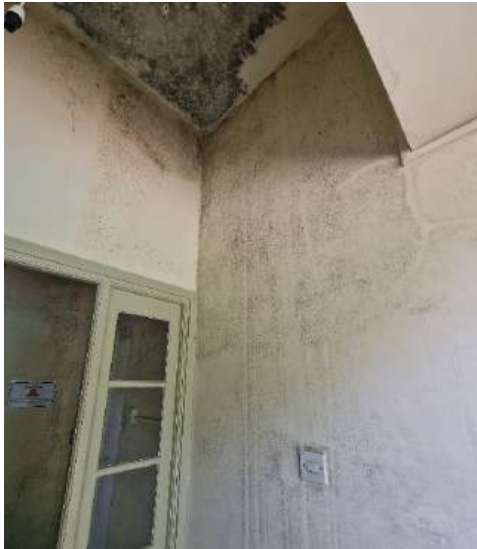
Photograph 9 - mould growth on wall (LGF Yew tree cottage)

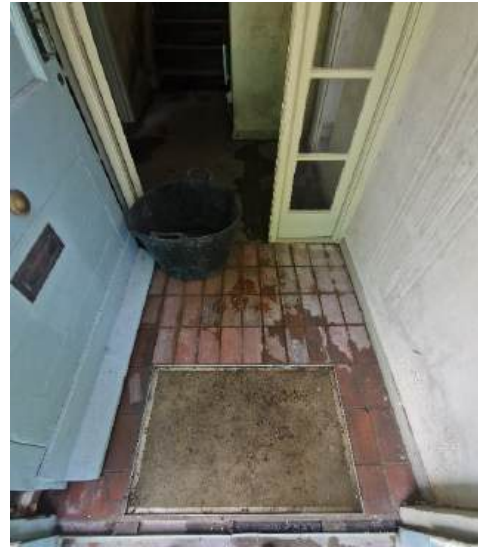
Photograph 10 - Terracotta tiles (LGF Yew tree cottage)

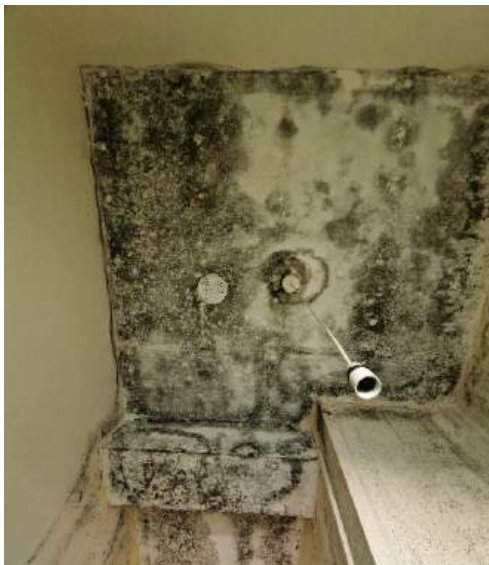
Photograph 11 - Hallway ceiling finish covered in mould (LGF Yew tree cottage)

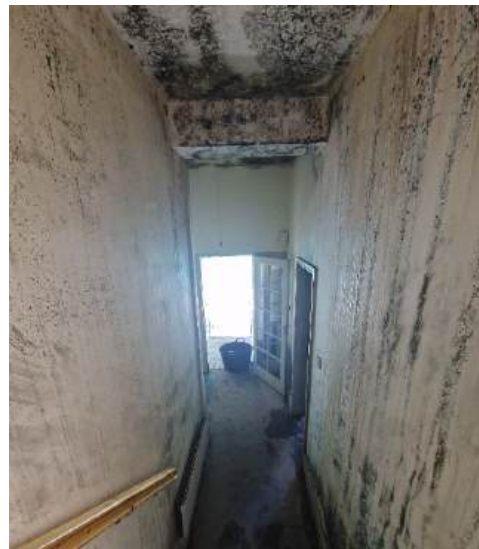
Photograph 12 - Hallway wall finish covered in mould (LGF Yew tree cottage)

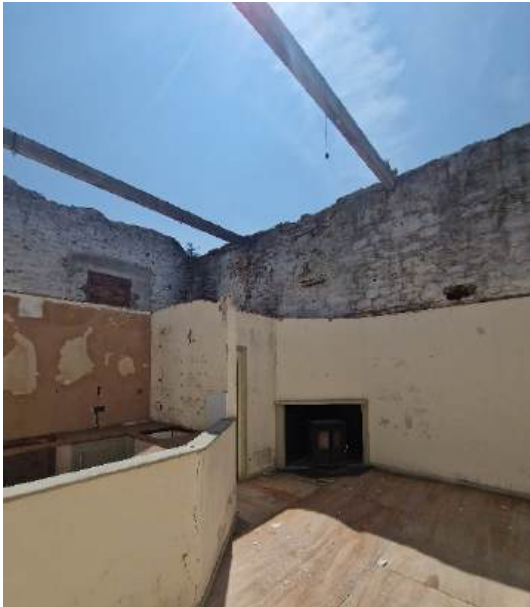
Photograph 13 - No ceiling in kitchen (GF Yew tree cottage)

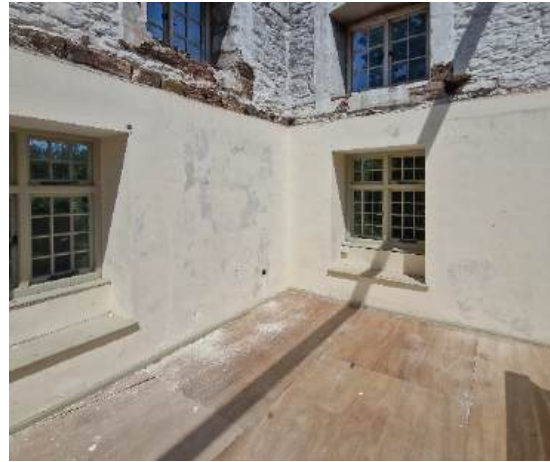
Photograph 14 - 9mm plywood overlay in kitchen (GF Yew tree cottage)

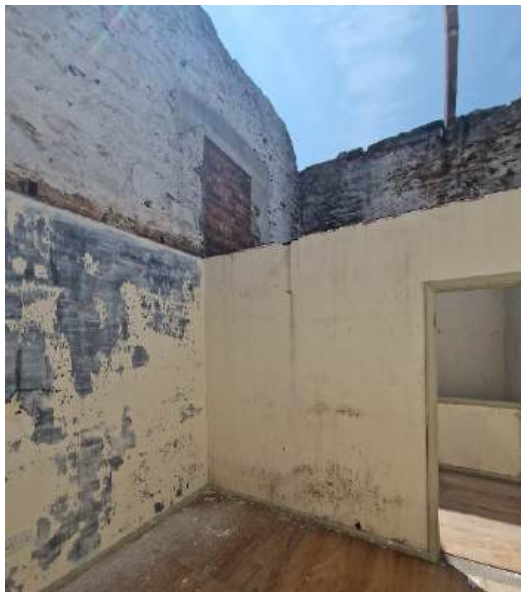
Photograph 15 - No ceiling finish in bedroom 1 (GF Yew tree cottage)

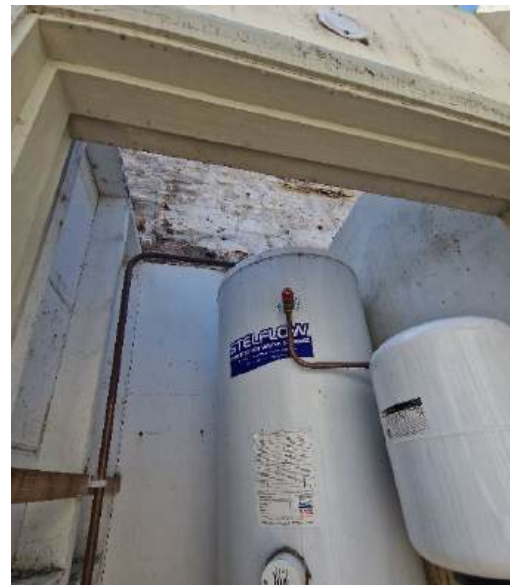
Photograph 16 - No ceiling finish in immersion cupboard (GF Yew tree cottage)

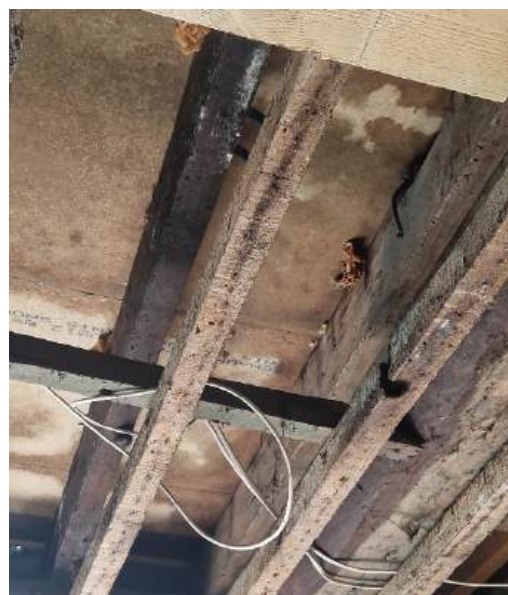
Photograph 20 -Fungal growth on lounge timber beams (GF Flat 6)

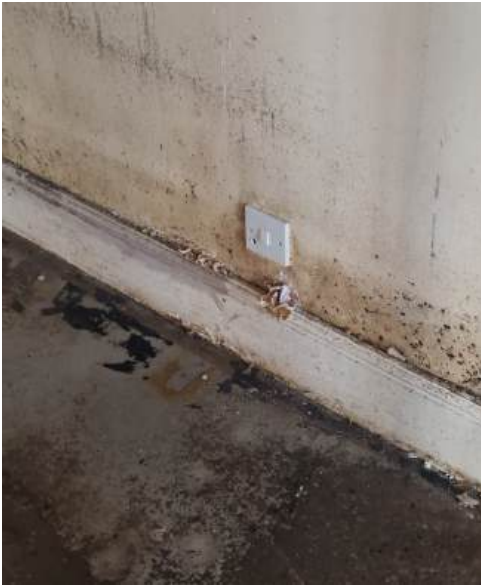
Photograph 21 - fungal growth on lounge skirting board (GF Flat 6)

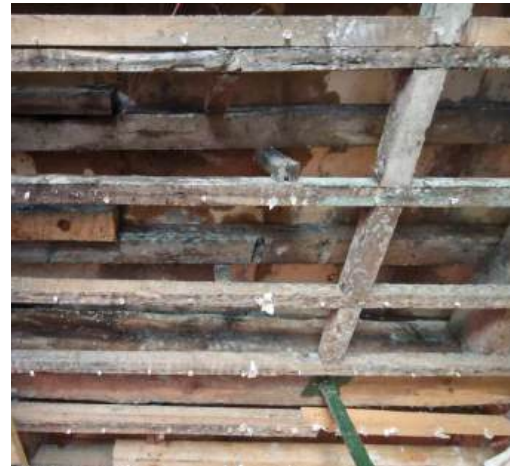
Photograph 24 - Kitchen ceiling finish removed (GF Flat 6)

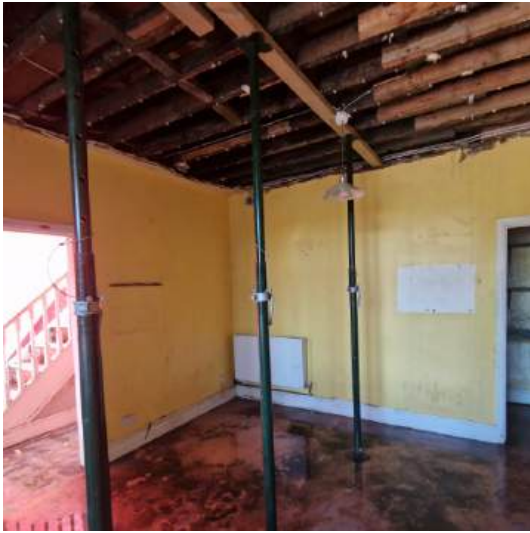
Photograph 25 - Kitchen floor flooded (GF Flat 6)

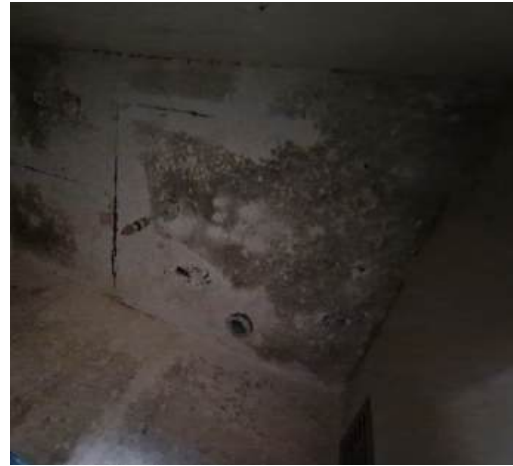
Photograph 26 - kitchen cupboard ceiling mouldy (GF Flat 6)

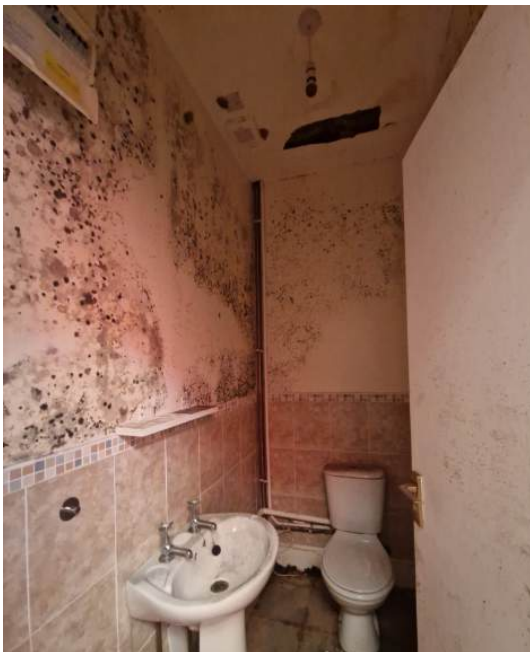
Photograph 27 - bathroom wall finishes mouldy (GF Flat 6)

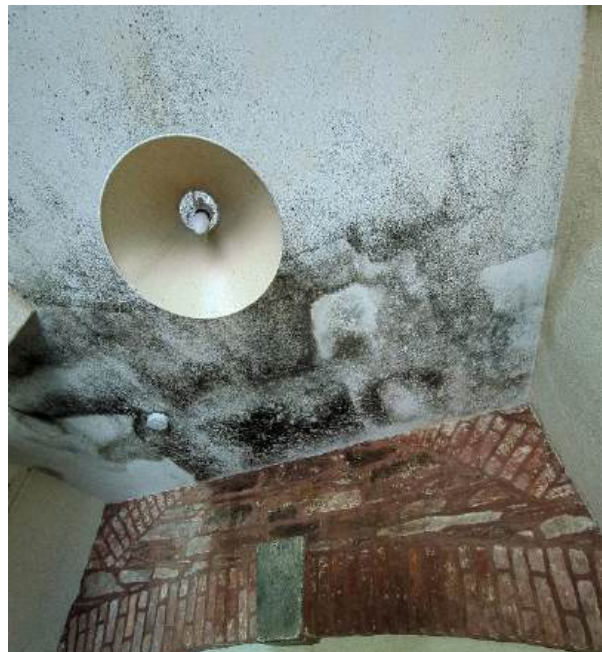
Photograph 28 - Lobby ceiling mouldy (LGF Horseshoe cottage)

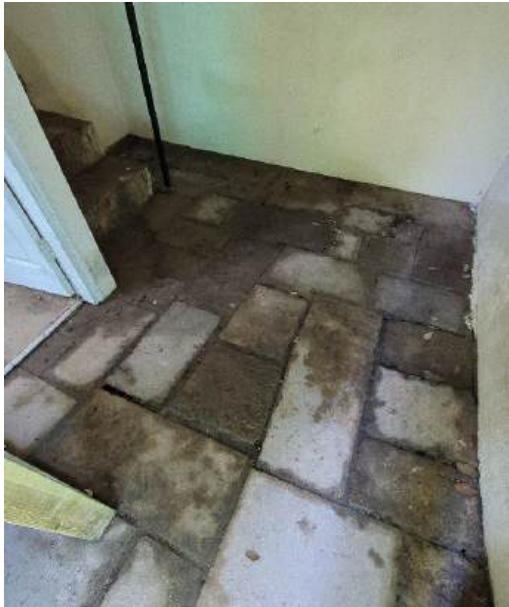
Photograph 29 - Stone flag stones (LGF Horseshoe cottage)

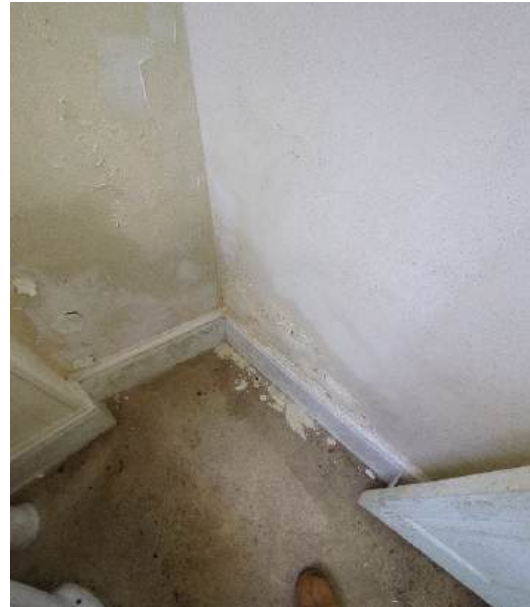
Photograph 30 - bathroom walls damp (LGF Horseshoe cottage)

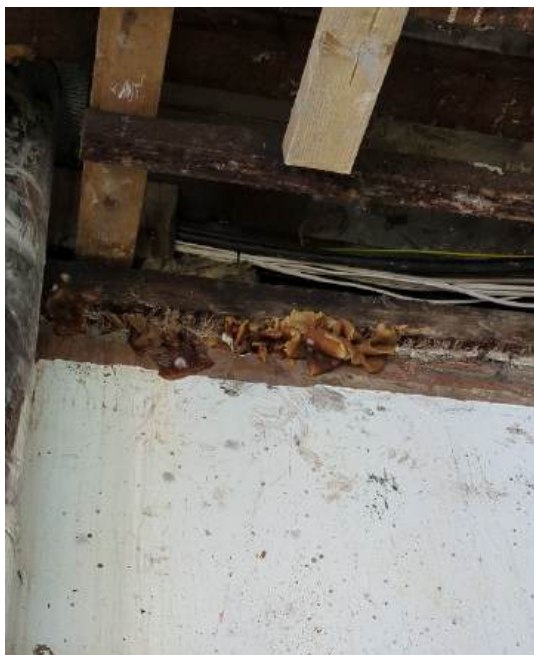
Photograph 33 - fungal growth in lounge ceiling (GF Horseshoe cottage)

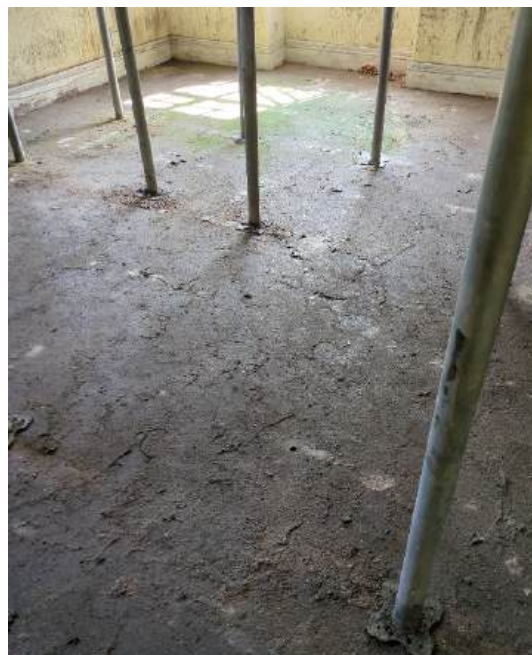
Photograph 34 - lounge concrete floor covered in debris (GF Horseshoe cottage)

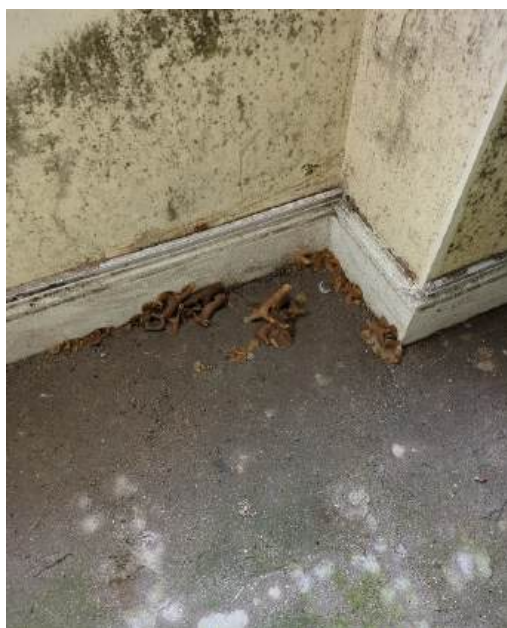
Photograph 35 - Fungal growth on lounge concrete floor (GF Horseshoe cottage)

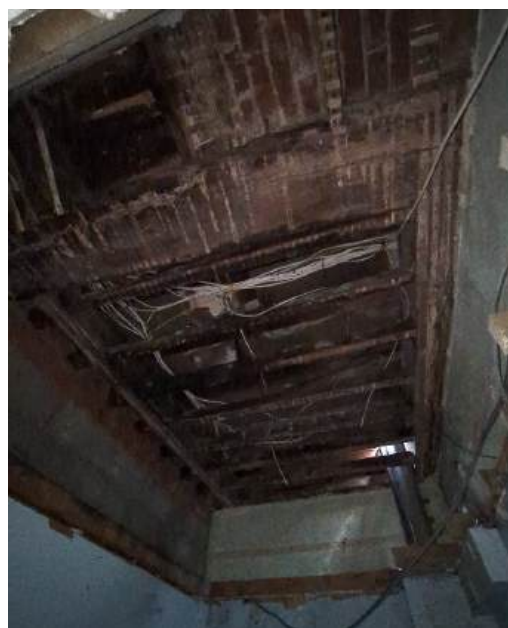
Photograph 36 - bathroom ceiling finish removed (GF Horseshoe cottage)

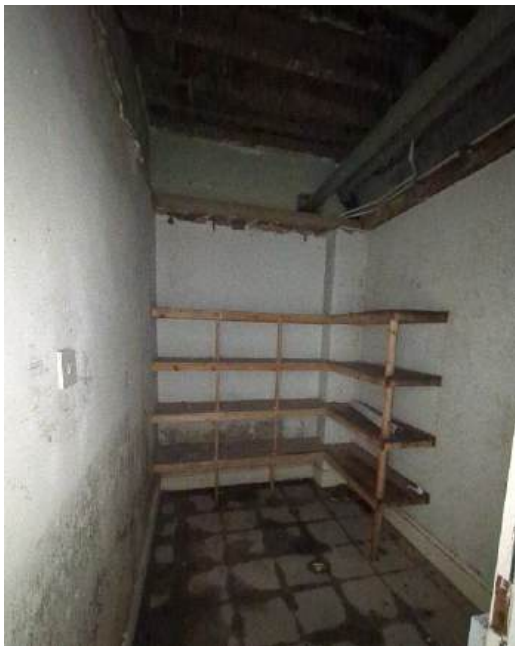
Photograph 39 - Tiled floor covering in store (GF Horseshoe cottage)

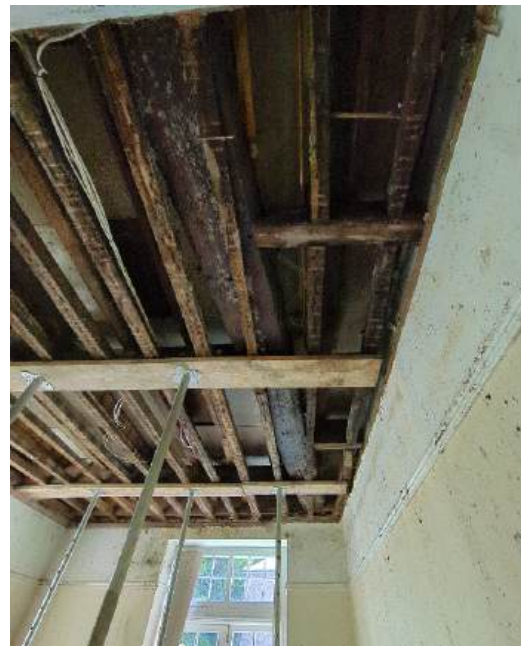
Photograph 40 - Bedroom 1 ceiling finish removed (GF Horseshoe cottage)

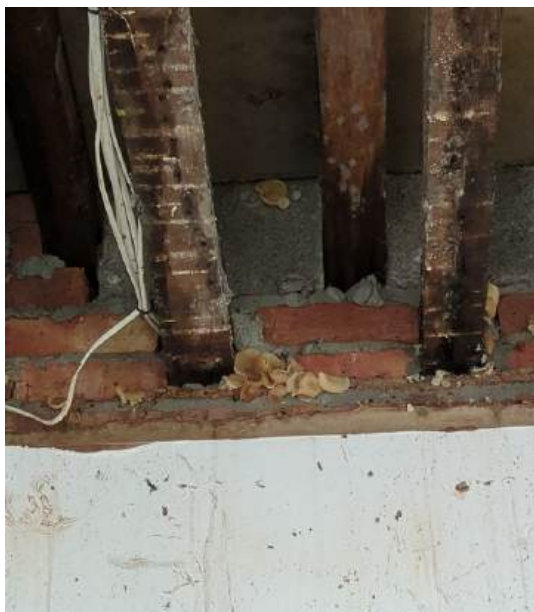
Photograph 41 - Fungal growth in Bedroom 1 ceiling (GF Horseshoe cottage)

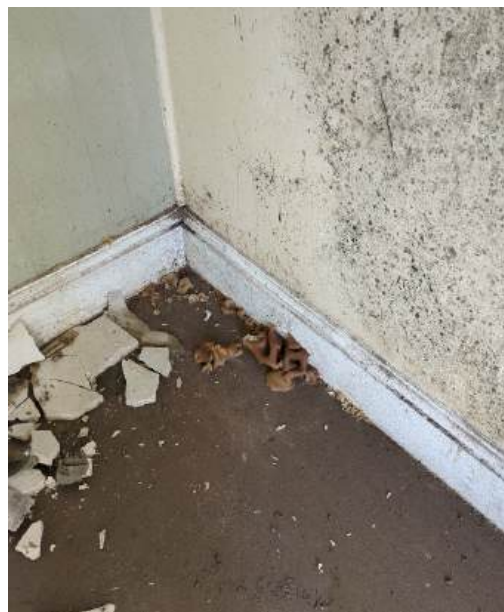
Photograph 42 - Fungal growth around skirting in bedroom 1 (GF Horseshoe cottage)

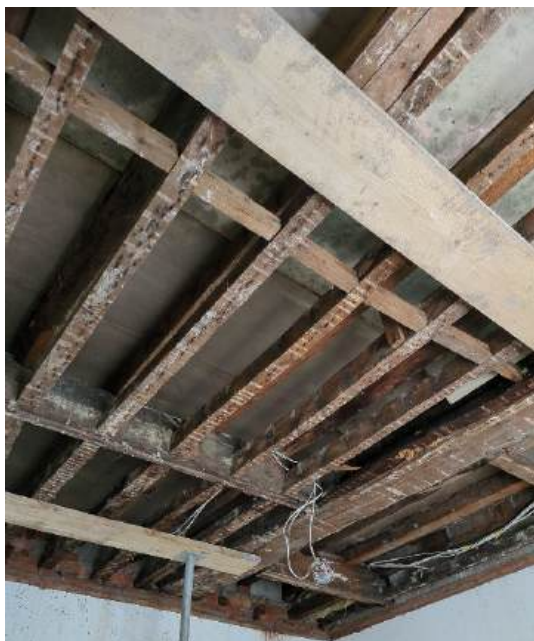
Photograph 43 - Bedroom 2 ceiling finished removed (GF Horseshoe cottage)

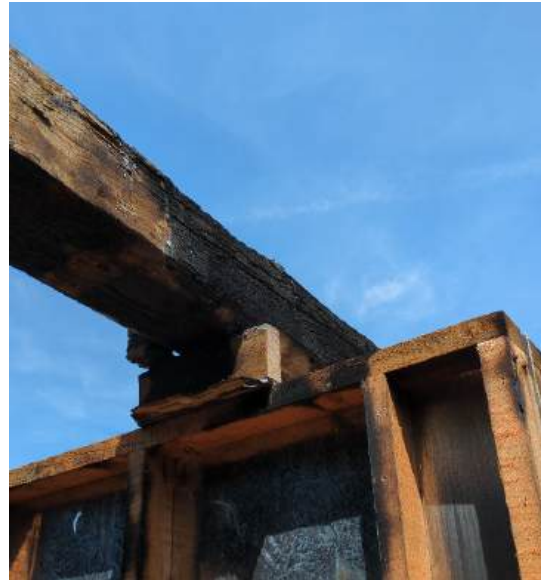
Photograph 54 - Significant charring to the timber truss in bedroom 2 (1F flat 6)

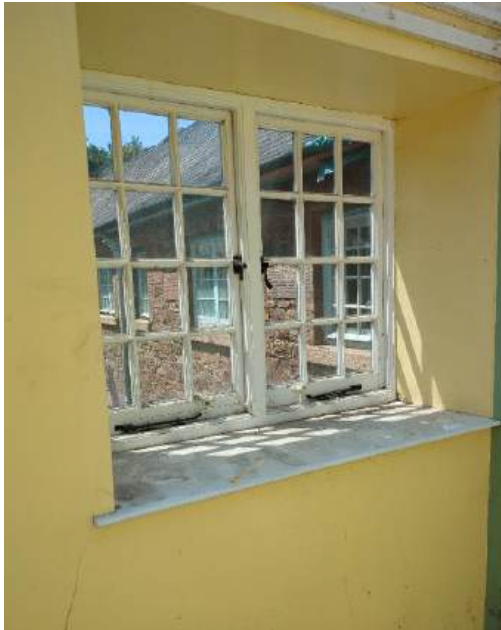
Photograph 57 - Bathroom timber framed window (1F flat 6)

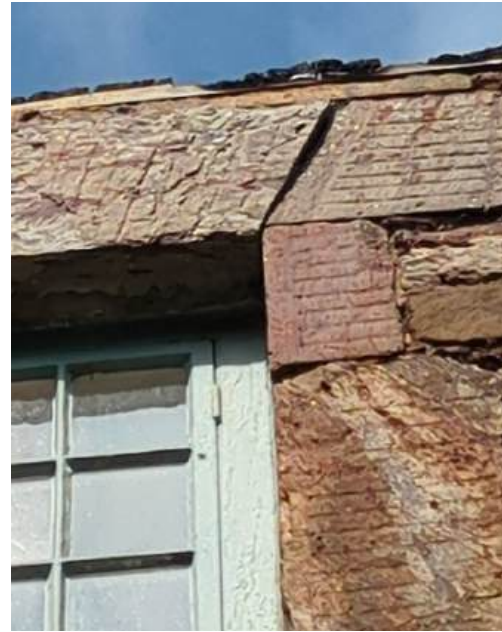
Photograph 62 - Key stone misalignment (East elevation)

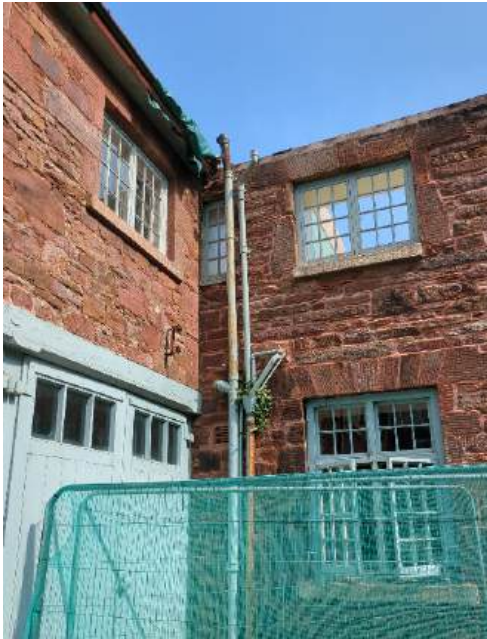
Photograph 65 - Disconnected downpipes
(South elevation)

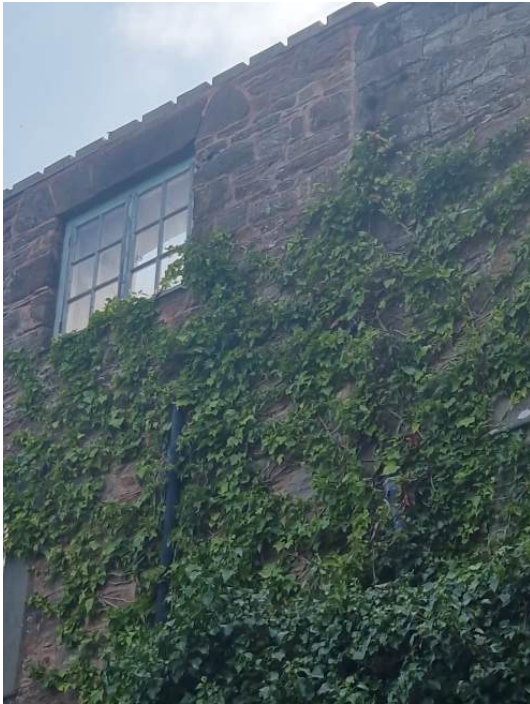
Photograph 69 - Disconnected downpipes
(West elevation)

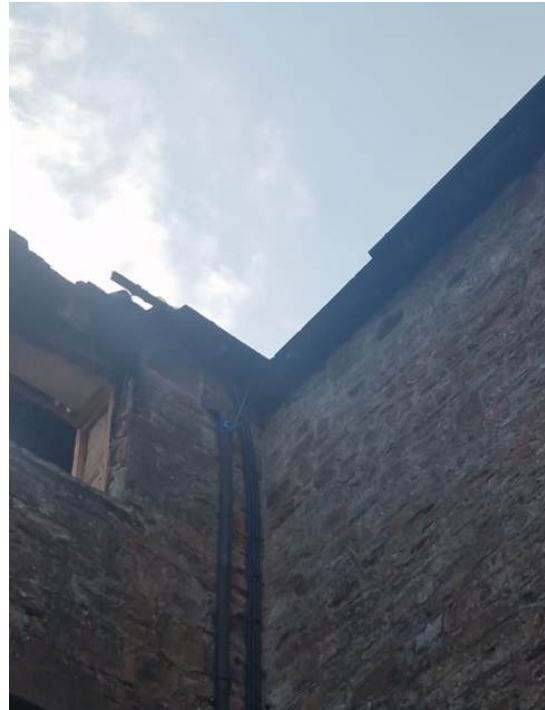
Photograph 70 - Disconnected guttering (West elevation)

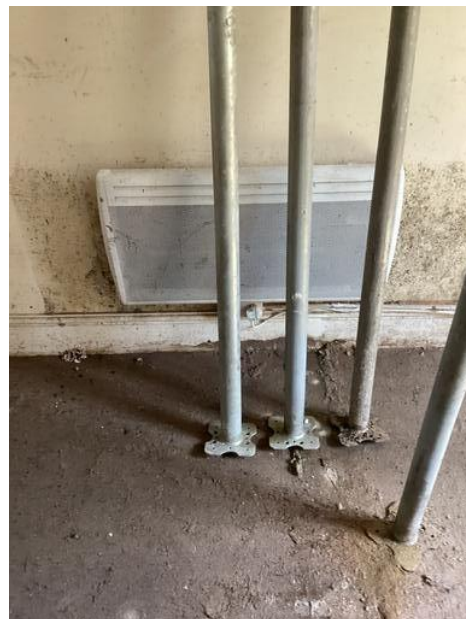
Photograph 17 - Horseshoe Cottage
(Kitchen) Water Heater

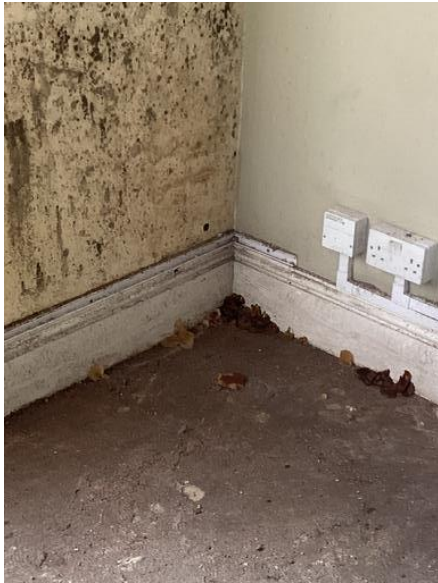
Photograph 18 - Horseshoe Cottage (Lounge)
Electric Heater

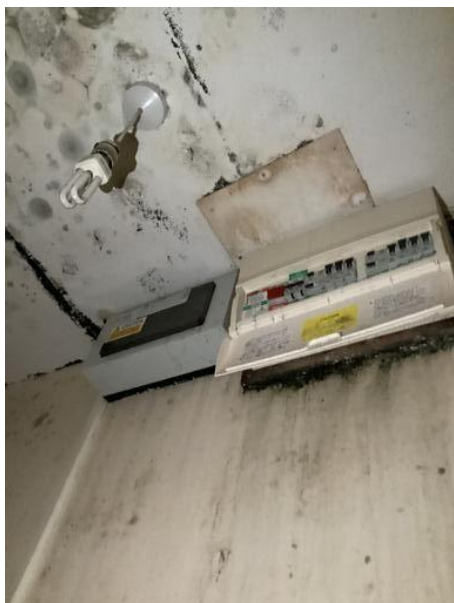
Photograph 22 - Horseshoe Cottage (Lounge)
General Wiring

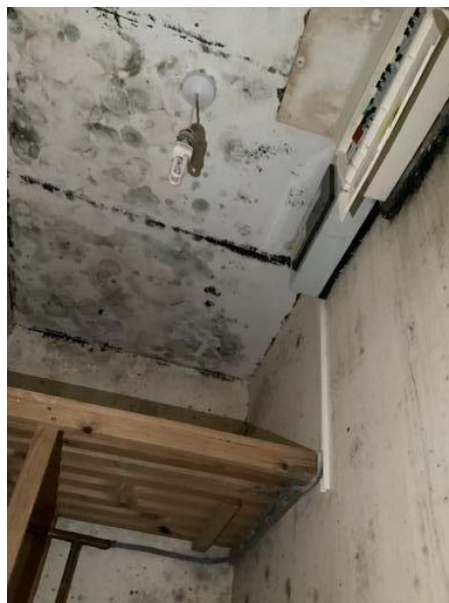
Photograph 23 - Horseshoe Cottage (Airing)
Lighting & Dist Boards

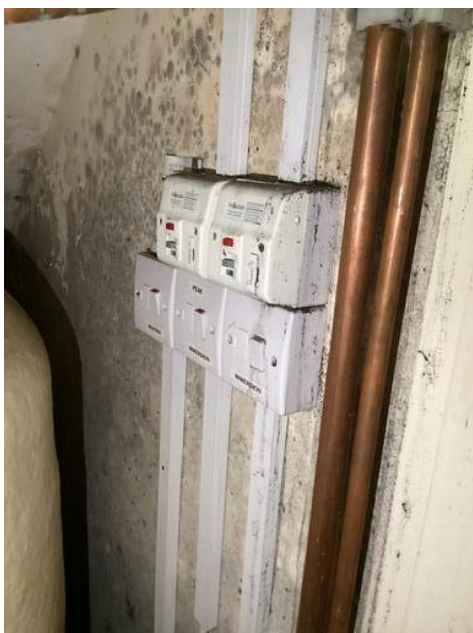
Photograph 24 - Horseshoe Cottage (Airing)
Lighting & Dist Boards

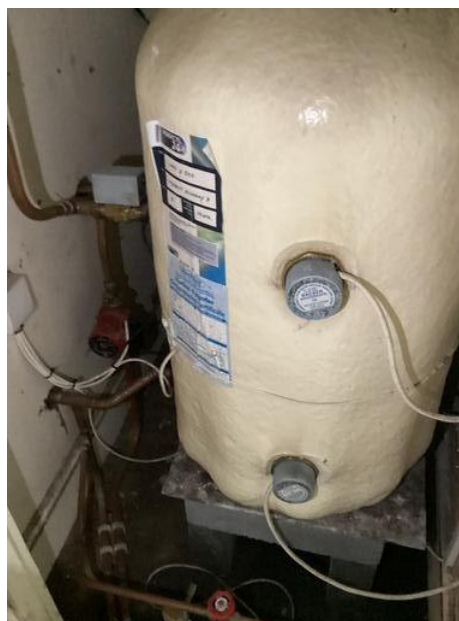
Photograph 25 - Horseshoe Cottage
Immersion Supplies

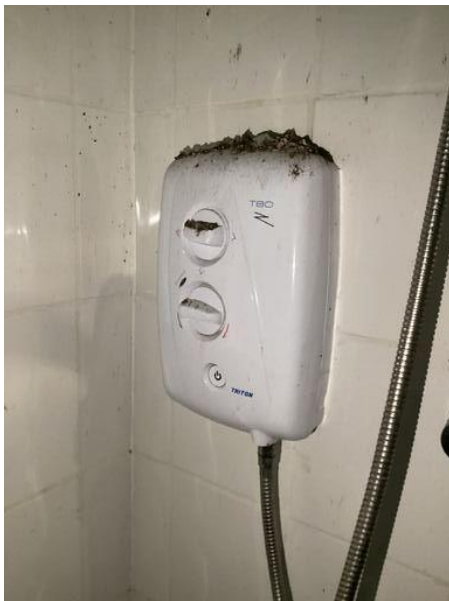
Photograph 26 - Horseshoe Cottage
Immersion Cylinder

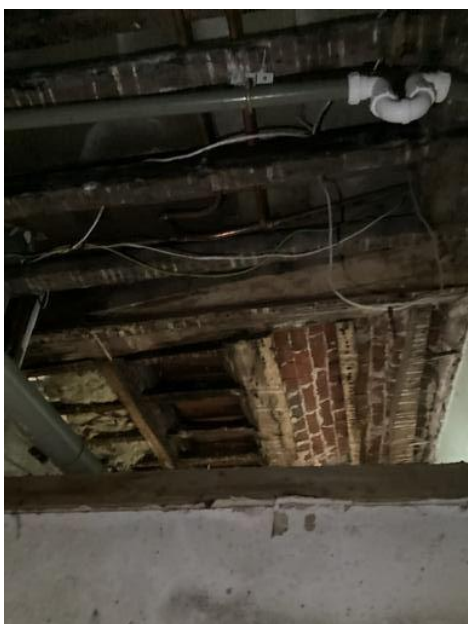
Photograph 32 - Horseshoe Cottage (Store)
General Wiring & Drainage

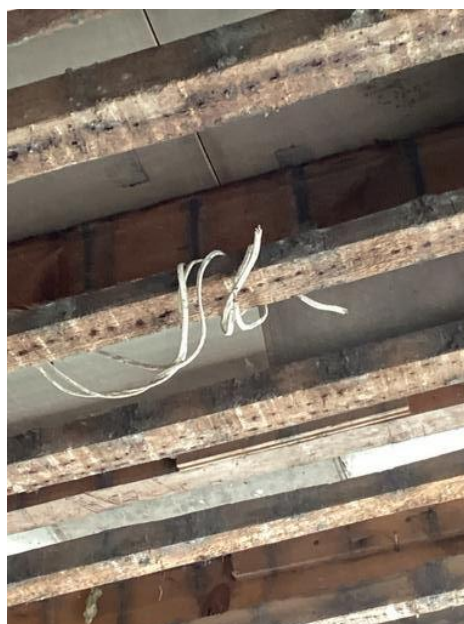
Photograph 33 - Horseshoe Cottage (Store)
General Wiring & Drainage

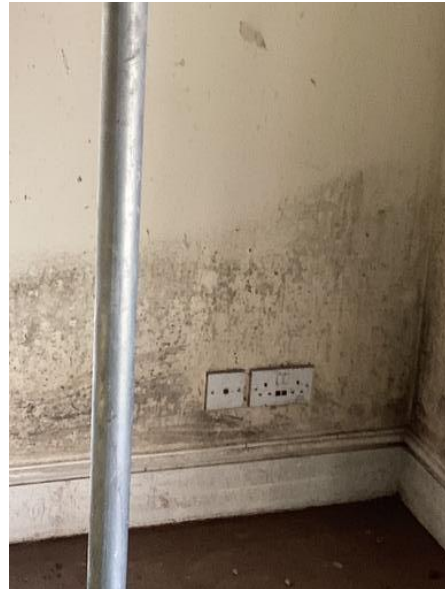
Photograph 35 - Horseshoe Cottage (Bed 1)
Electric Heater

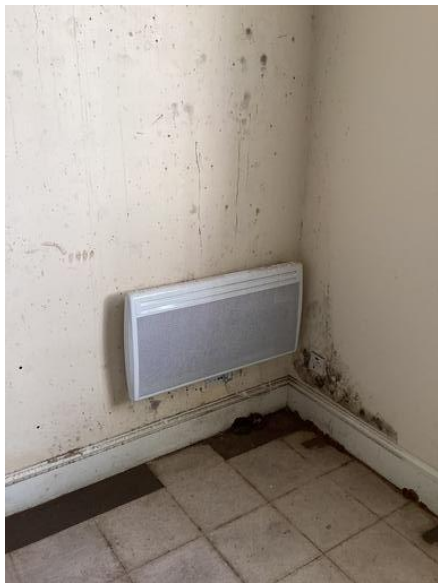
Photograph 36 - Horseshoe Cottage (Bed 1)
Power & TV

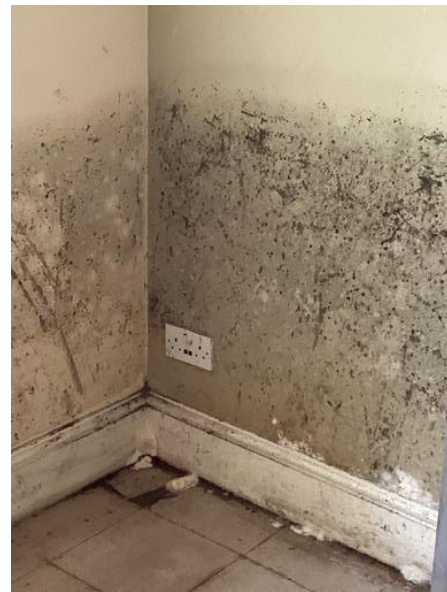
Photograph 37 - Horseshoe Cottage (Bed 2)
Electric Heater

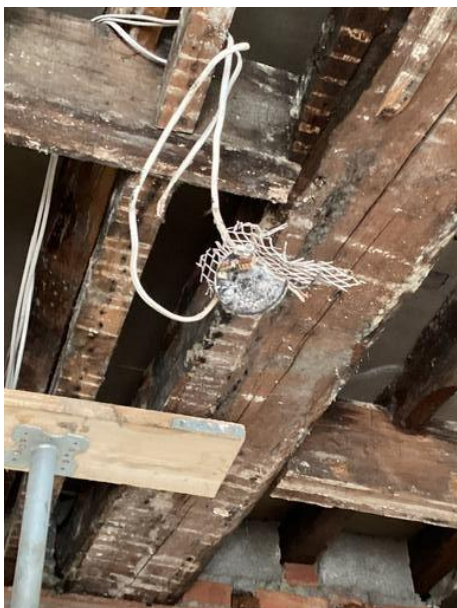
Photograph 38 - Horseshoe Cottage (Bed 2)
Power

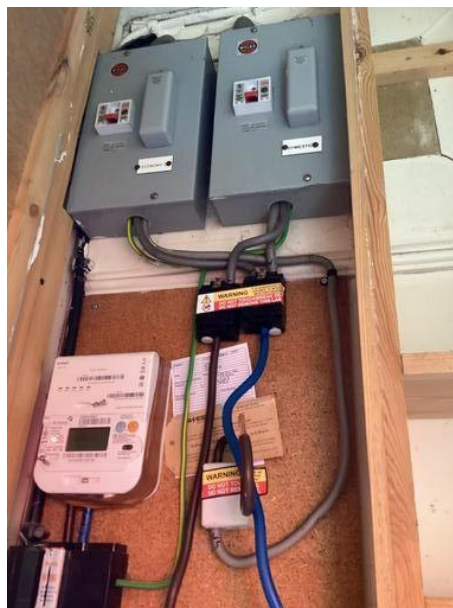
Photograph 39 - Horseshoe Cottage (Bed 2)
General Wiring & Smoke Detector

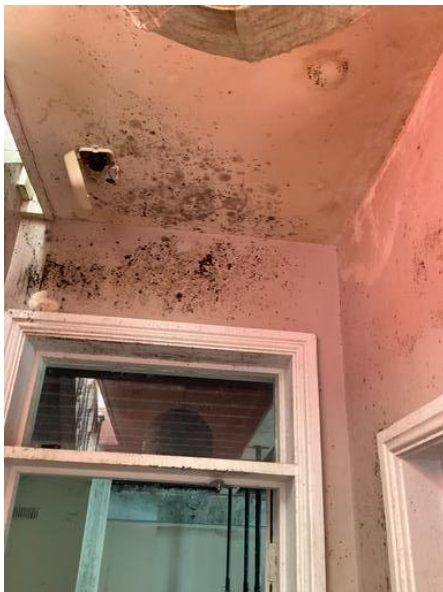
Photograph 42 - Flat 6 (Lobby)
Lighting

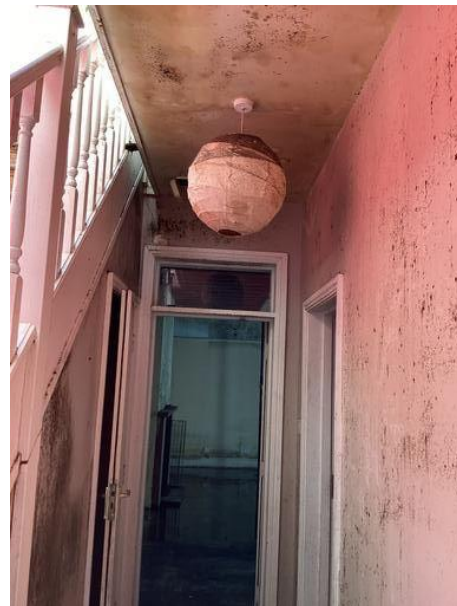
Photograph 43 - Flat 6 (Hall)
Battery Smoke Detector

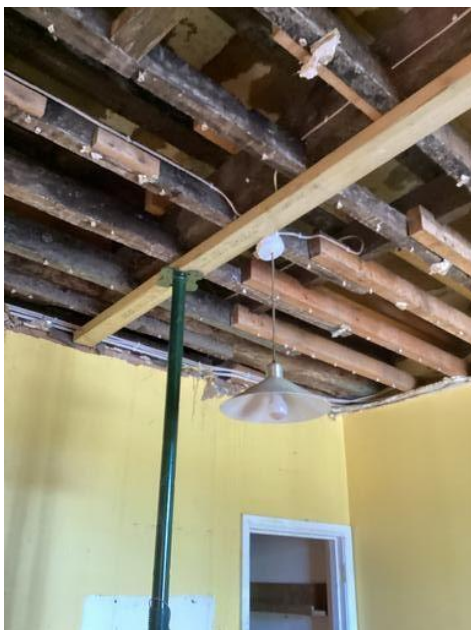
Photograph 44 - Flat 6 (Hall)
Lighting

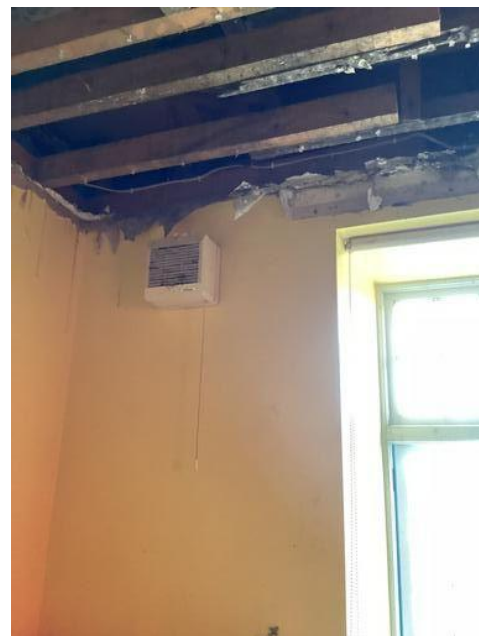
Photograph 45 - Flat 6 (Kitchen)
Lighting & General Wiring

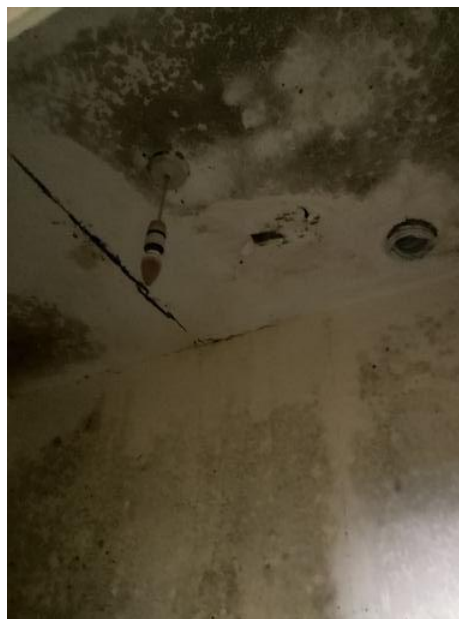
Photograph 47 - Flat 6 (Kitchen)
General Wiring

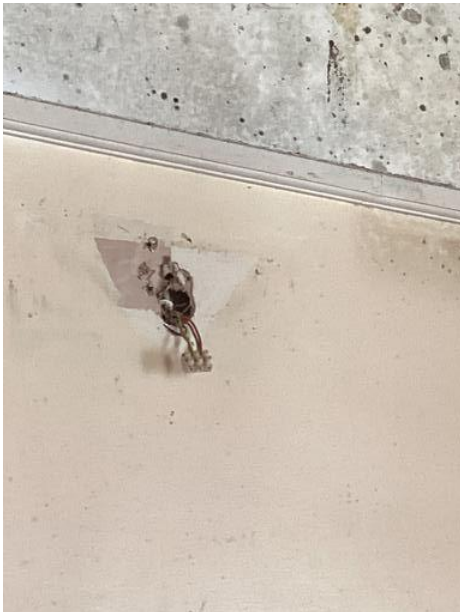
Photograph 52 - Flat 6 (Understairs)
Lighting

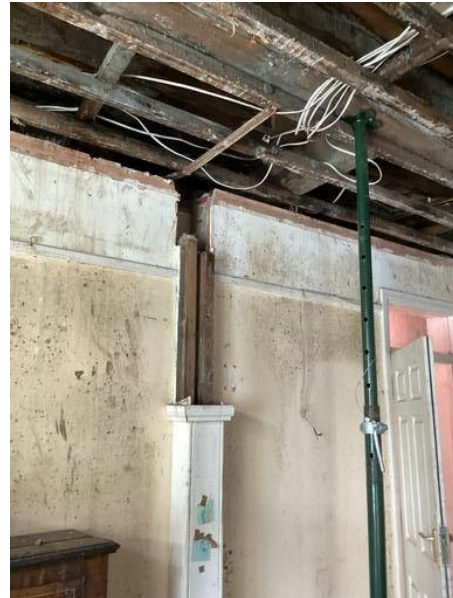
Photograph 55 - Flat 6 (Lounge)
General Wiring

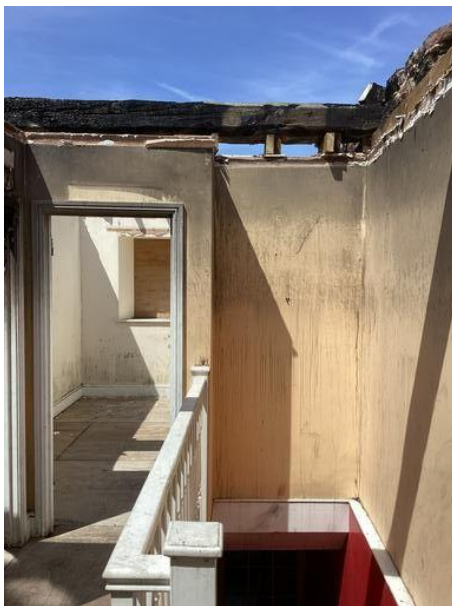
Photograph 56 - Flat 6 (Lounge)
General Wiring

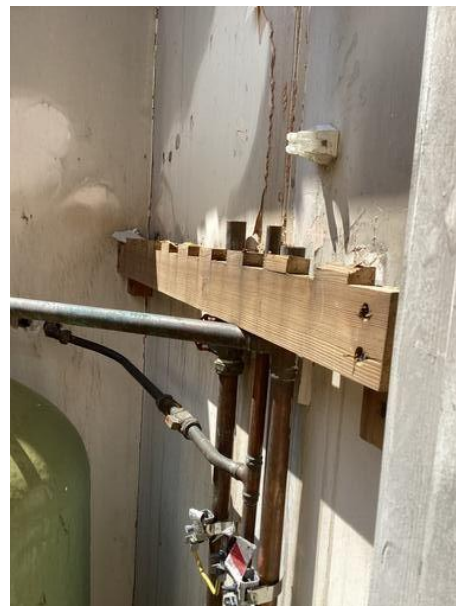
Photograph 57 - Flat 6 (Landing)
General

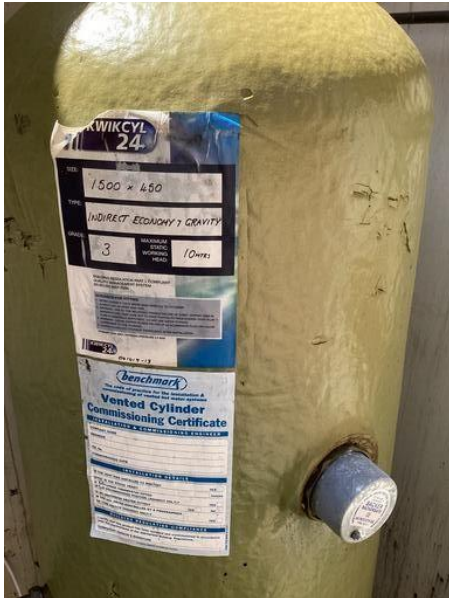
Photograph 58 - Flat 6 (Immersion)
Pipes To Above Cut Off

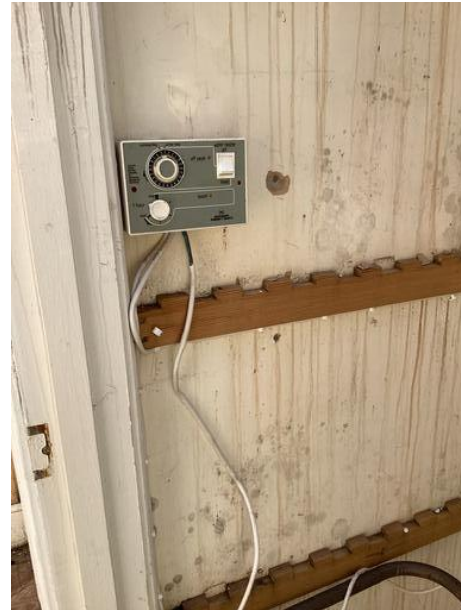
Photograph 59 - Flat 6 (Immersion)
Cylinder

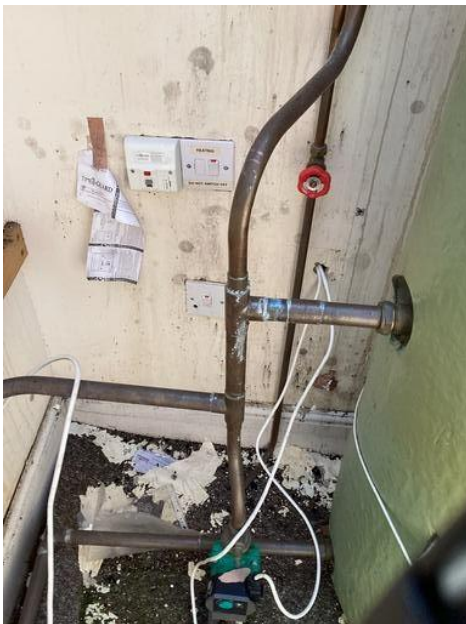
Photograph 61 - Flat 6 (Immersion)
Pump & Wiring

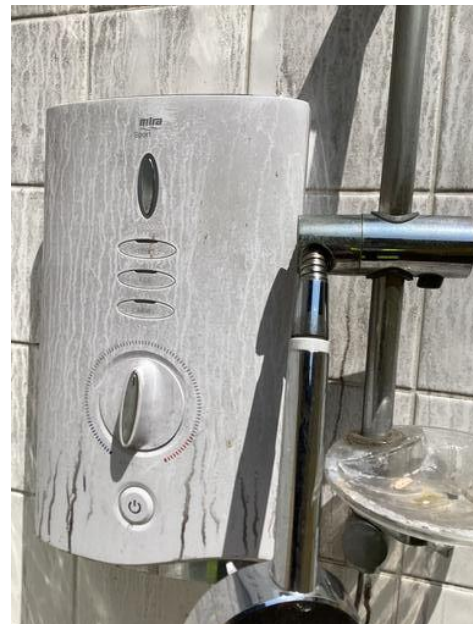
Photograph 62 - Flat 6 (Bath)
Electric Shower

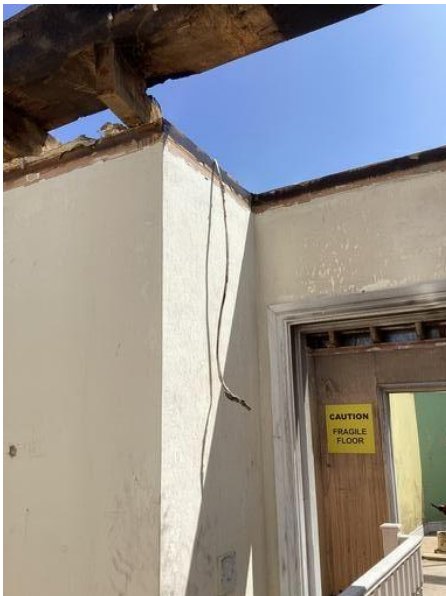
Photograph 65 - Flat 6 (Bed 1)
General Wiring

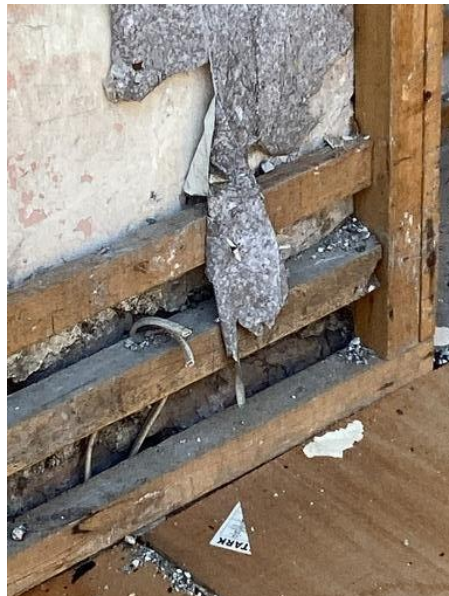
Photograph 66 - Flat 6 (Bed 2)
General Wiring

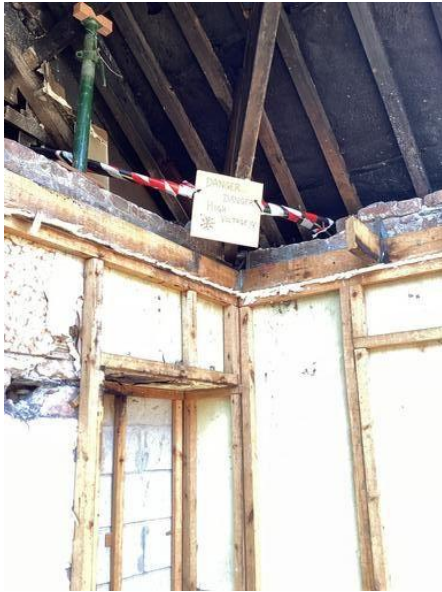
Photograph 67 - Flat 6 (Bed 2)
Temporary Supplies To Commercial Units

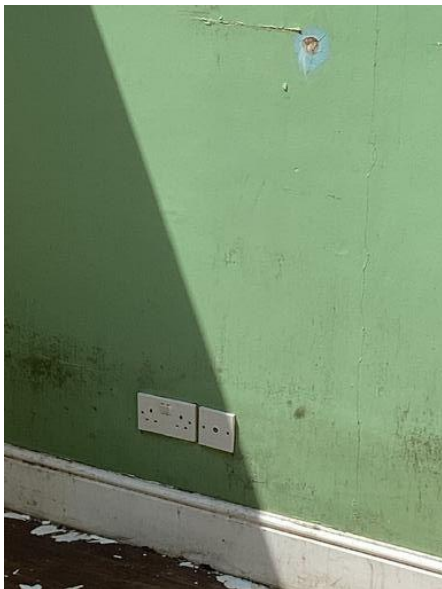
Photograph 69 - Flat 6 (Bed 3)
Power & TV

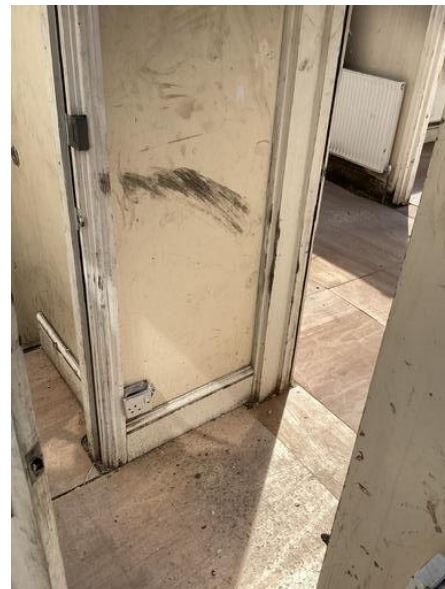
Photograph 70 - Flat 3 (Landing)
Power
