MOUNT EDGCUMBE JOINT COMMITTEE – SUPPLEMENT PACK I

10. Mount Edgcumbe Fire Damage Options Appraisal:

Barrow Centre, Mount Edgcumbe.

Fire Damage Refurbishment - Options Appraisal

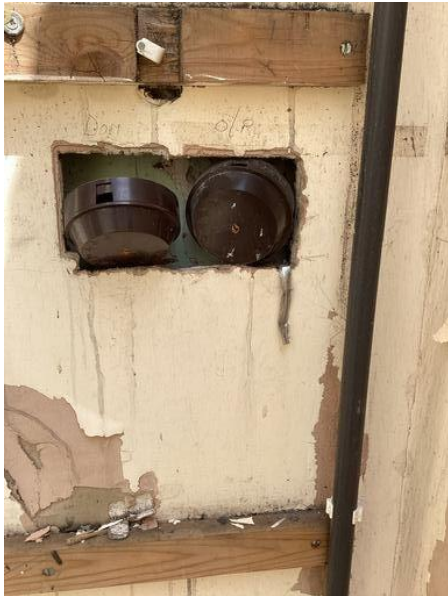
Photograph 71 - Flat 3 (Store)
General Wiring

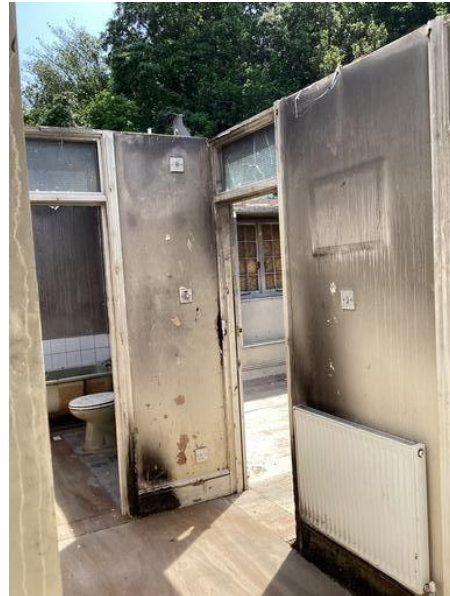
Photograph 72 - Flat 3 (Corridor)
General

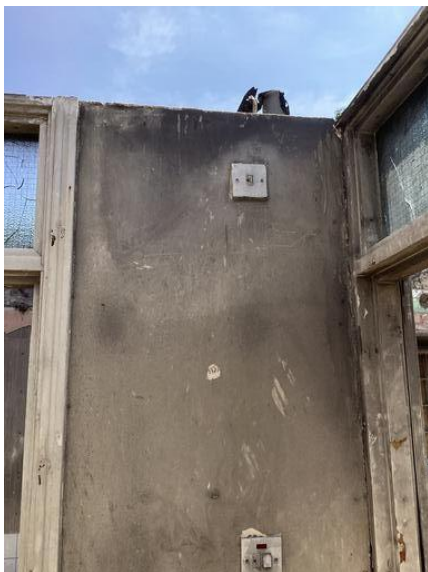
Photograph 73 - Flat 3 (Corridor)
Power

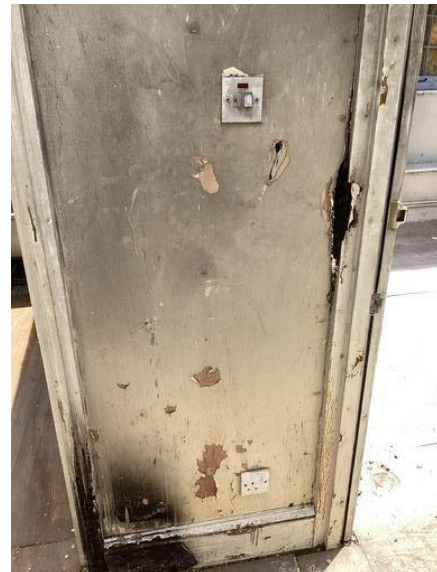
Photograph 74 - Flat 3 (Corridor)
Power

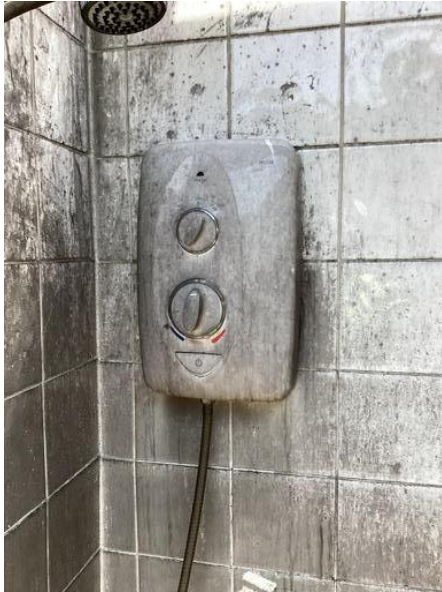
Photograph 75 - Flat 3 (Bath)
Electric Shower

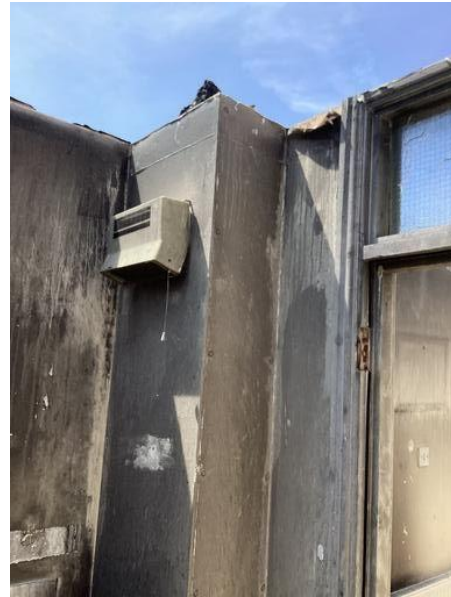
Photograph 76 - Flat 3 (Bath)
Electric Heater

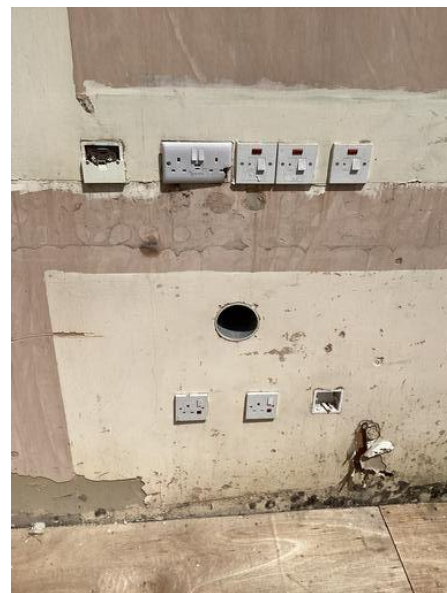
Photograph 78 - Flat 3 (Kitchen)
Power

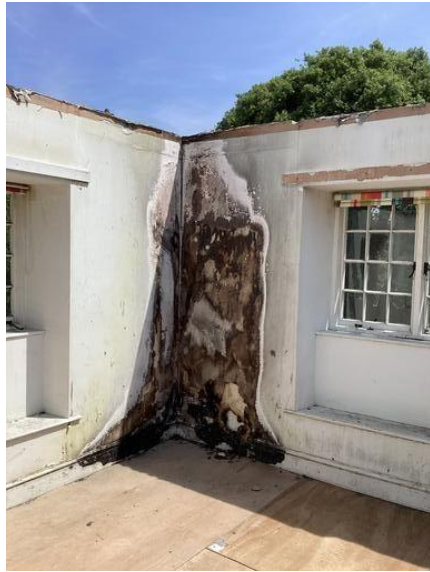
Photograph 79 - Flat 3 (Lounge)
Secondary Electrical Fire

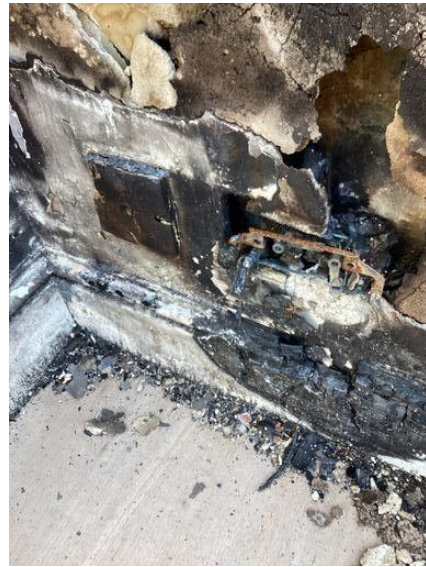
Photograph 80 - Flat 3 (Lounge)
Burnt Out Socket

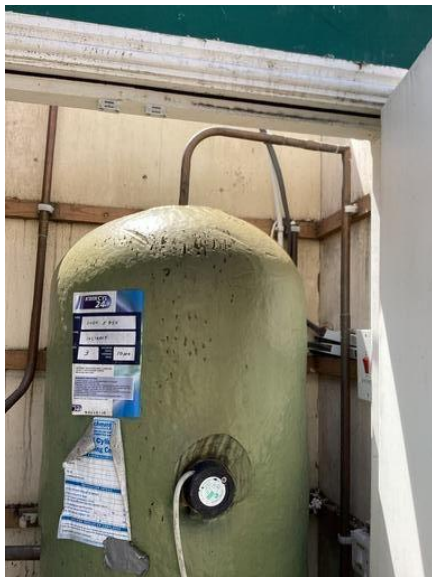
Photograph 81 - Flat 3 (Immersion)
Cylinder & Shower Isolator

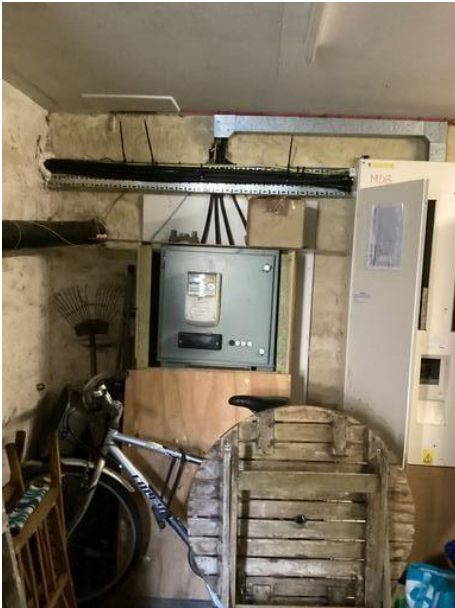
Photograph 83 - Electrical Mains Incomer &
Panel Board To Commercial Units

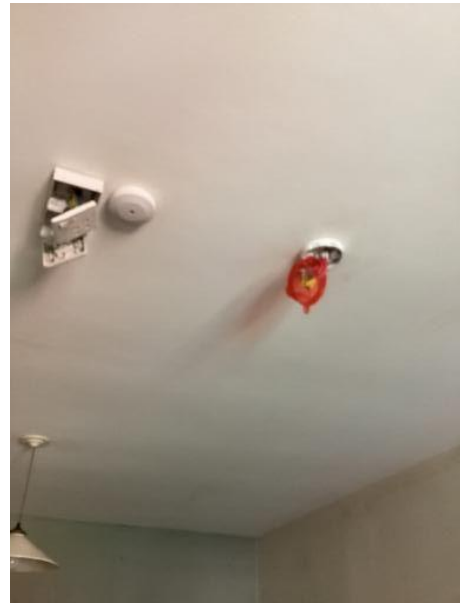
Photograph 84 - First Floor Office
Power, Data, Lighting & Smoke Detector

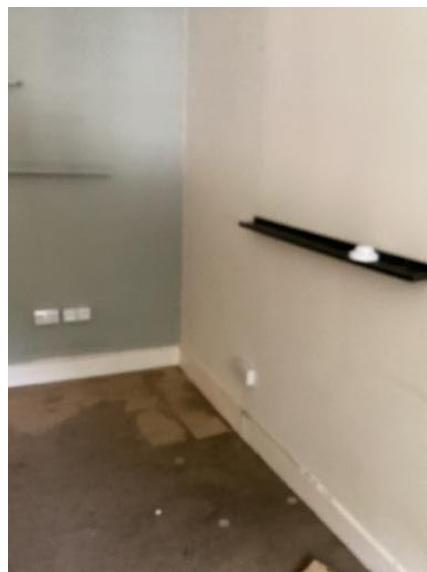
Photograph 85 - First Floor Office
Small Power

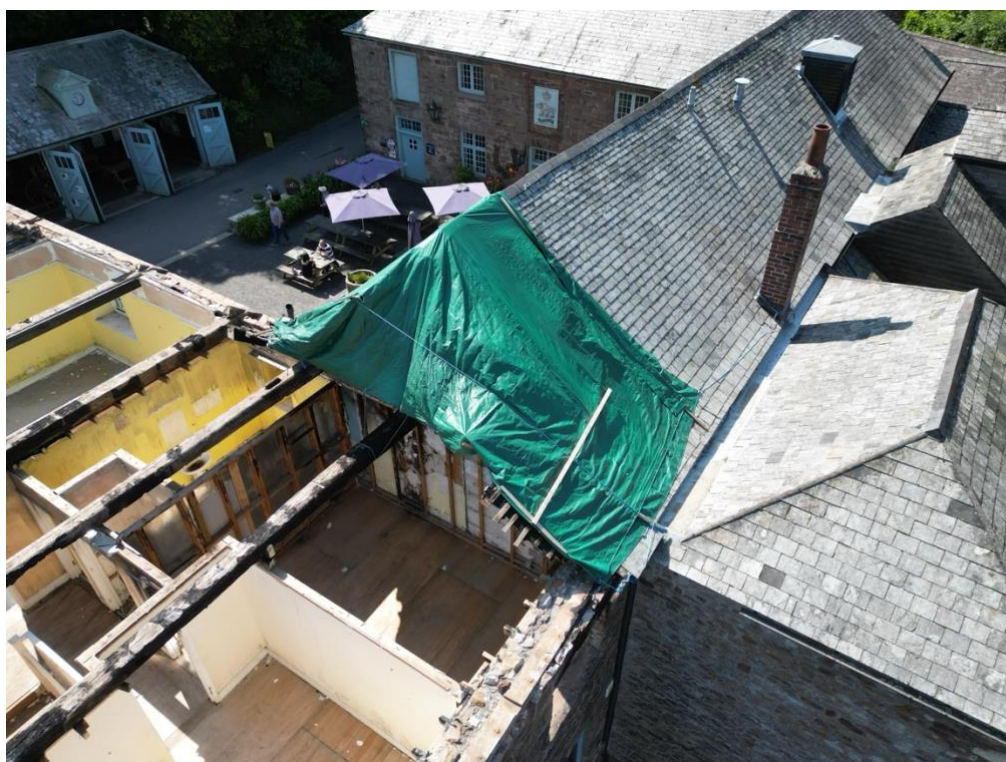
Figure 10 Abutment to central wing where further spread of the fire was prevented.

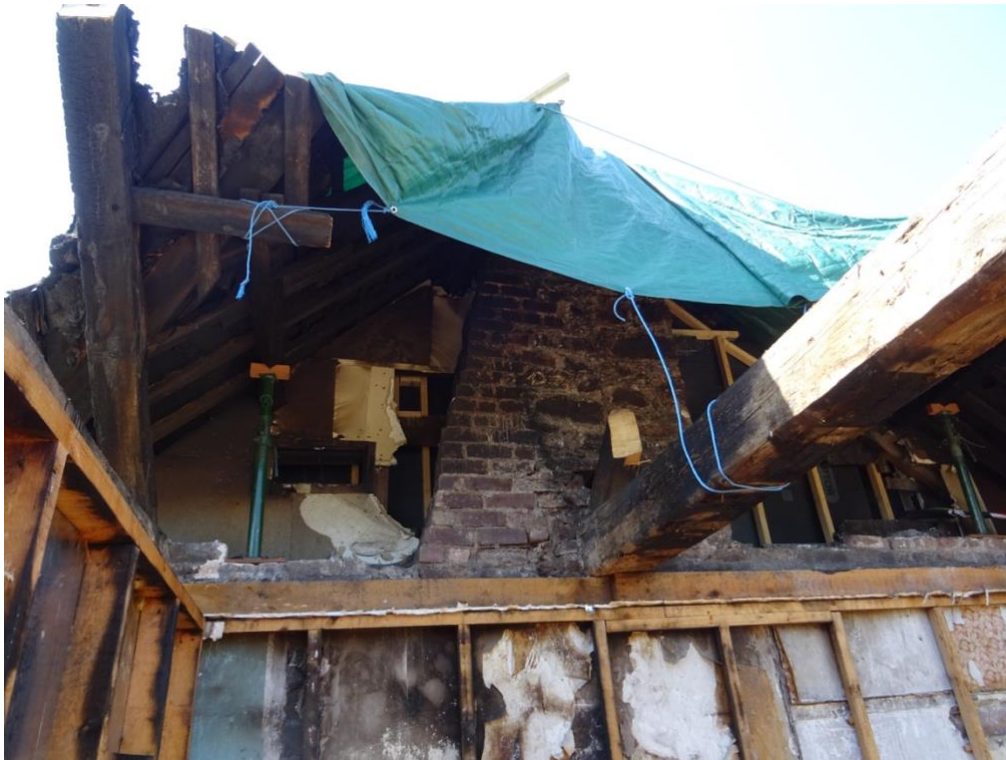
Figure 11 Abutment to central wing where further spread of the fire was prevented.

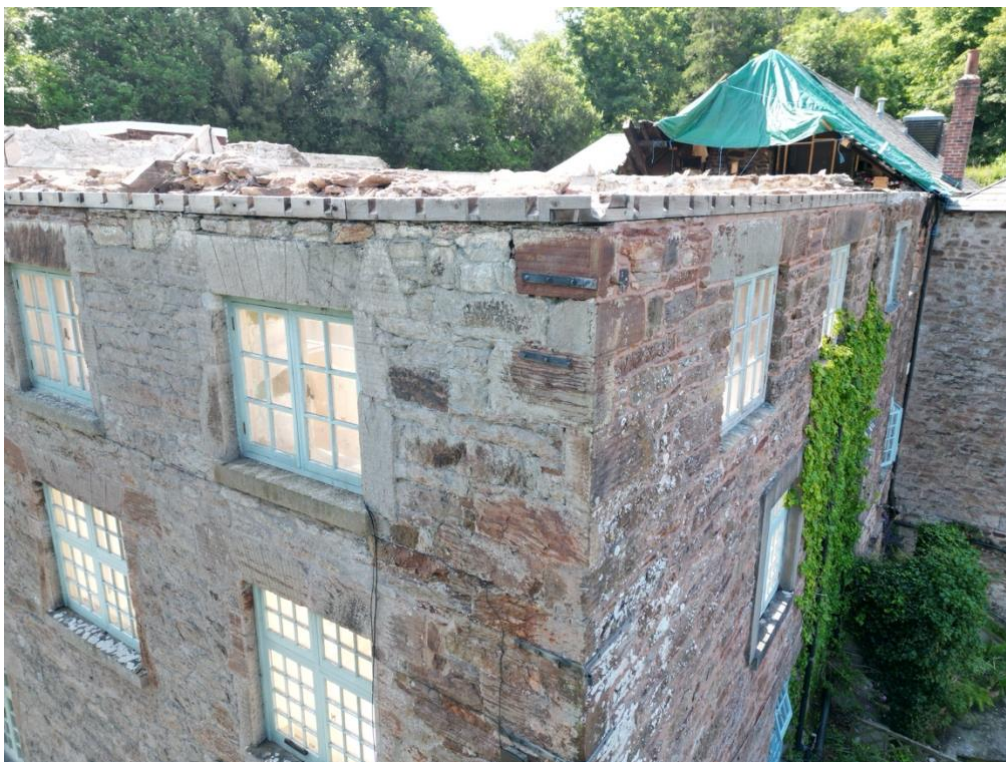
Figure 12 North west corner. The crenulated soffit design can be seen here which should be replicated moving forward.

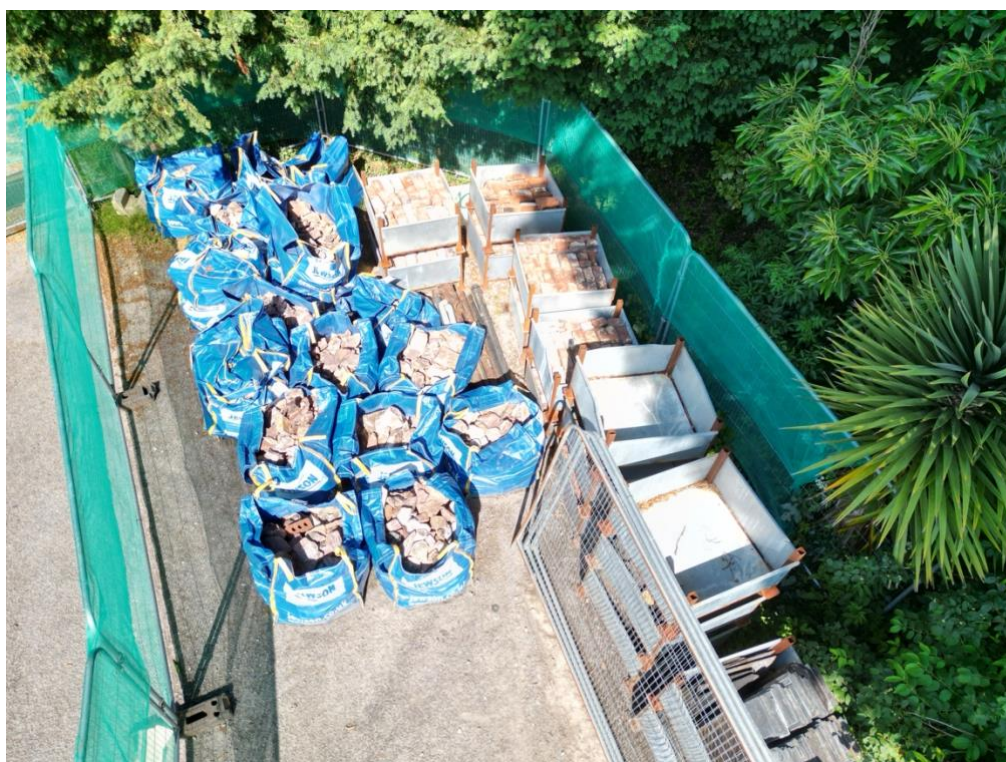
Figure 14 Stored material for reinstatement

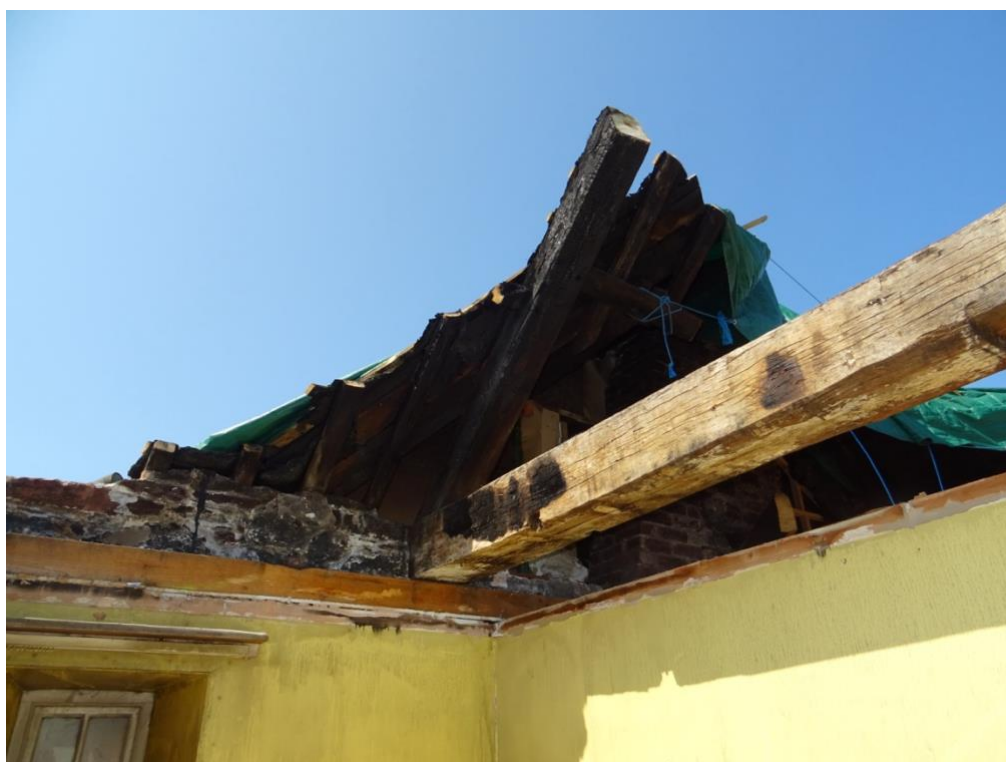
Figure 18 Retained chord tie beam.

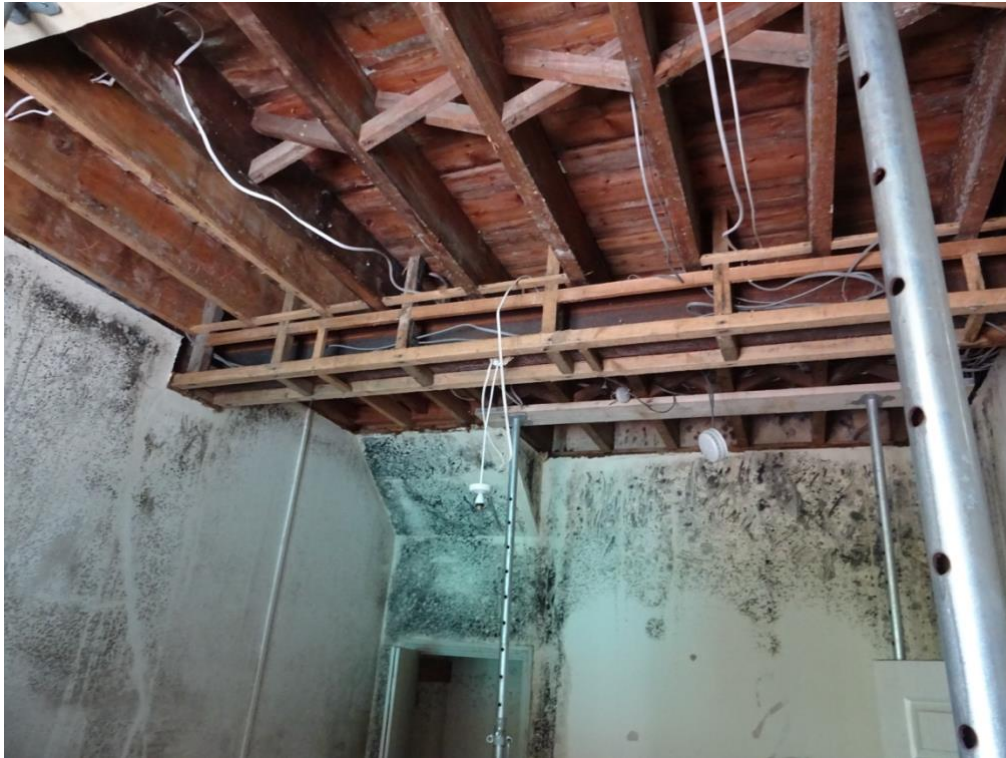
Figure 19 Ceiling areas removed from much of the lower floors.

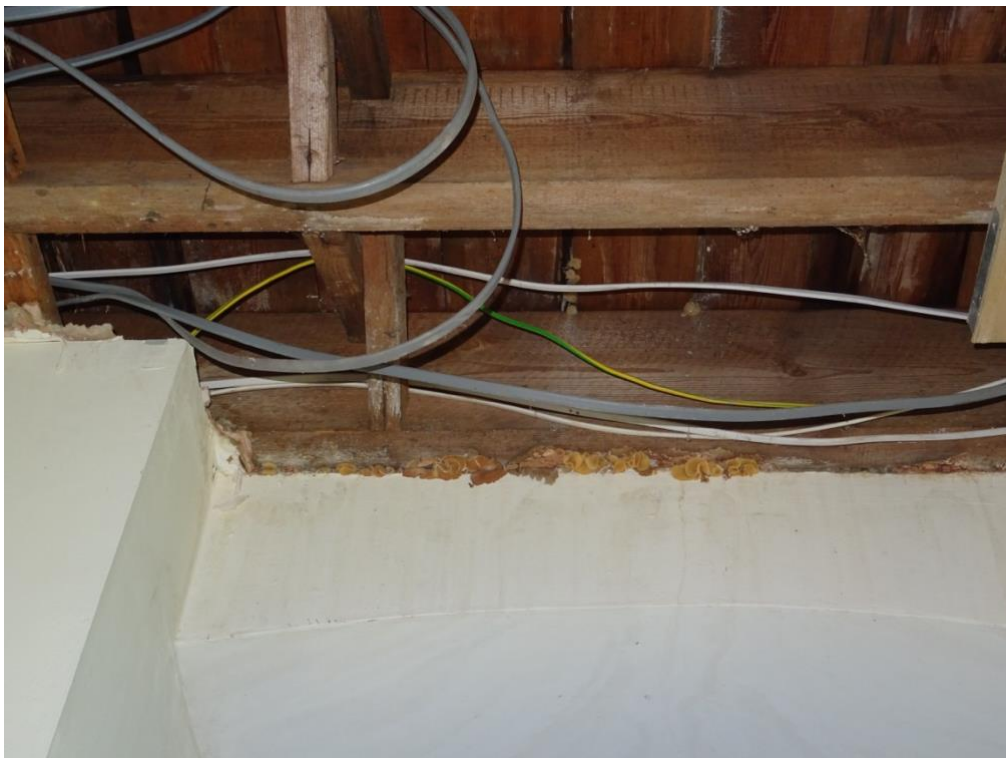
Figure 20 Fungal growth to supporting timbers

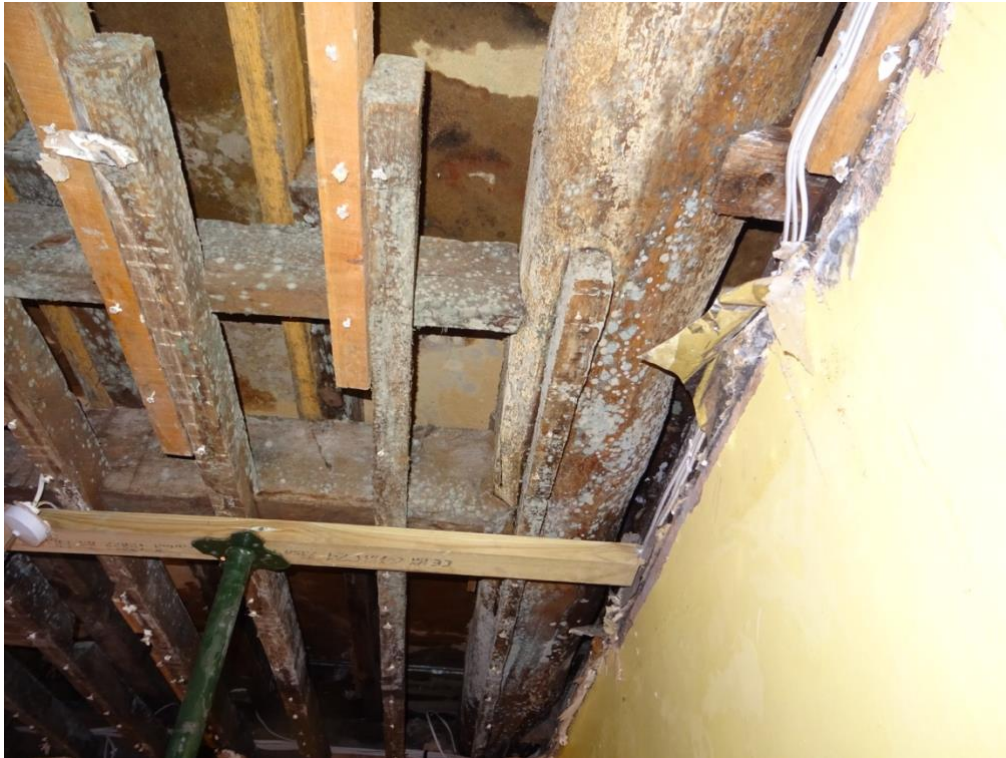
Figure 21 Mould and damp to supporting timbers

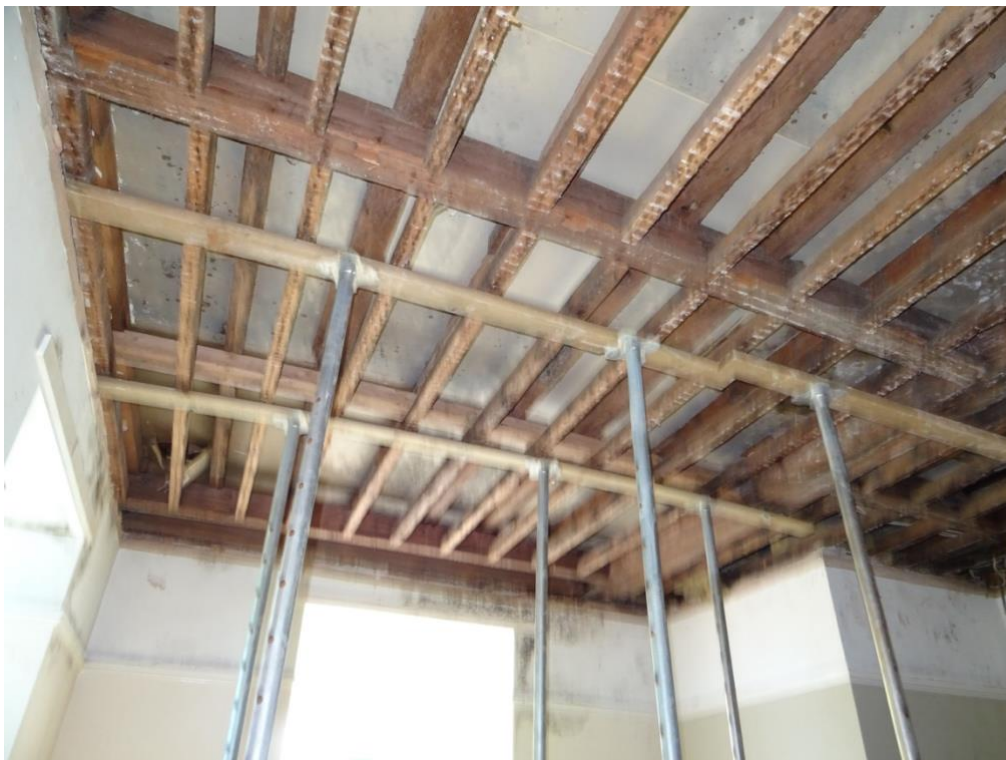
Figure 22 Supporting props to first floor structure.

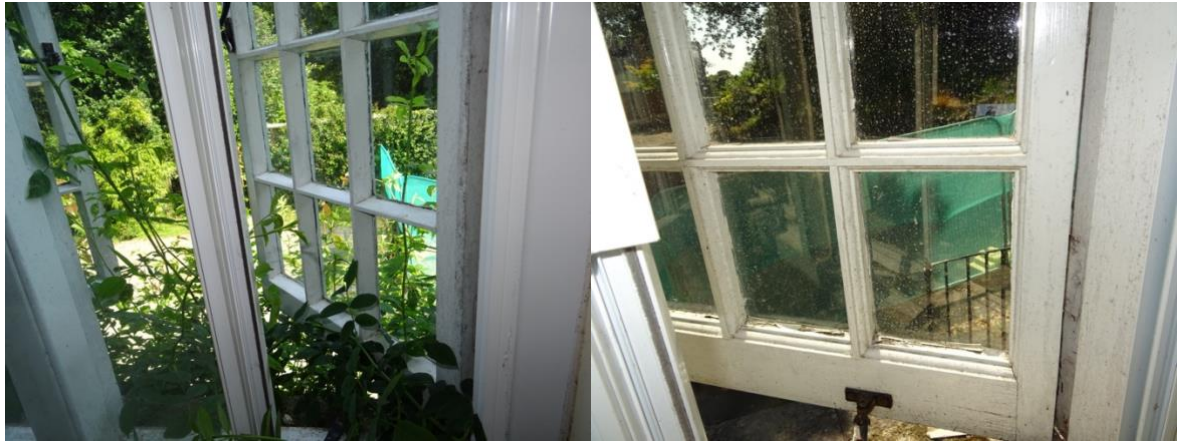
Figure 23 An example of the different glazing bar styles within the property.

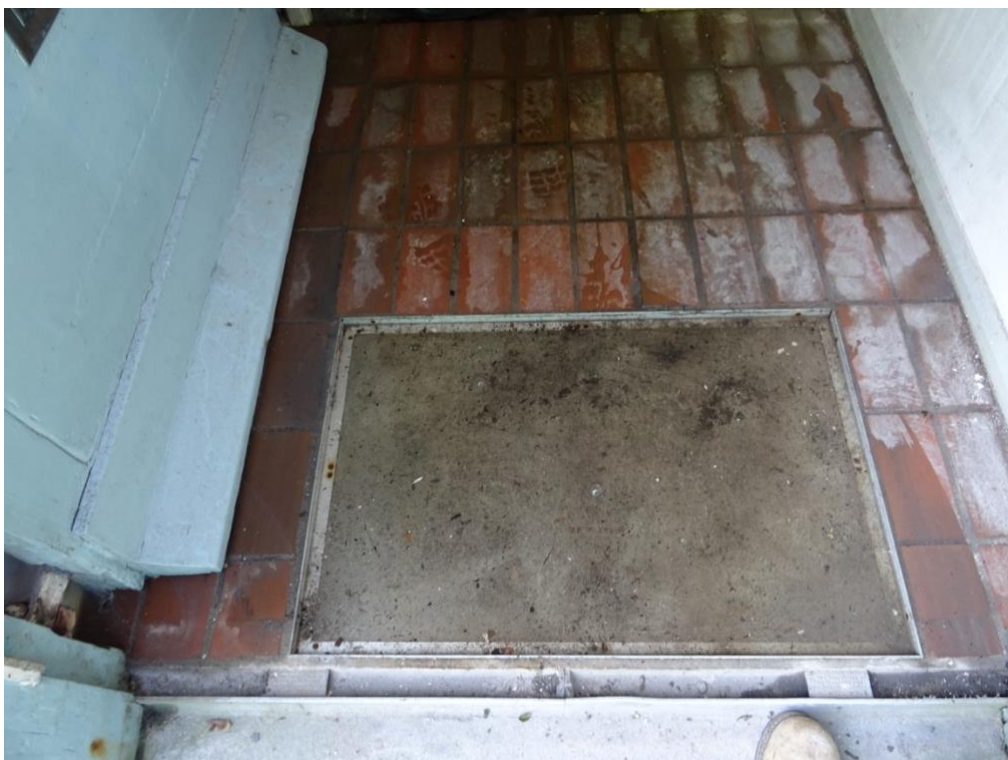
Figure 24 Retained tile floor to Yew Tree Cottage

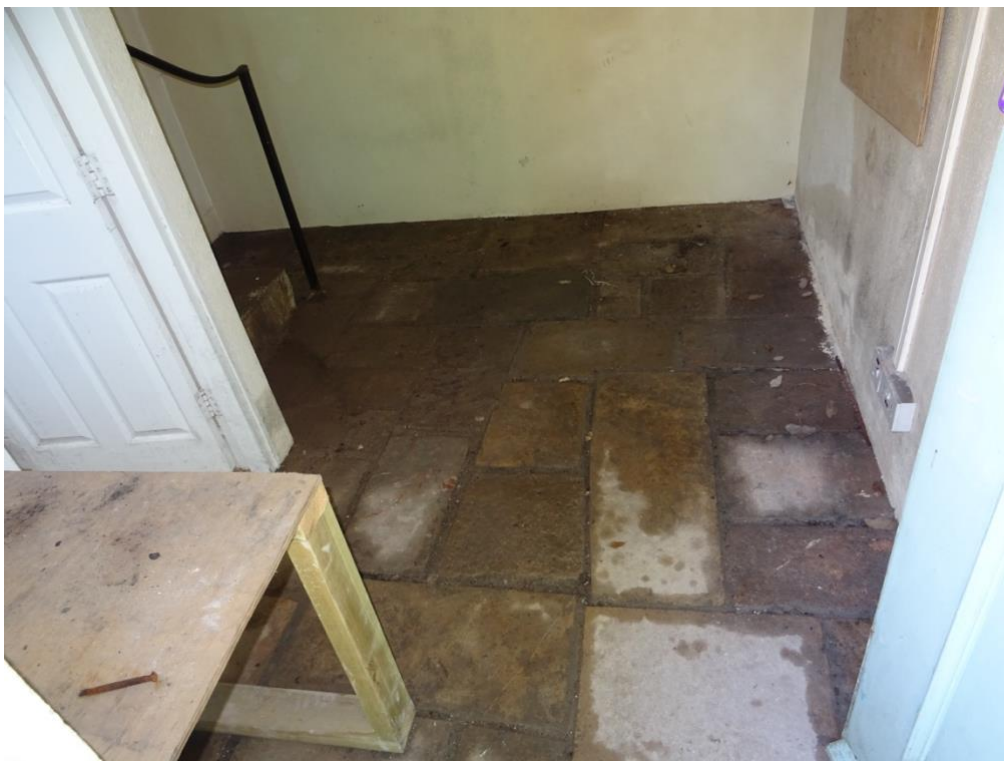
Figure 25 Retained stone flag floor to Horseshoe Cottage.

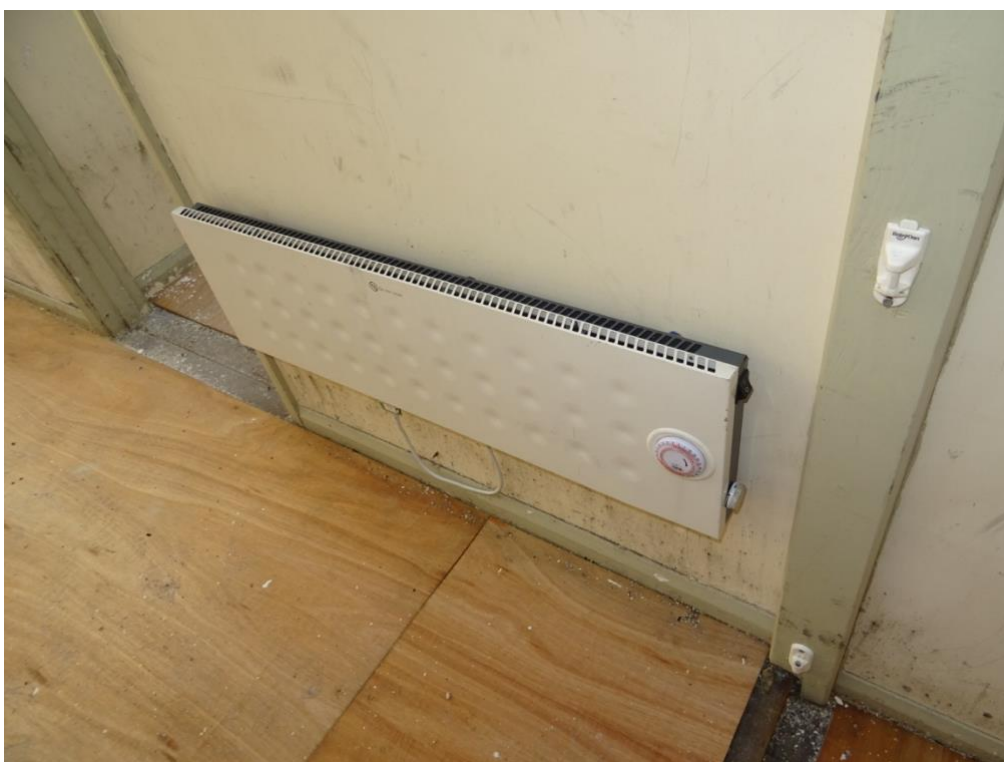
Figure 26 Example of heating system to the apartments.

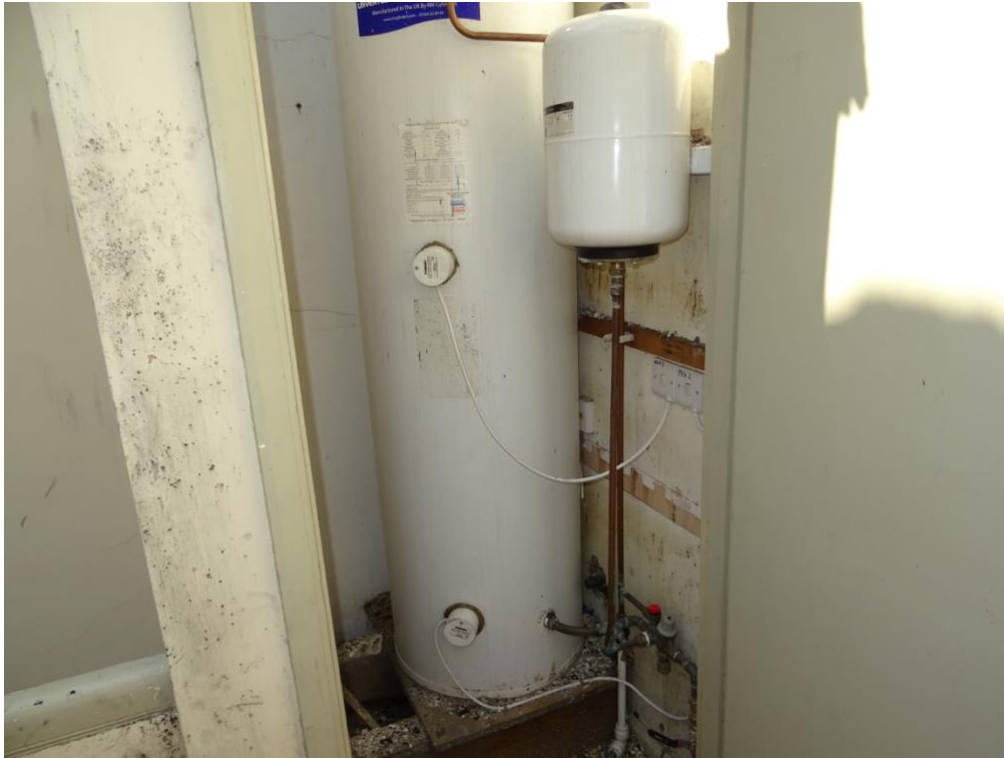
Figure 27 Example of hot water system to the apartments.

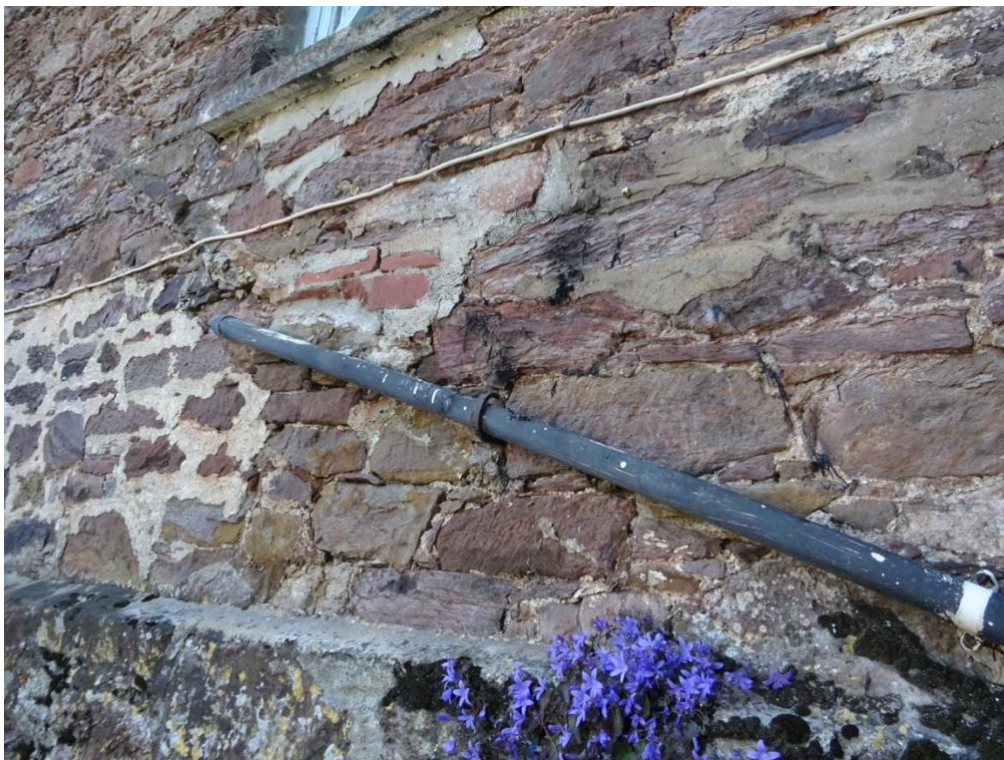
Figure 28 Poor cement based mortar to walling.
