Plymouth City Council – Risk Assessment March Review

The Hoe Foreshore 2010

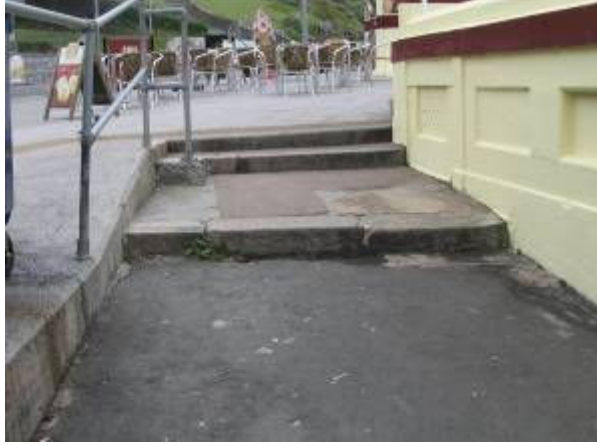
<p>Image 1</p> <p>Steps to Pebbleside beach – surface broken Repairs needed along path length</p> <p><b>Work Completed</b> ✓</p> <p>←</p> <hr/> <p>Image 2</p> <p>As above image 1</p> <p><b>Work Completed</b> ✓</p> <p>→</p>

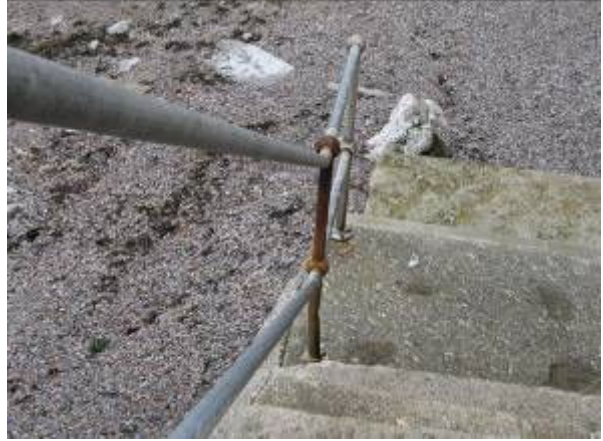
<p>Image 5</p> <p>Steps to Pebbleside beach – section of steps damaged <b>Work Completed</b> ✓</p> <p>←</p> <hr/> <p>Image 6</p> <p>Steps to Pebbleside beach, handrail damaged and section missing – Repair and replace handrail <b>Repair completed</b> <b>Bottom section of railing needs replacing</b></p> <p>→</p>

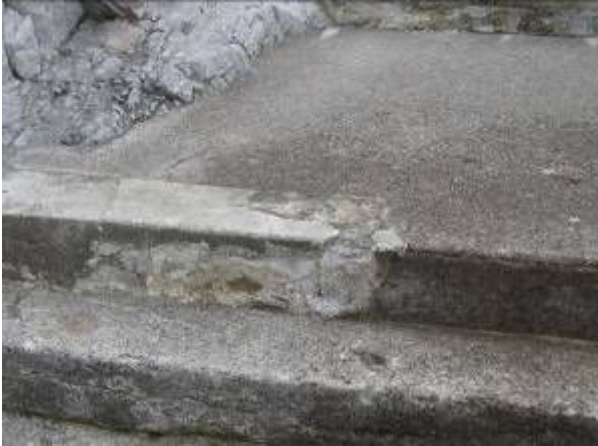
<p>Image 9 Below café, sections of steps damaged and worn away – needs repairing</p> <p><b>Work Completed</b> ✓</p> <p>←</p>

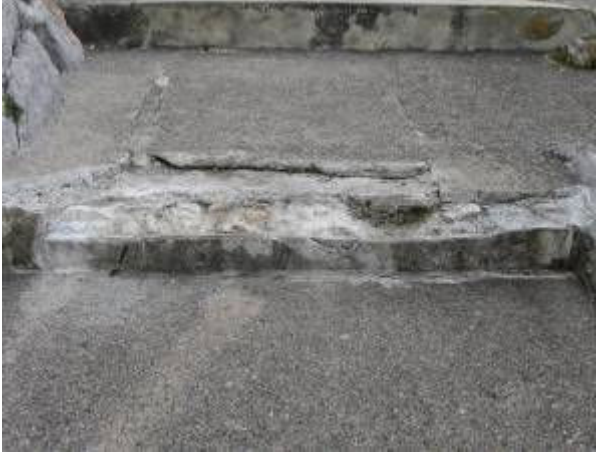
<p>Image 10</p> <p><b>Work Completed</b> ✓</p> <p>As above image 9</p> <p>→</p>

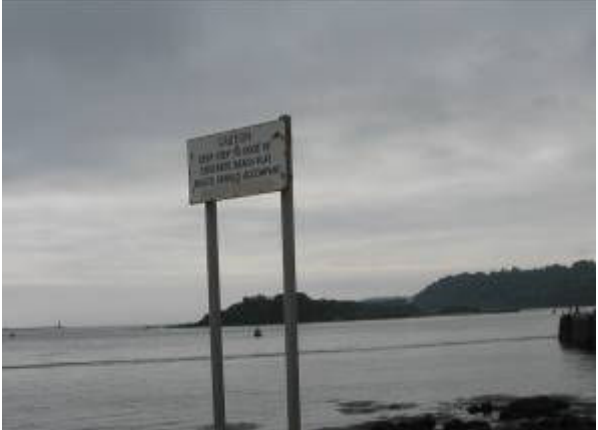
<p>Image 11</p> <p>As above image 9</p> <p><b>Work Completed</b> ✓</p> <p>←</p>

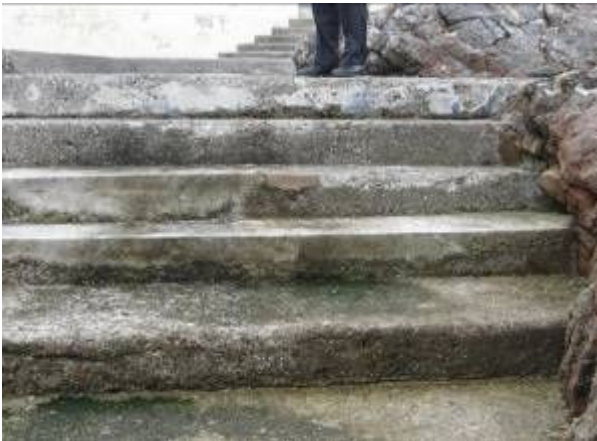
<p>Image 14</p> <p>Steps below beach huts damaged and worn, no hand rail present</p> <p><b>Hand-rail to install</b></p> <p>→</p>

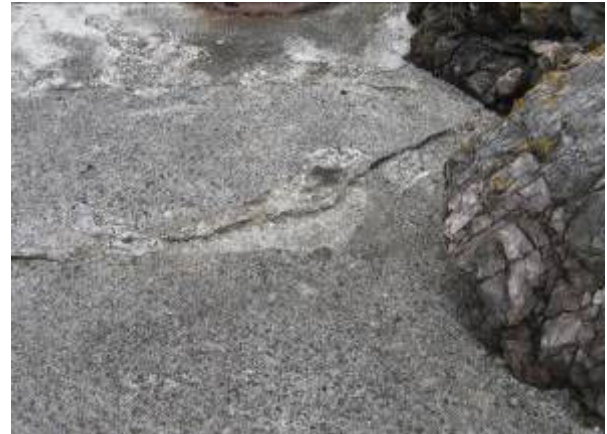
<p>Image 15</p> <p>As above image 14</p> <p>←</p>

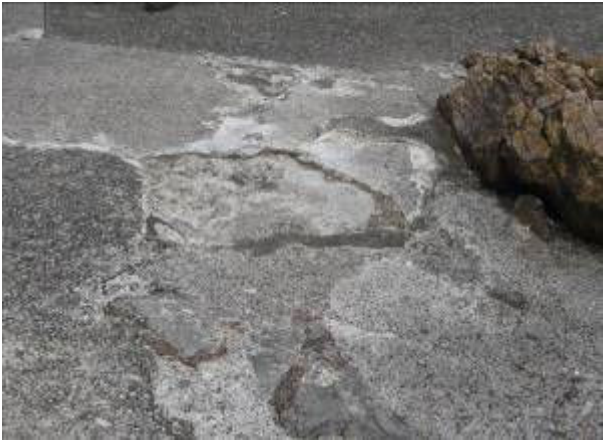
<p>Image 16</p> <p>As above image 14</p> <p>→</p>

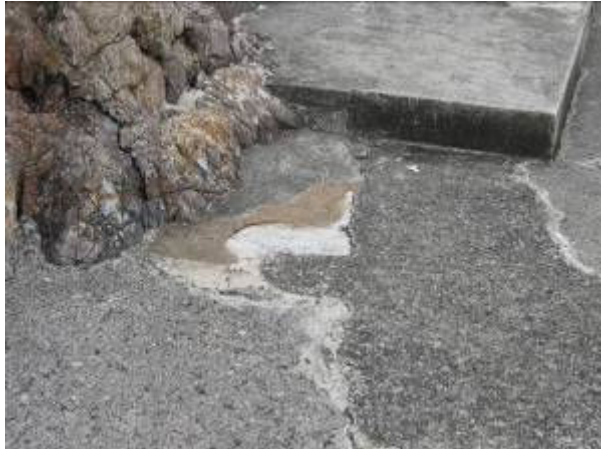
<p>Image 17</p> <p>As above image 14</p> <p>←</p> <p>Image 18</p> <p>As above image 14</p> <p>→</p>

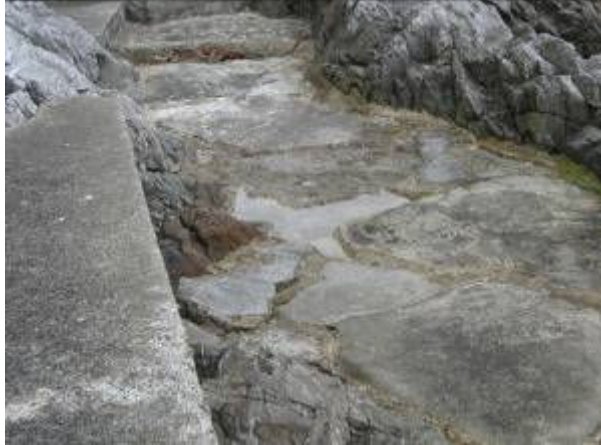
<p>Image 19</p> <p>Two sections of hand rail need to be installed</p> <p><b>Work Completed</b> ✓</p> <p>←</p> <p>Image 20</p> <p>As above image 19</p> <p><b>Work Completed</b> ✓</p> <p>→</p>

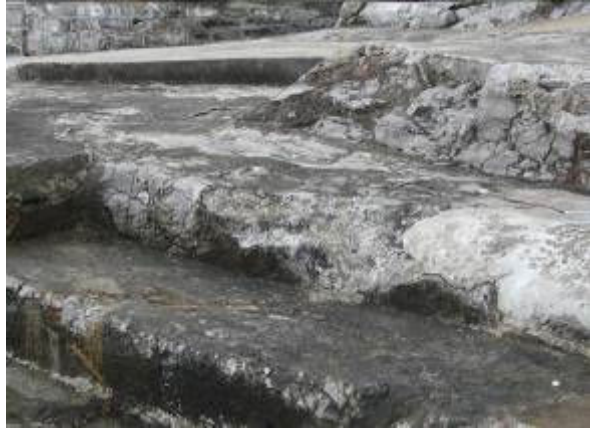
<p>Image 29</p> <p>Section of steps damaged by winter storm</p> <p><b>Work Completed</b> ✓</p> <p>←</p>

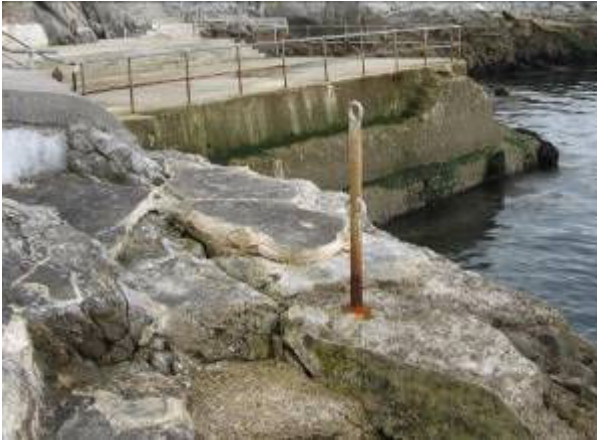
<p>Image 30</p> <p>As above image 29</p> <p><b>Work Completed</b> ✓</p> <p>→</p>

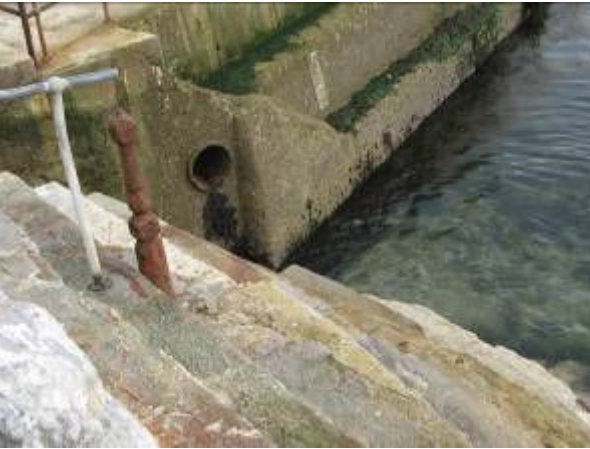
<p>Image 31</p> <p>No hand rail – danger to public falling onto Rocks – new hand rail required</p> <p><b>Work Completed</b> ✓</p> <p>←</p>

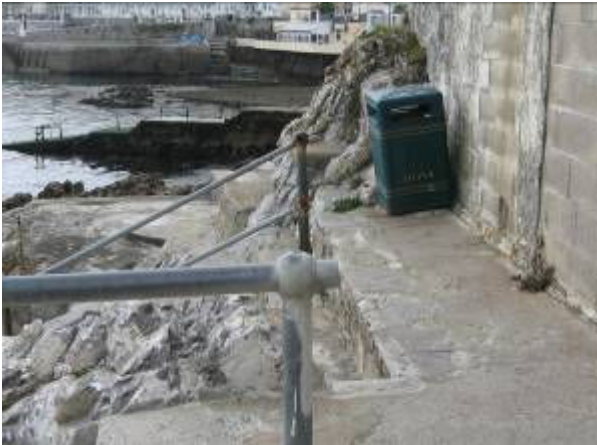
<p>Image 32</p> <p>Steps badly worn, hand rail missing – close off across the top with new hand rail</p> <p><b>Work Completed</b> ✓</p> <p>→</p>

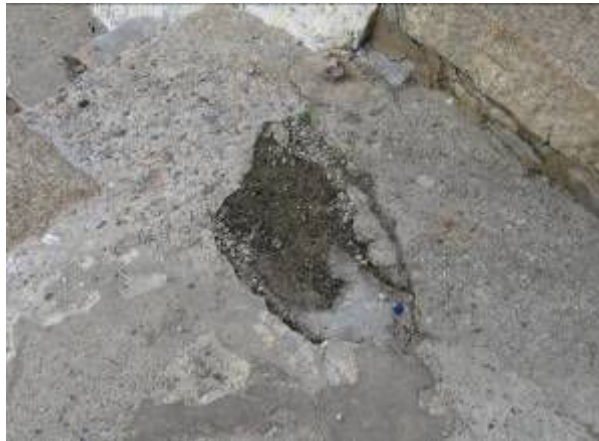
<p>Image 33</p> <p>As above image 32</p> <p><b>Work Completed</b> ✓</p> <p>←</p>

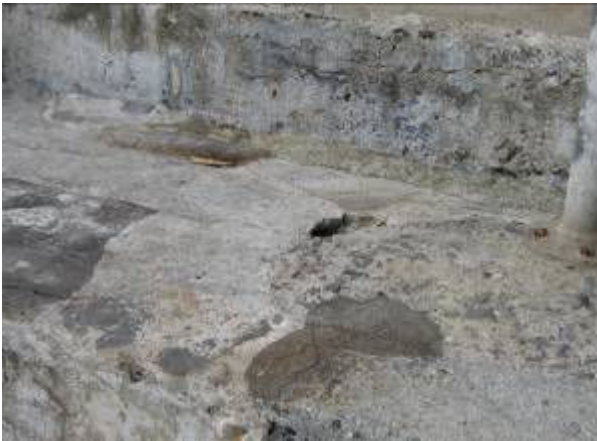
<p>Image 34</p> <p>Path and steps below old men's pool store Badly worn following winter storms</p> <p><b>Work Completed</b> ✓</p> <p>→</p>

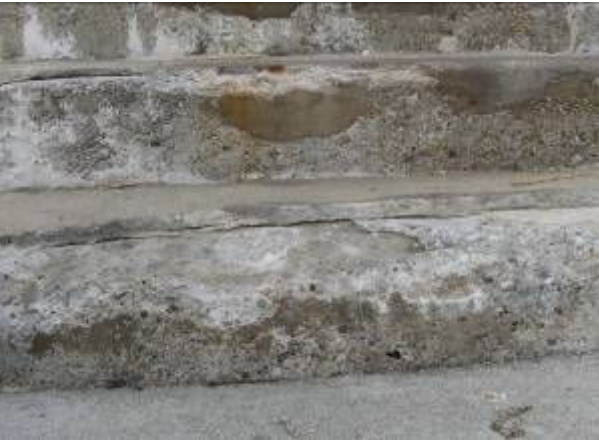
<p>Image 35</p> <p>As above image 34</p> <p><b>Work Completed</b> ✓</p> <p>←</p>

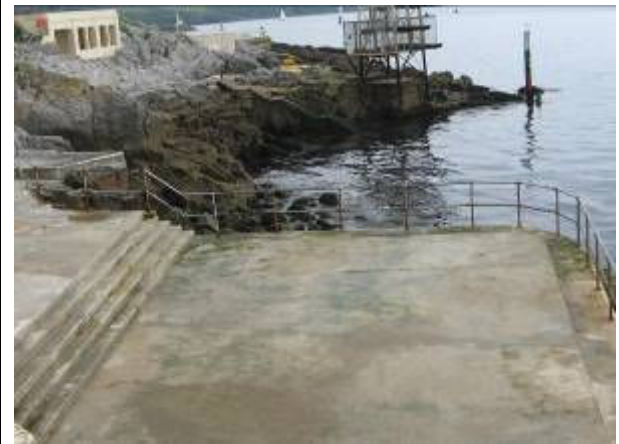
Image 40

Old men's pool now filled in – hand rail rusty and loose in ground, water collecting on new surface as not level

As above image 39

**Hand-rail repaired, water still collecting.**

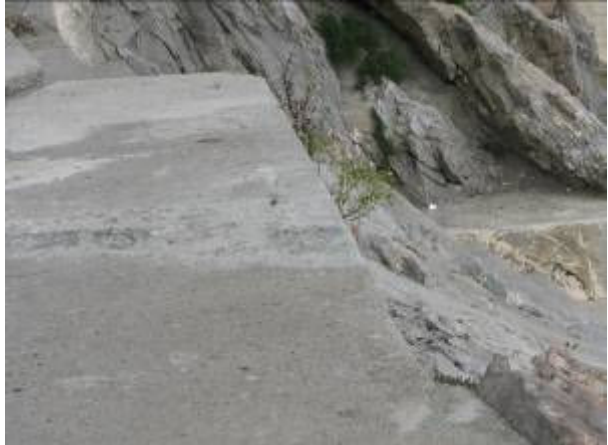
<p>Image 43</p> <p>As above image 42</p> <p><b>Hand-rail installed</b> ✓</p> <p>←</p> <p>Image 44</p> <p>As above image 42</p> <p><b>Hand-rail installed</b> ✓</p> <p>→</p>

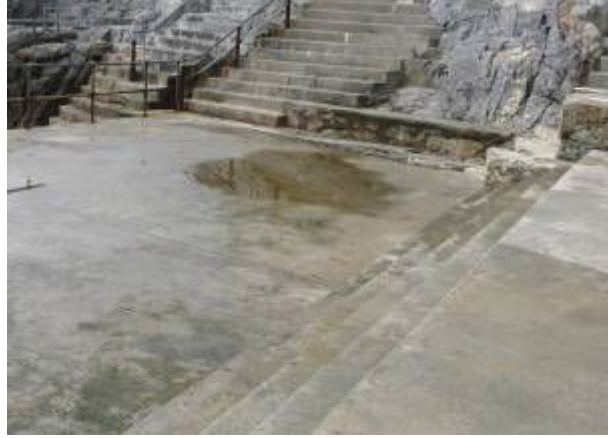
<p>Image 47</p> <p>Worn steps by men's pool</p> <p><b>Steps repaired</b> ✓</p> <p>←</p> <p>Image 48</p> <p>Men's pool sign no longer required – remove</p> <p><b>Work Completed</b> ✓</p> <p>→</p>

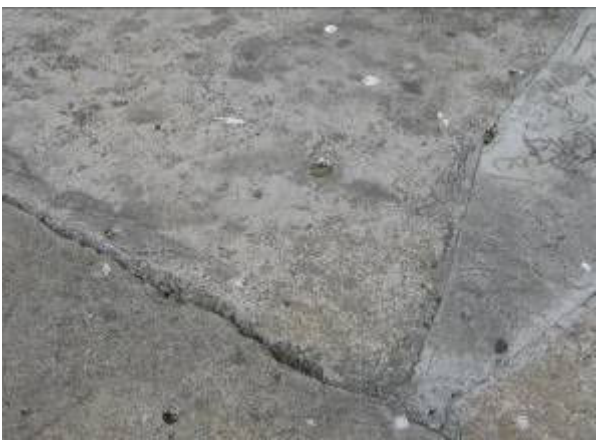
<p>Image 51</p> <p>Path breaking up</p> <p><b>Path repaired</b> ✓</p> <p>←</p>

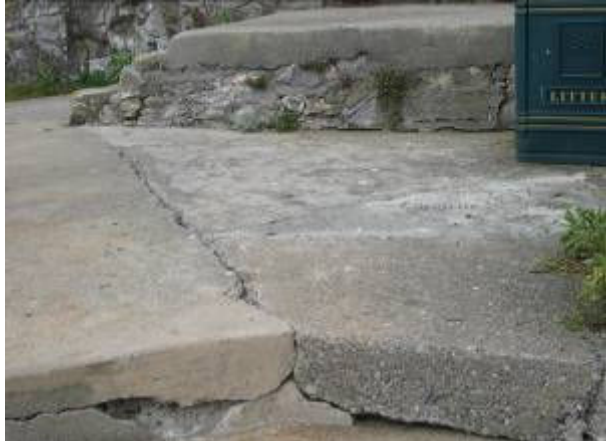
<p>Image 52</p> <p>As above image 51</p> <p><b>Path repaired</b> ✓</p> <p>→</p>

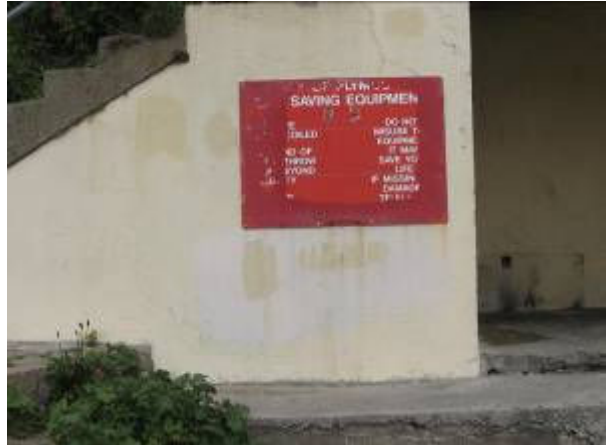
Image 53

Old shelter by baby pool, sign out of date and shelter being used for anti social behaviour, making fires, bottle smashing etc  
**Shelter now closed off sign still to remove.**

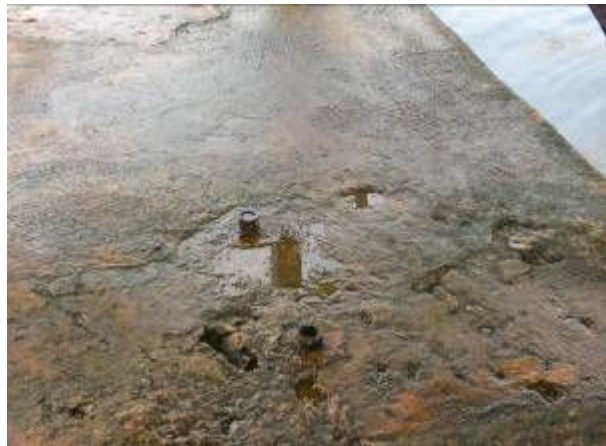
Image 54

As above image 53

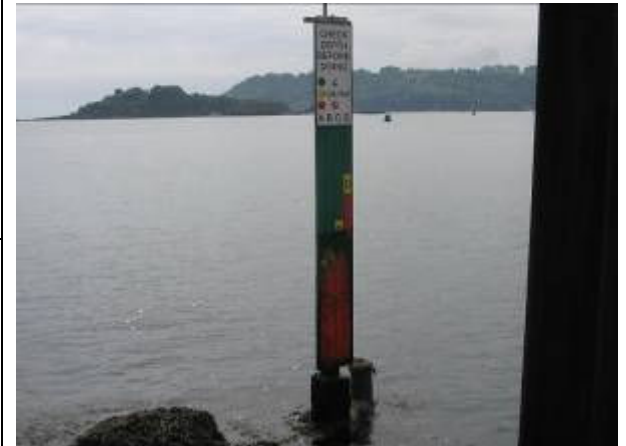
Image 55

Diving platform, sharp bolts exposed at base, structure target for anti social behaviour - children still able to access even with cage.

**Diving platform gone** ✓

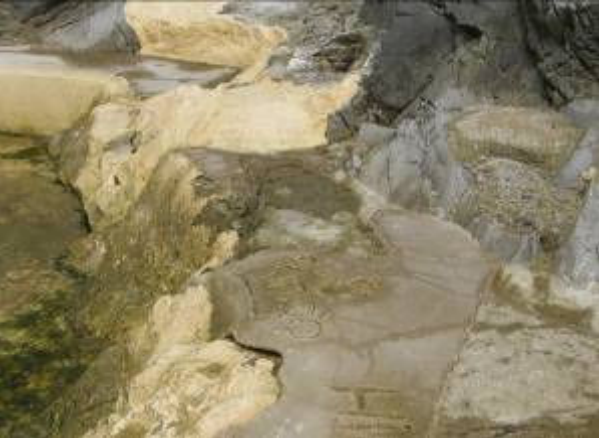
<p>Image 58</p> <p>As above image 57</p> <p><b>Pool filled in</b> ✓</p> <p>→</p>

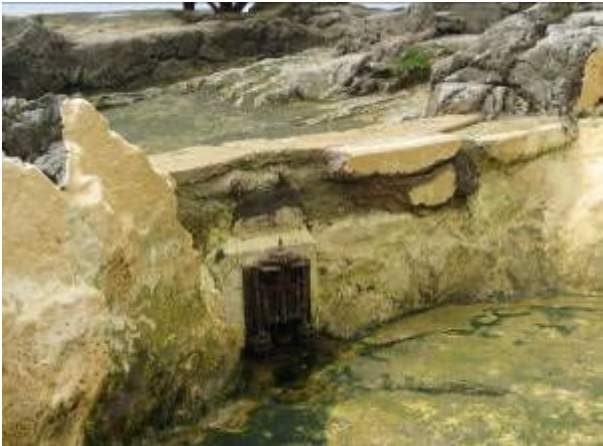
<p>Image 59</p> <p>As above image 57</p> <p><b>Pool filled in</b> ✓</p> <p>←</p>

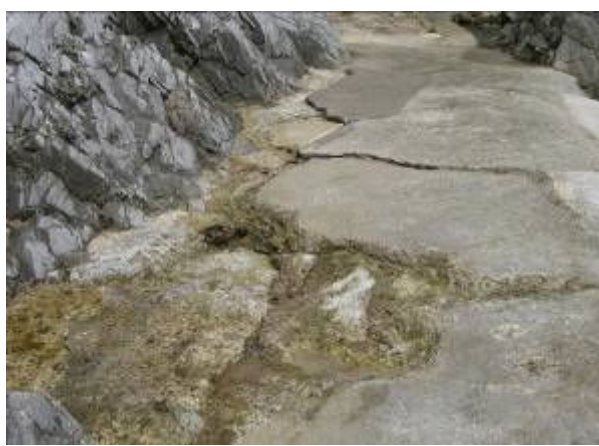
<p>Image 60</p> <p>Path at rear of baby pool breaking up badly</p> <p><b>Path repaired</b> ✓</p> <p>→</p>

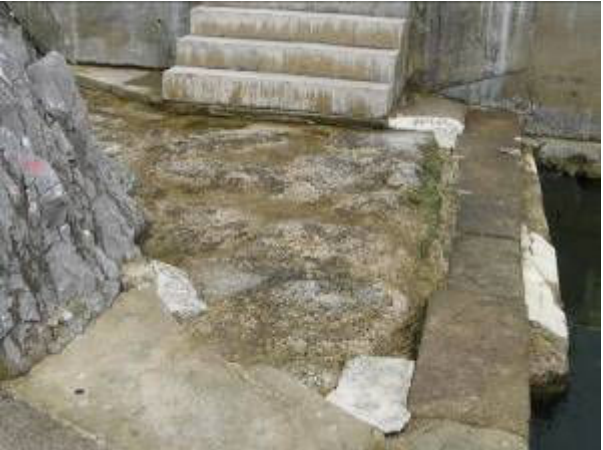
<p>Image 61</p> <p>Outer wall around Tinside Pool and steps to it, no hand rail and drop onto rocks</p> <p><b>Hand-rail installed</b> ✓</p> <p>←</p>

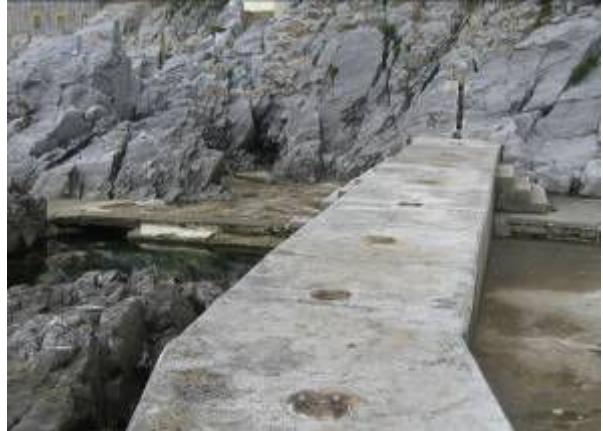
<p>Image 62</p> <p>As above image 61</p> <p><b>Area now fenced off</b> ✓</p> <p>→</p>

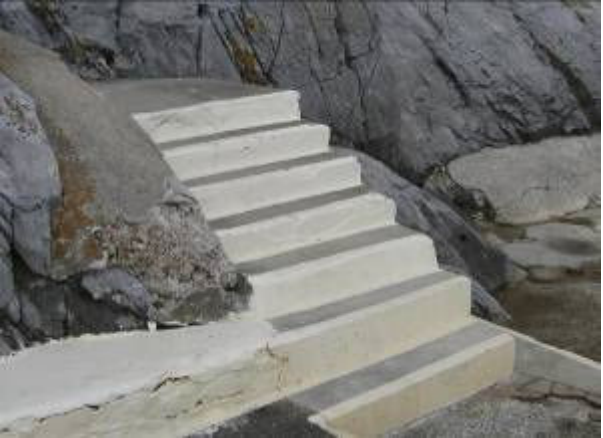
<p>Image 63</p> <p>Steps at back of baby pool, no hand rail</p> <p><b>Hand-rail installed</b> ✓</p> <p>←</p>

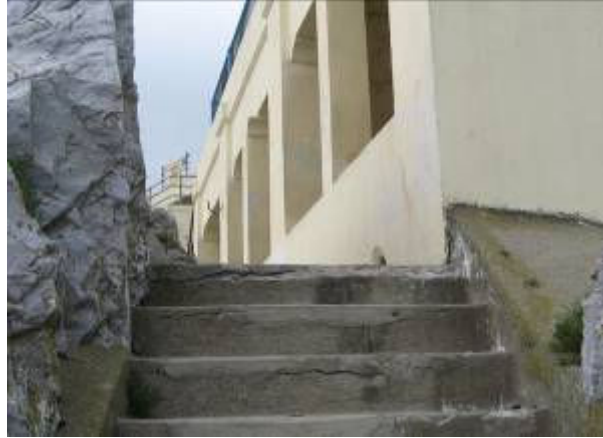
<p>Image 64</p> <p>As above image 63</p> <p><b>Hand-rail installed</b> ✓</p> <p>→</p>

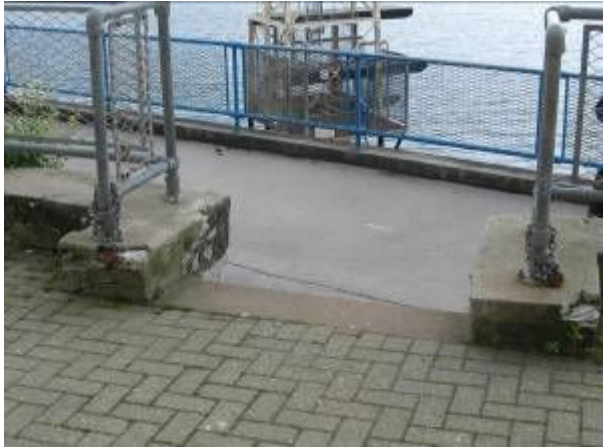
Image 65

Top of steps breaking out

**Area repaired** ✓

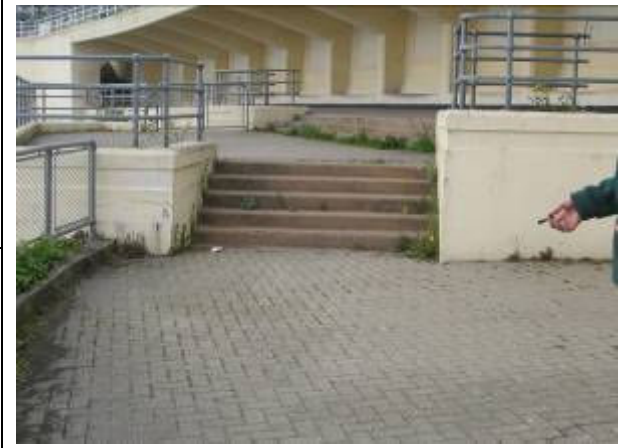
Image 67

Signs no longer needed now that men's pool has gone – remove

**Signs removed** ✓

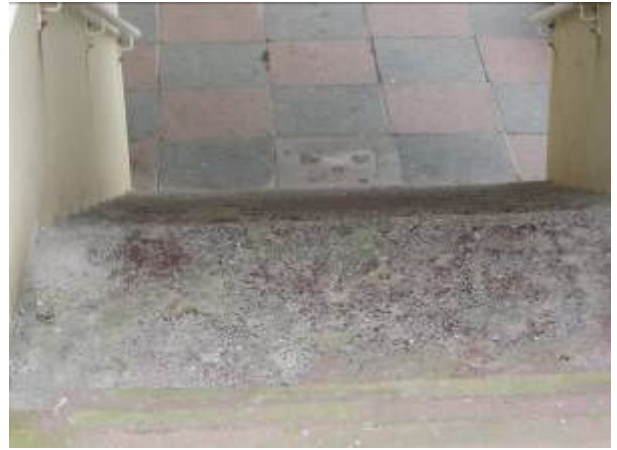
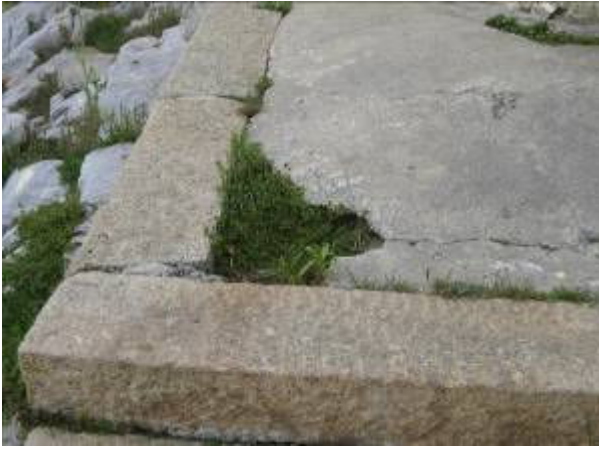
<p>Image 71</p> <p>Path below colonnade breaking up</p> <p><b>Path repaired ✓</b></p> <p>←</p> <hr/> <p>Image 72</p> <p>Pier men's steps badly damaged in winter storm</p> <p><b>Pier repaired ✓</b></p> <p>→</p>

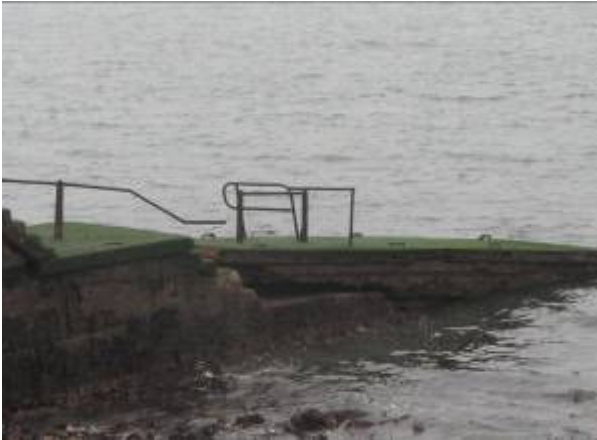
<p>Image 73</p> <p>As above image 72</p> <p><b>Pier repaired</b> ✓</p> <p>←</p>

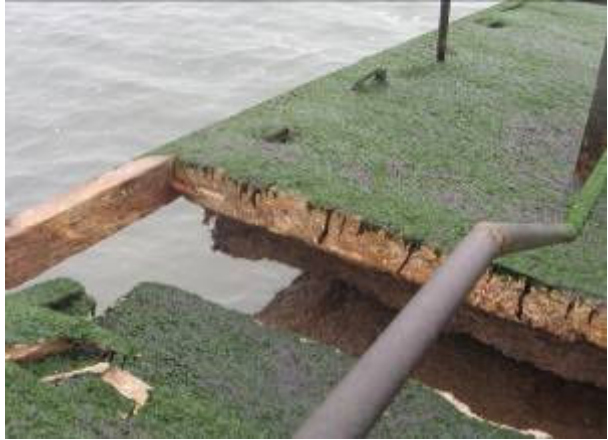
<p>Image 74</p> <p>As above image 72</p> <p><b>Pier repaired</b> ✓</p> <p>→</p>

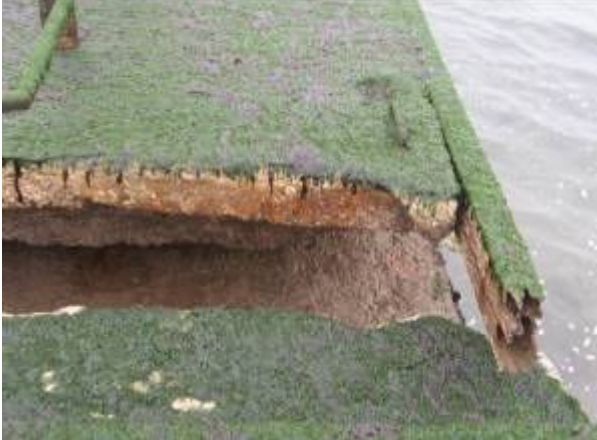
<p>Image 75</p> <p>As above image 72</p> <p><b>Pier repaired</b> ✓</p> <p>←</p>

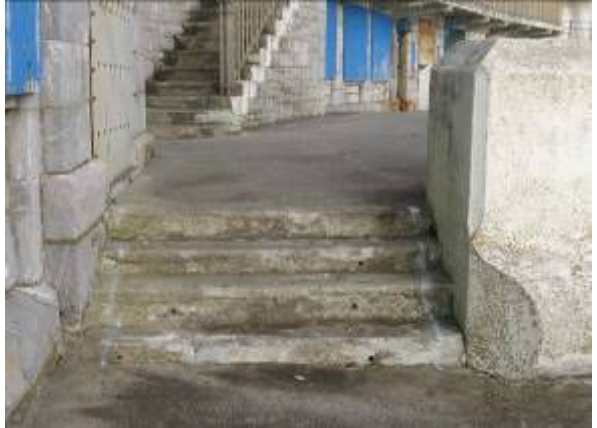
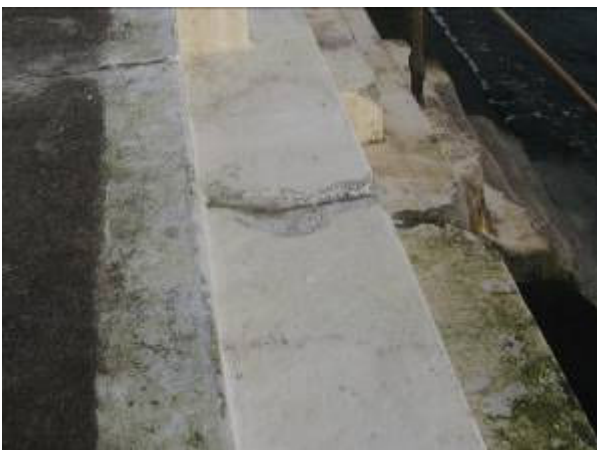
<p>Image 79</p> <p>Steps into sea damaged and worn by winter storm</p> <p><b>Steps Repaired</b> ✓</p> <p>←</p> <hr/> <p>Image 80</p> <p>As above image 79</p> <p><b>Steps Repaired</b> ✓</p> <p>→</p>

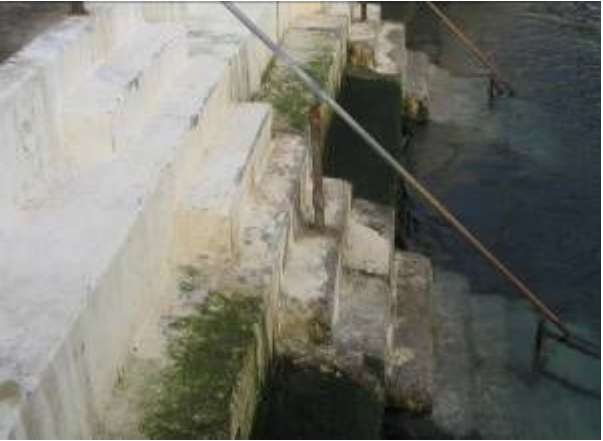
<p>Image 81</p> <p>As above image 79</p> <p><b>Steps Repaired</b> ✓</p> <p>←</p>

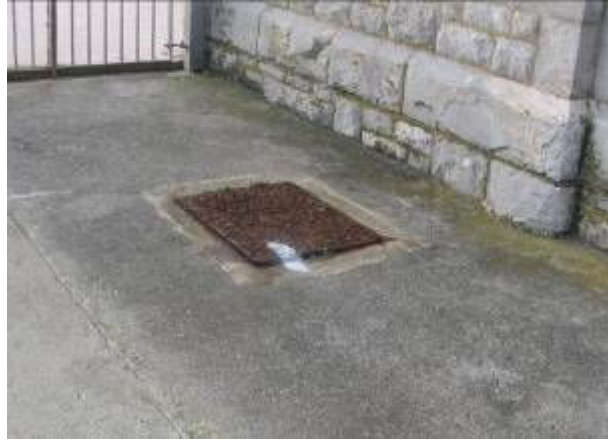
<p>Image 82</p> <p>Drain cover raised, trip hazard</p> <p><b>Work completed</b> ✓</p> <p>→</p>

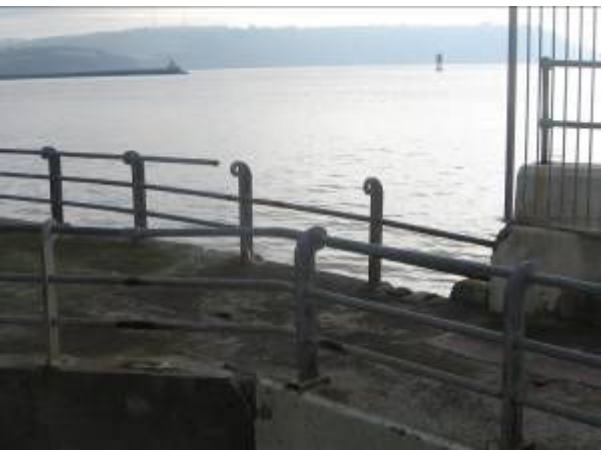
<p>Image 83</p> <p>Hand rails missing following winter storm</p> <p><b>Still need replacing</b></p> <p>←</p>

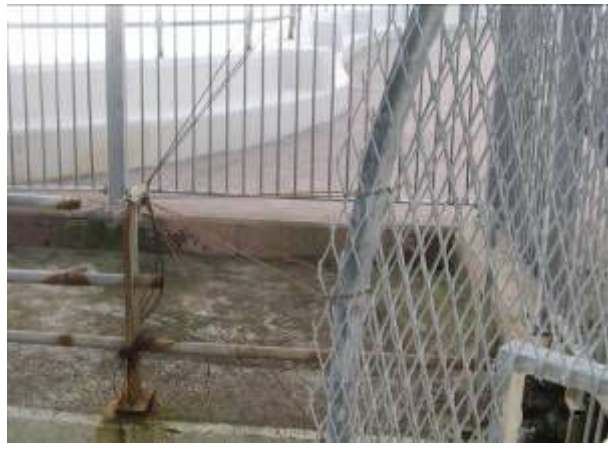
<p>Image 84</p> <p>As above image 83</p> <p><b>Still need replacing</b></p> <p>→</p>

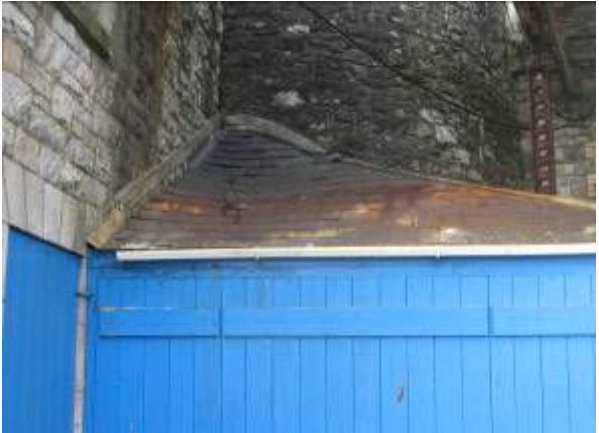
<p>Image 93</p> <p>Roof of old store falling in on itself</p> <p><b>Roof repaired</b> ✓</p> <p>←</p> <p>Image 94</p> <p>As above image 93</p> <p><b>Roof repaired</b> ✓</p> <p>→</p>

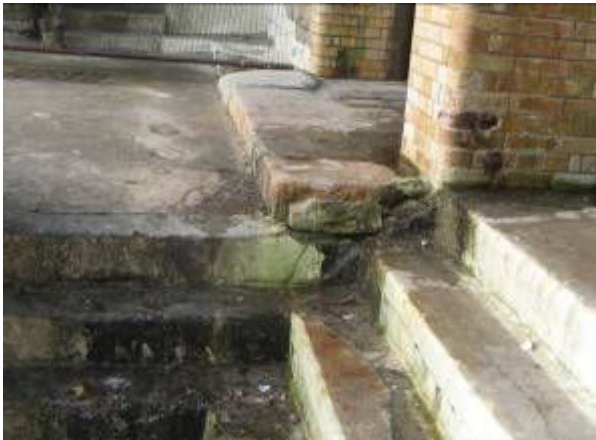
<p>Image 97</p> <p>Steps and sea walls to left of Tinside pool</p> <p><b>Work completed</b> ✓</p> <p>←</p>

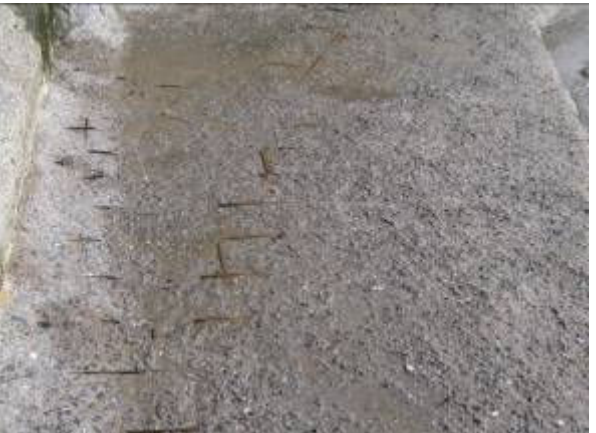
<p>Image 99</p> <p>As above image 97</p> <p><b>Area still worn</b></p> <p>←</p>

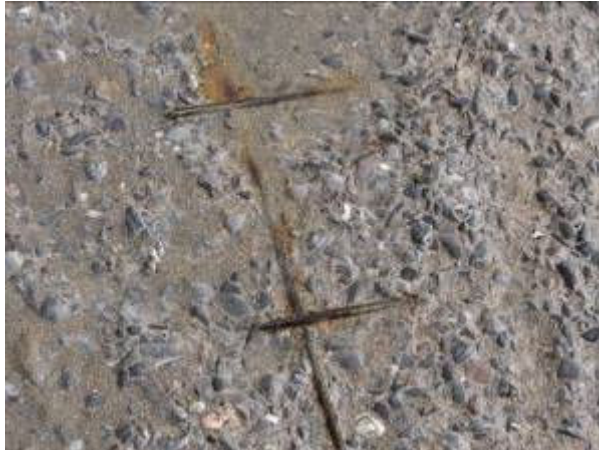
<p>Image 100</p> <p>As above image 97</p> <p><b>Area still worn</b></p> <p>→</p>

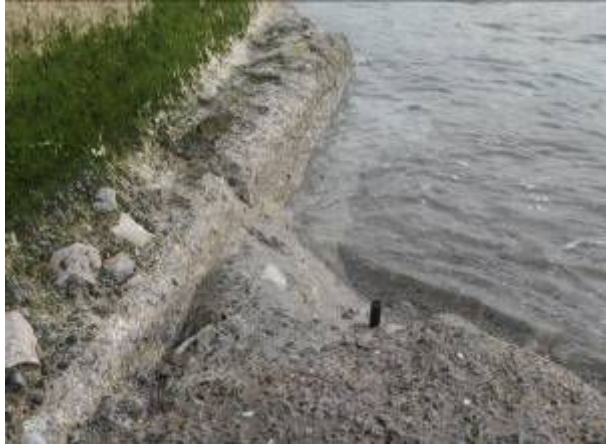
<p>Image 102</p> <p>As above image 97</p> <p><b>Area repaired</b> ✓</p> <p>→</p>

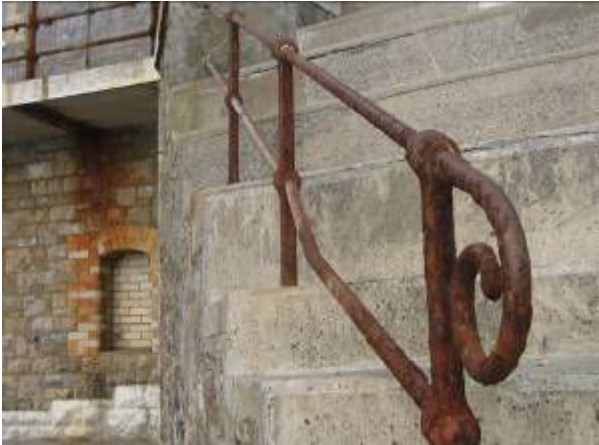
<p>Image 103</p> <p>Hand rails very rusty</p> <p><b>Hand rail needs replacing</b></p> <p>←</p>

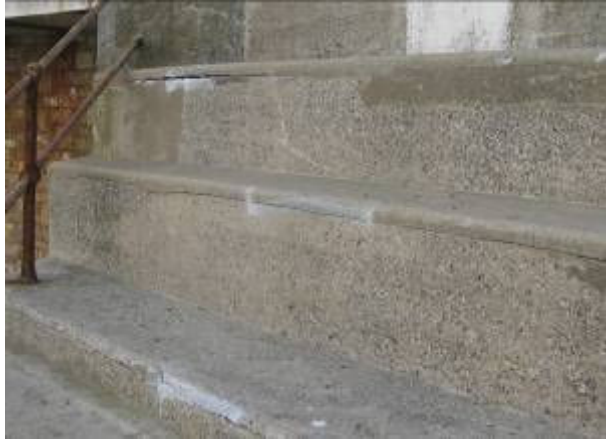
<p>Image 104</p> <p>Steps need repairing</p> <p><b>Work completed</b> ✓</p> <p>→</p>

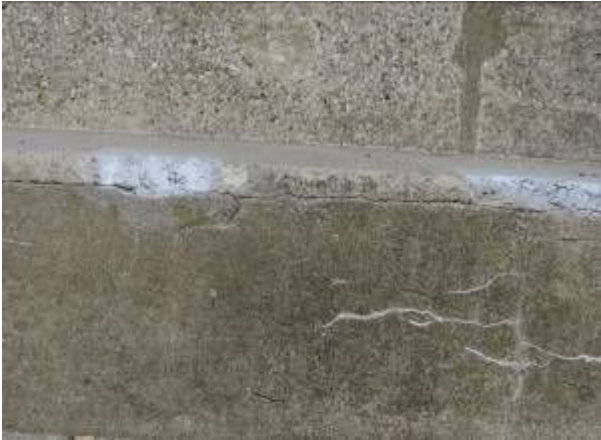
<p>Image 105</p> <p>As above image 104</p> <p><b>Work completed</b> ✓</p> <p>←</p>	 
	<p>Image 106</p> <p>As above image 104</p> <p><b>Work completed</b> ✓</p> <p>→</p>

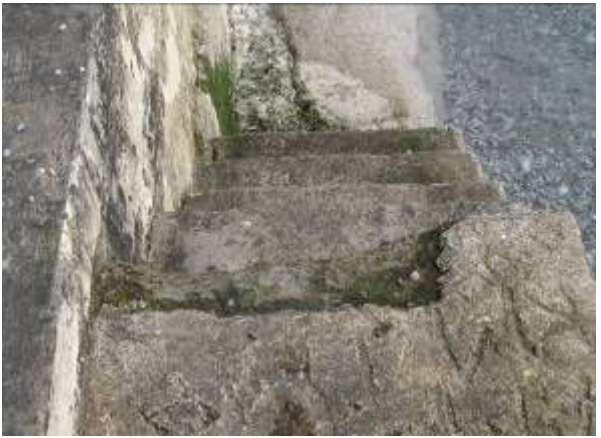
<p>Image 107</p> <p>Hand rail missing, steps need repairing</p> <p><b>Still needs sorting</b></p> <p>←</p>

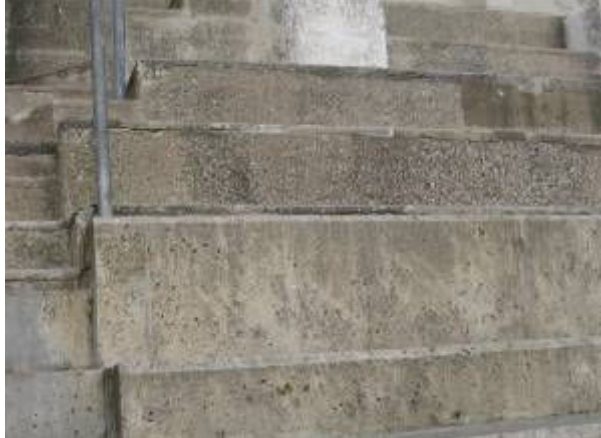
<p>Image 108</p> <p>Steps need repairing</p> <p><b>Work completed</b> ✓</p> <p>→</p>

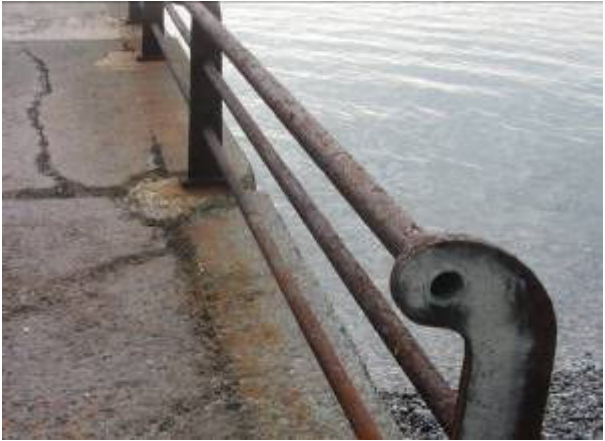
<p>Image 115</p> <p>Base of sea wall starting to be undermined by the sea</p> <p><b>All repaired</b> ✓</p> <p>←</p> <hr/> <p>Image 116</p> <p>Top of sea wall starting to break out and hand rails very rusty</p> <p><b>Sea wall repaired</b> ✓</p> <p><b>Hand-rail needs attention</b> →</p>

<p>Image 117</p> <p><u>As above image 116</u></p> <p>←</p>

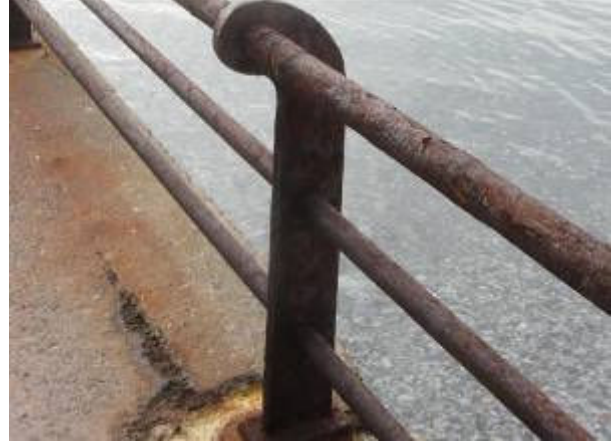
<p>Image 118</p> <p><u>As above image 116</u></p> <p>→</p>

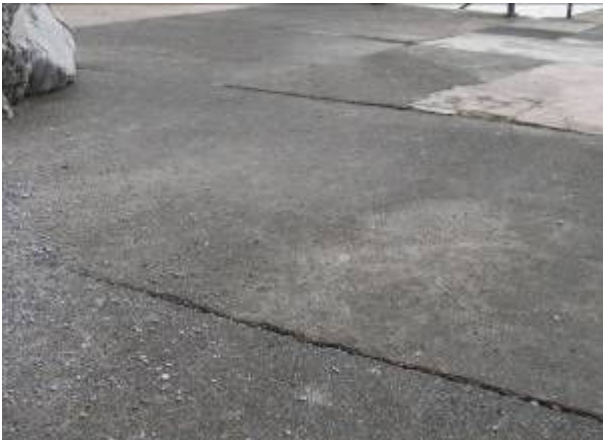
<p>Image 119</p> <p>As above image 116</p> <p><b>All re-pointed</b> ✓</p> <p>←</p>

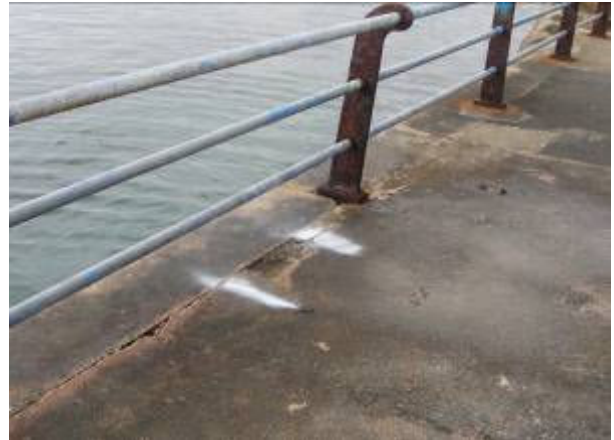
<p>Image 120</p> <p>As above image 116</p> <p><b>Further damage has now occurred here major repair now needed</b></p> <p>→</p>

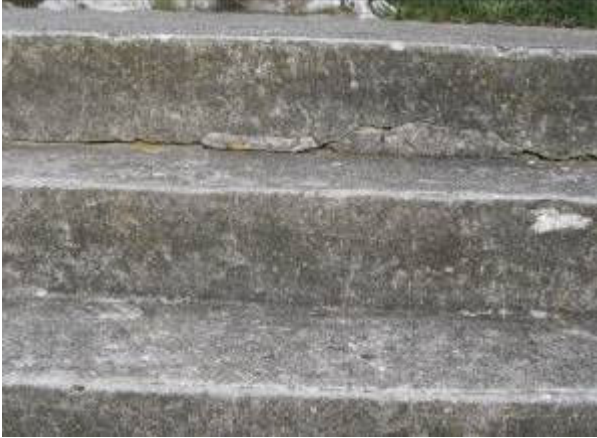
<p>Image 125</p> <p>Steps breaking up</p> <p><b>Work completed</b> ✓</p> <p>←</p> <hr/> <p>Image 126</p> <p>As above image 125</p> <p><b>Work completed</b> ✓</p> <p>→</p>

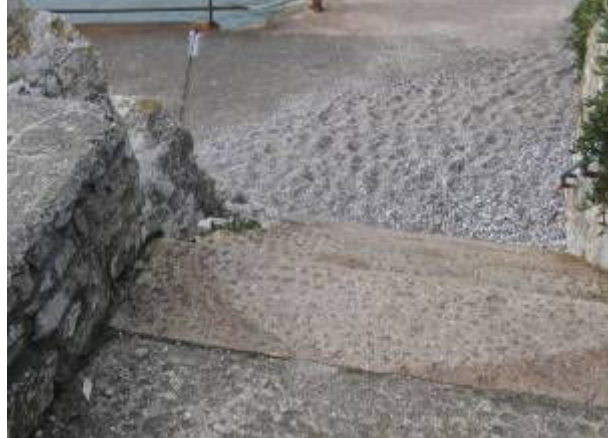
<p>Image 127</p> <p>As above image 125</p> <p><b>Work completed</b> ✓</p> <p>←</p> <hr/> <p>Image 128</p> <p>As above image 125</p> <p><b>Work completed</b> ✓</p> <p>→</p>

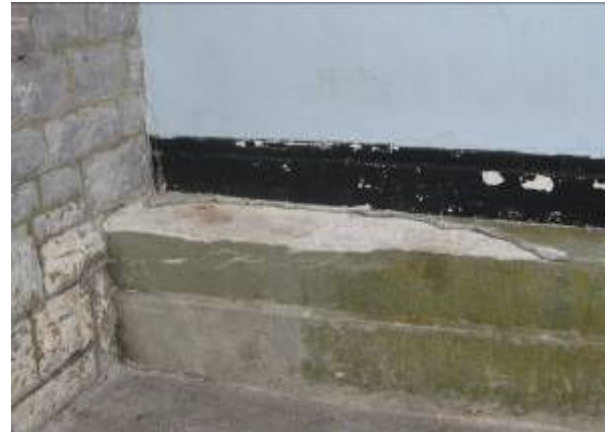
<p>Image 133</p> <p>Path and wall breaking up</p> <p><b>Work completed</b> ✓</p> <p>←</p>

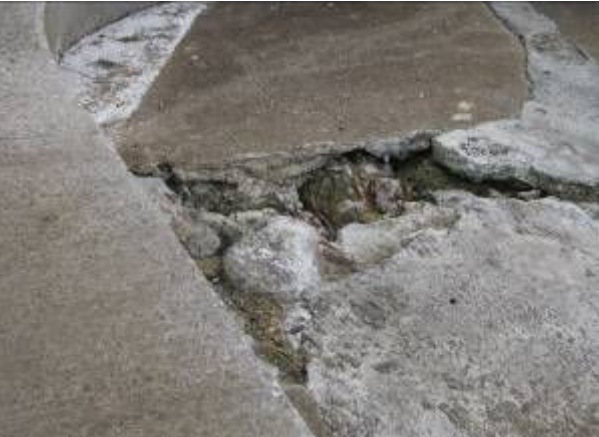
<p>Image 134</p> <p>As above image 133</p> <p><b>Work completed</b> ✓</p> <p>→</p>

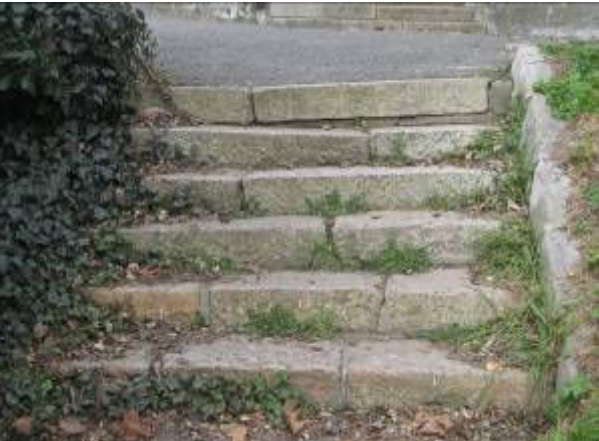
<p>Image 136</p> <p>Steps collapsed, hand rail missing</p> <p><b>Steps repaired</b> ✓</p> <p><b>Hand-rail to be fitted</b></p> <p>→</p>

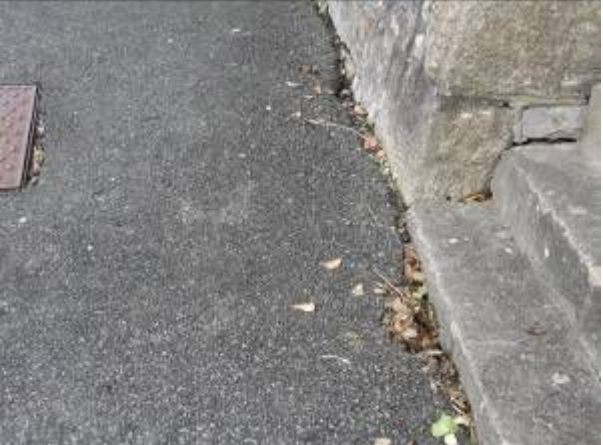
<p>Image 137</p> <p>Steps breaking up, joints gone</p> <p><b>Work completed</b> ✓</p> <p>←</p>

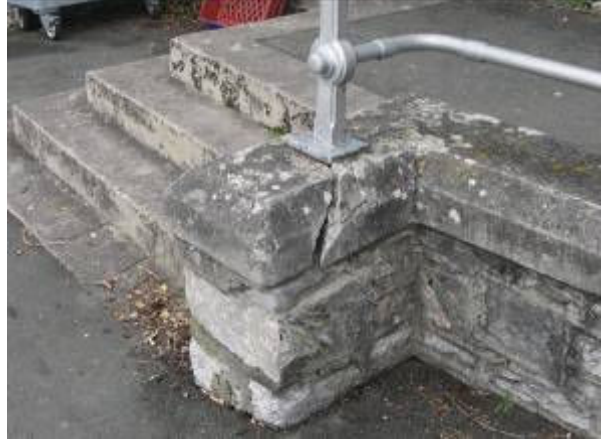
<p>Image 138</p> <p>As above image 137</p> <p><b>Work completed</b> ✓</p> <p>→</p>

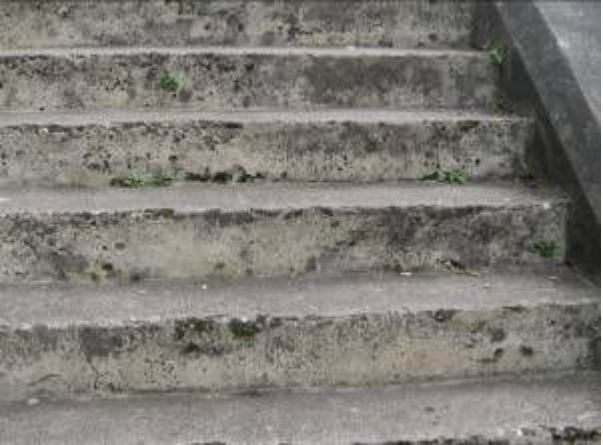
<p>Image 139</p> <p>Edge of steps worn, hand rail missing</p> <p><b>Work completed</b> ✓</p> <p>←</p>
